Fatigue Testing and Retrofit Details of High-Mast Lighting Towers

RYAN J. SHERMAN, MATTHEW H. HEBDON and ROBERT J. CONNOR

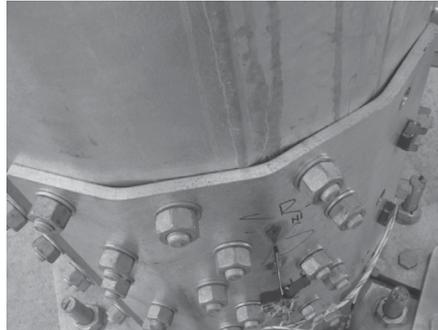
Additional fabrication and fit-up issues were encountered during the installation of the jacket retrofits. A fabrication error resulted in poor alignment between the breaks in the pole and those in the jacket. It was believed to be a result of a combination of inaccurate field measurements and radial misalignment (see Figure 8 for resulting retrofit fit-up). This fabrication issue was only present in the short-jacket retrofit.

Fig. 8. Short-jacket retrofit misalignment.

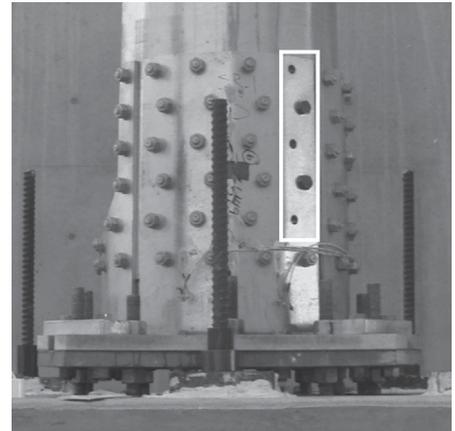
In addition, the internal winch plate on the as-built tube wall conflicted with bolt holes in both the tall and the short-jacket retrofits. The box in Figure 9 highlights the location of the conflict on the short-jacket retrofit. The decision was made to omit a number of fasteners to represent a worst-case field-installed condition.

Fig. 9. Short-jacket retrofit with bolts removed at winch plate conflict.

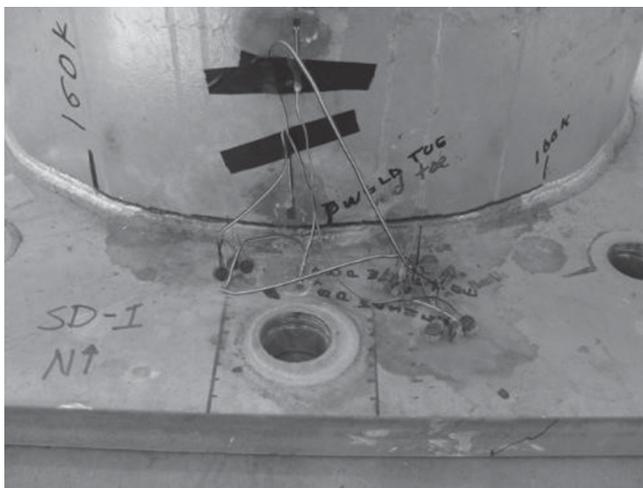
AB_1 had cracks of 14 in. (see Figure 11) on the south and 3.5 in. on the north. Specimen AB_2 had cracks of 21.5 in. and 17 in. (south and north, respectively). All cracks initiated from the base plate to tube wall weld at the upper weld toe. Both tests were stopped due to the size of the fatigue cracks.

Fig. 11. Cracking on south face of AB_1.

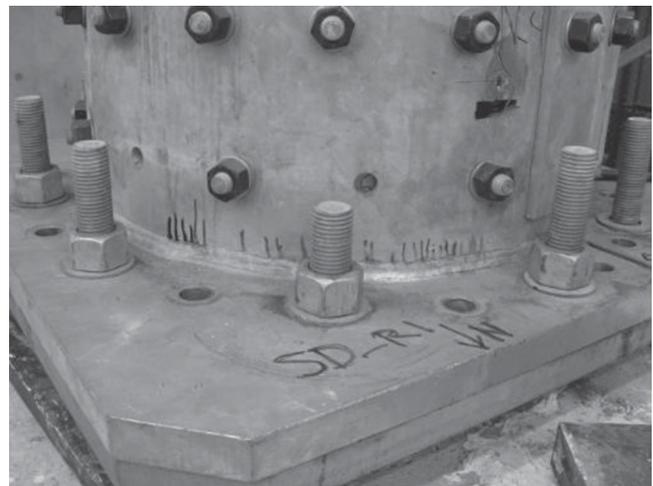
Fig. 12. Specimen TR_1: north crack at upper weld toe after inspection with dye penetrant.

(see Table 1). In two specimens (TR_1 and TR_3), cracks formed at the tube-to-base plate connection in the upper weld toe at the point of maximum stress. Specimen TR_2 was considered a runout for this test after cycling more than 10,000,000 cycles. The other two specimens had fatigue cracks that initiated in the weld toe at the points of maximum stress. Figure 12 shows the completed TR_1 specimen with fatigue cracks after using dye penetrant to verify crack length. The final crack length for specimen TR_1 was 21 in., while TR_3 had a crack measuring 19.5 in. All tests were stopped due to the crack length.

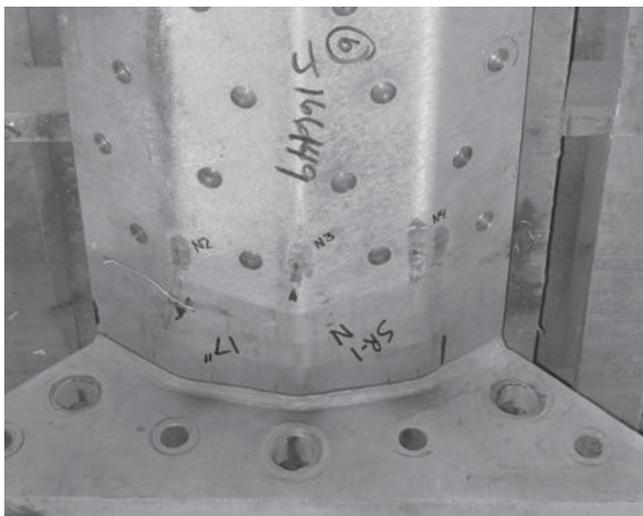
Strain gages were placed in similar locations as the tall jacket in order to compare behavior. The stress range was maintained in the as-built pole at 8 ksi for the short jackets. Specimen SR_1 had a fatigue life of 1,146,000 cycles, specimen SR_2 had a fatigue life of 2,323,000 cycles and specimen SR_3 had a fatigue life of 5,037,731 cycles before reaching failure (see Table 1). Fatigue cracks initiated at the points of maximum stress and generally had consistent crack growth. Cracks initiated at the upper weld toe of the base plate-to-tube wall connection and grew circumferentially. Each of the three specimens formed cracks at both sides of the jacket (where stresses were highest). Crack lengths varied from 2.0 in. to 17.0 in. (see Figure 13 for cracks on specimen SR_1). Once again, all tests were stopped due to crack length.

Fig. 13. Specimen SR_1: north crack at upper weld toe after inspection with dye penetrant.
