Old Bridges Give Clues to Steel Deck Performance

ROMAN WOLCHUK

Two notable examples are the Harlem River Bridge and the Bronx-Kill Bridge in New York City built in 1936 and recently resurfaced. The writer had an opportunity, on behalf of American Iron and Steel Institute, to investigate the conditions of these steel decks after 27 years of service.

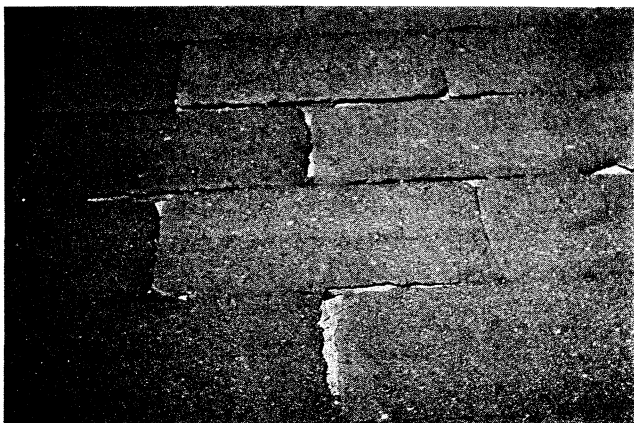
There are indications that the difference in performance of the planking on the two bridges was due, primarily, to the difference in the quality of the original plank and the difference in method of placement of the planks on the deck.

The manner of placement of the plank is responsible for its bond to the deck and is very important because deterioration starts as the bond along the plank periphery is broken, and the plank begins to crumble at the edges, progressively exposing the deck (Fig. 2).

Fig. 2. Deteriorated original planking, Bronx-Kill Bridge

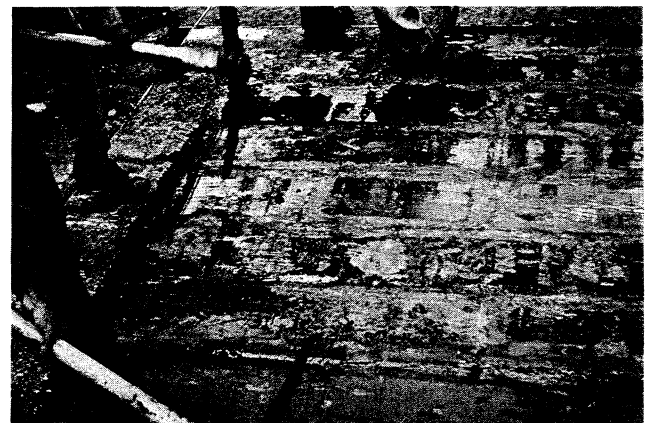
Adhesion of the plank to the deck was very strong, and the bond was unbroken under the middle portions of the planks (Fig. 3), where the original asphalt cement was found to be still tacky. Around the periphery of the planks the bond was broken over a width of 2 to 4 in., and dust from the pulverized bituminous coating and the plank material had accumulated there. Whatever cor-

Fig. 3. Removal of planks by pick. Shiny surfaces are areas where the bond between the plank and the deck was intact

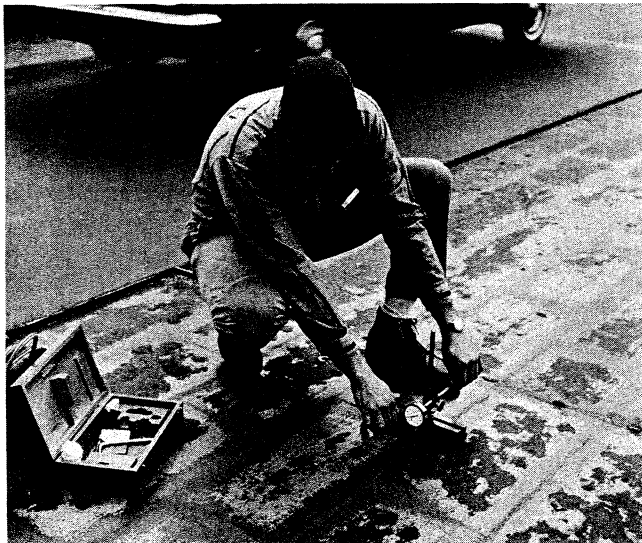
The effects of corrosion consisted of streaks of shallow pock marks, pits and scars following the outlines of the planks where the bond between the deck and the plank had failed. Outside of these strips, generally from 2 to 4 in. wide, the deck was not affected by corrosion.

Depths of corrosive pits and scars in the deck surface ranged in typical cases from 4 to 40 mils. Depths were measured directly by a dial indicator which could be moved horizontally along a steel base. Fig. 7a shows a characteristic profile across the affected strip corresponding to the conditions shown in Fig. 4; Fig. 7b shows a similar profile corresponding to the somewhat deeper scars in Fig. 5.

Fig. 4. Dial indicator measurements of typical deck surface condition. Corresponding profile is shown in Fig. 7a

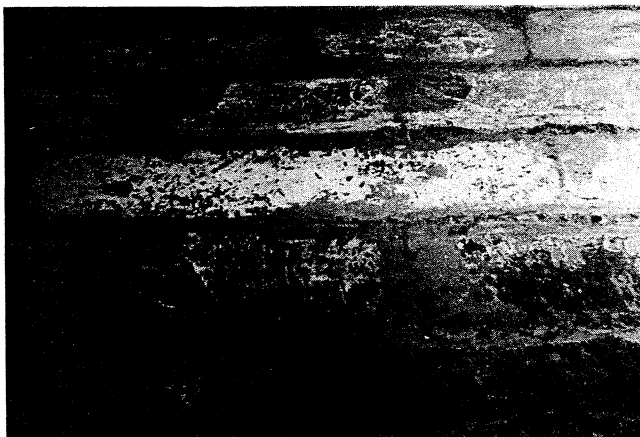
Fig. 5. View of typical deck surface condition, revealing only shallow corrosion marks and pits. Corresponding profile is shown in Fig. 7b

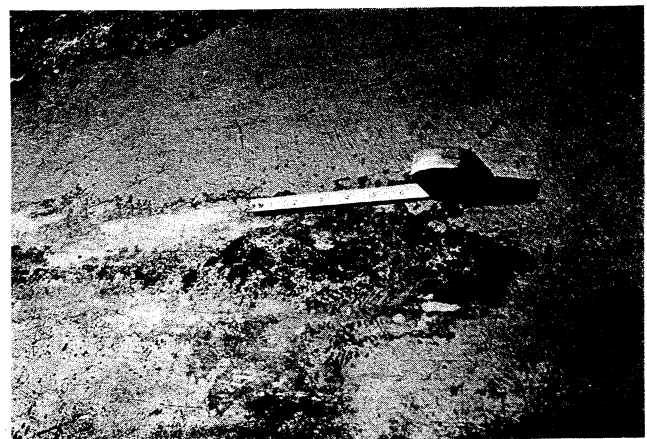
Deeper and more extensive pits were observed only infrequently. Figure 6 shows a cluster of pits and scars, surrounded by an area entirely unaffected by corrosion; the corresponding cross section is given in Fig. 7c. It shows that the depth of pit measured from the original steel deck surface was about 75 mils, or somewhat less than $\frac{1}{16}$ in. The deepest pit recorded anywhere on the decks was 115 mils. In general, however, conditions shown in Figs. 8a and 8b were typical.

Fig. 6. Deeper corrosion pits, observed infrequently. Surrounding area unaffected by corrosion. Typical profile in Fig. 7c

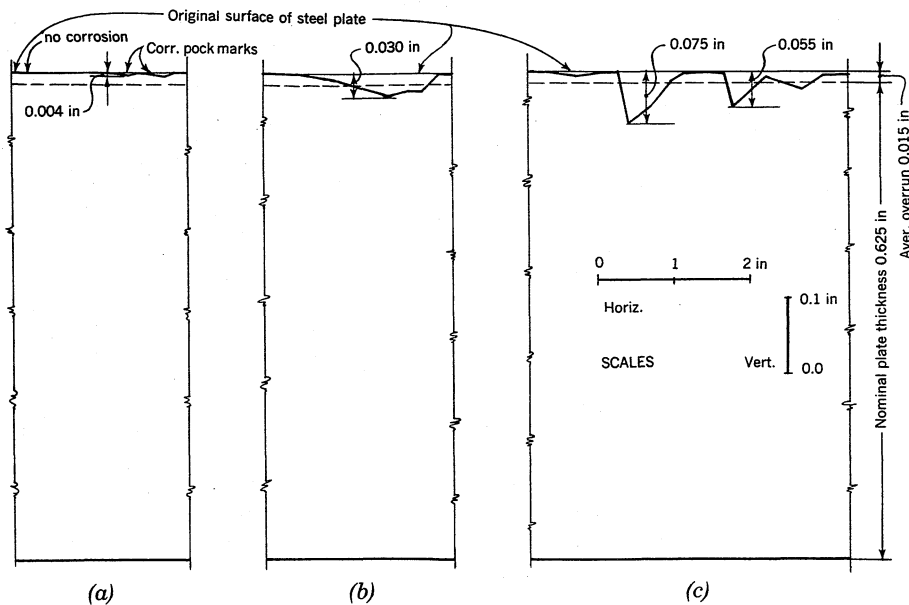
Fig. 7. Typical deck surface profiles

(a) Profile corresponding to Fig. 4

(b) Profile corresponding to Fig. 5

(c) Profile corresponding to Fig. 6
