Experience with Use of Heavy W Shapes in Tension

JOHN W. FISHER and ALAN W. PENSE

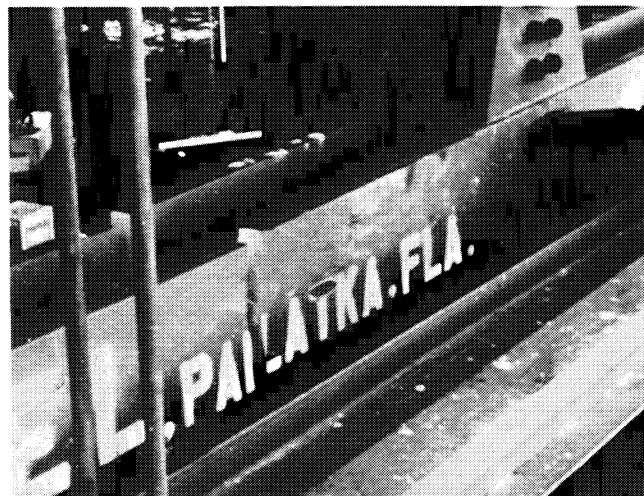
Fig. 1. Fractured chord of Orlando Civic Center truss

The fracture in the bottom chord of the truss shown in Figs. 1 and 2 originated from a crack formed from the flame-cut surface of the web cope hole in a W14 × 370 A572 Gr.50 steel section. Figure 6 shows the fracture surface and a closeup view of the crack origin. The dark oxide-covered surface extends 1.15 in. from the edge of the cope into the flange; its maximum width 2.75 in. At the other end of the web cope, no obvious cracking was visible, as shown in Fig. 7. This area was saw-cut from the section and the flame-cut

Welded attachments should be limited to the surfaces of jumbo sections where significantly higher fracture resistance exists. This permits surface welds to be made without introducing adverse conditions at the fusion line and weld termination. All welding processes result in nonmetallic microdiscontinuities at the toes of groove and fillet welds. These will have no significance for static behavior with the levels of absorbed energy in the surface layer of all the sections examined. Surface welds will not result in the embedment of these discontinuities into the material that is very notch sensitive. As a result, loads applied through exterior welded attachments will not be affected by the interior grain structure and notch sensitive material. This has been demonstrated in many service applications, including trusses shown in Fig. 1.

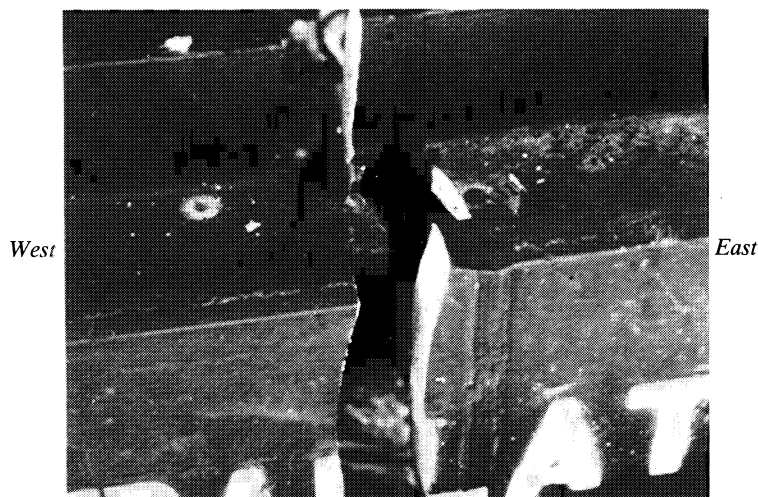
The cracks that developed have all been associated with groove welded splices in the flanges and webs of the steel sections. In the fracture shown in Fig. 2, the crack originated from the flame-cut copes in the web adjacent to the flange groove welds and extended into the web-flange core (i.e. the web-to-flange intersection). Other cracks have originated from the termination of groove welds in the web,

Fig. 2. Close-up of fracture

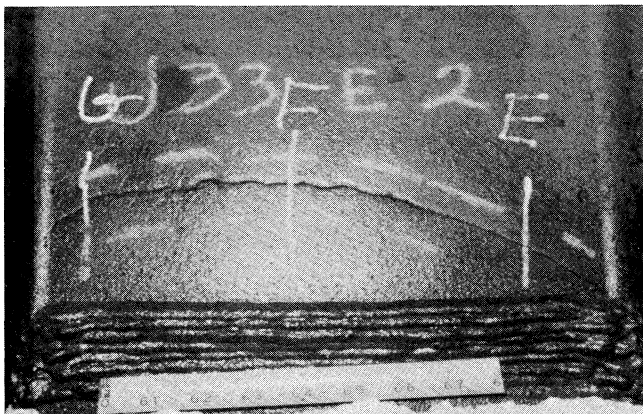
Fig. 3. Cracked column web originating at groove-welded web splice termination

The cracks that originated from the web groove weld termination shown in Fig. 3 occurred in W14 x 730 A572 Gr.50 steel sections. However, this material was supplied as killed, fine-grain practice steel. Figure 13 shows a schematic of the column splice at the cracked section. Partial penetration welds were placed in the flange and a double bevel groove weld in the web. At the weld ends, the bevel was radiused to the surface. Production of the web groove welds creates high tensile residual stresses in the longitudinal and transverse directions of the weld as it shrinks and cools. As a result, the weld termination resides in a region of yield point residual tensile stress in the web of the rolled section.

The cracks developed in these sections occurred even when preheat and postheat treatments were used. At the time cracks formed, ambient temperature was between 25 and 40° F. The crack shown in Fig. 4 likely occurred from an embedded defect on the fusion line of the rolled section. No core was removed at the crack origin so this was not verified by examination.

The cracks formed in the column webs in Figs. 3 and 4, result from the low level of fracture toughness in the core and adjacent web centerline and the high residual stresses from weld shrinkage. The joint configuration insures the web weld terminates in a region of low fracture toughness. The resulting transverse and longitudinal weld shrinkage insures that this region is at the yield point. The stress intensity at the weld end can be defined

It does not seem advisable to provide web-groove welds (partial or full penetration) that terminate in or are adjacent to the web core. Since milled surfaces usually exist, it is impossible to provide web-groove welds without significant levels of residual stress. Hence, the possibility of initiating crack instability will be great. Whatever shear or load transfer that is required from the web should be accomplished by using splice plates fillet-welded to either the web surface away from the core or the flange tips.

Care should be exercised in the use of groove welded web splices in column sections. It would be preferable to use fillet-welded shear plates attached to the section surface or a bolted shear splice, as in Fig. 35.

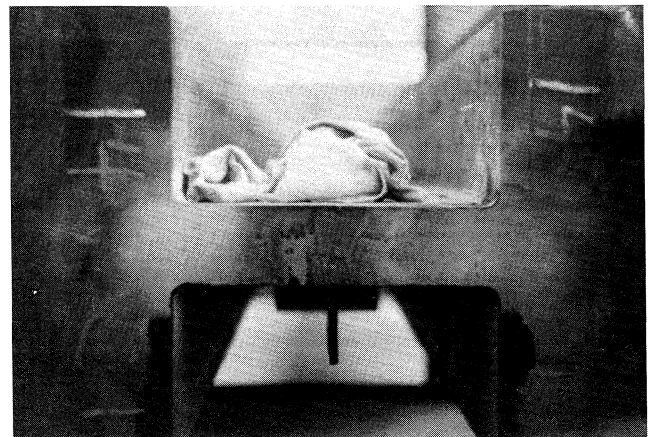
(a). Milled end of column at splice

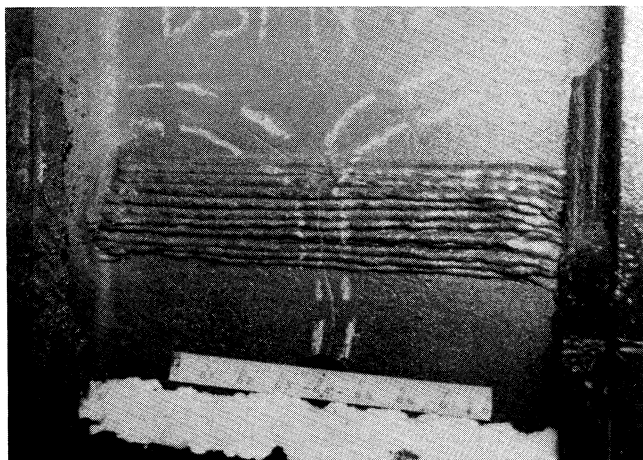
Fig. 4. Cracked column web originating at groove weld

flanges. For the crack in Fig. 4, it is probable an internal defect near the fusion line initiated crack instability. The stress intensity factor for this condition can be approximated as

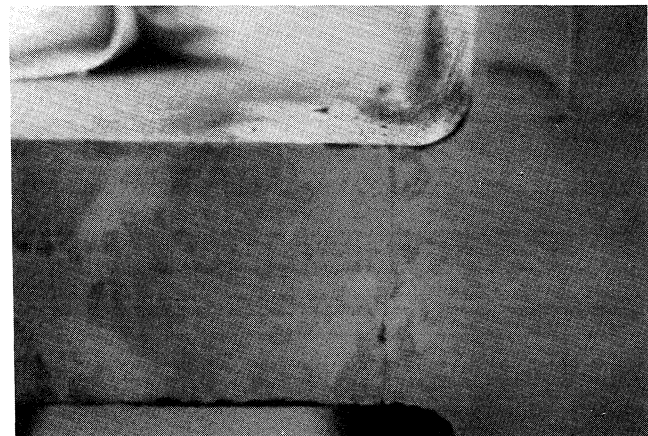
(b). Longitudinal crack in web
Fig. 5. Crack originating from flame-cut edge

The cracks detected in the milled end of the column in Fig. 5 were observed to form from the flame-cut edge. These cracks extended about $\frac{3}{4}$ in. into the length direction of the section. These columns were also W14 \times 730 A572 Gr.50 steel sections. As apparent from Fig. 11, a thin martensitic layer can be expected at the flame-cut edge. Also, residual tensile surface stresses will develop as the cut is made and the material transforms from a liquid to solid state and cools. Measurements have demonstrated that yield point residual stresses will develop at a flame-cut edge.²

Cracks originating from a flame-cut edge (as in Fig. 5) are oriented in an even lower notch sensitive area. Charpy V-notch tests with a transverse-longitudinal orientation (TL) are in Fig. 34. As can be seen, the absorbed energy is between 1 and 5 ft-lbs. up to 212° F. Hence, lower bound fracture toughness of about 20 ksi $\sqrt{\text{in.}}$ appears appropriate for this orientation.

This indicates the yield stress σ_y will initiate crack extension into the section. These cracks will arrest as they extend out of the residual tensile stress region. Noted earlier, this type of crack was observed to extend 0.5 to 0.75 in. into the shape before arresting.

When flame-cutting large jumbo sections, care needs to be exercised to prevent the formation of brittle untempered martensite. This can be minimized with preheat and post-heat treatment. Fortunately, the longitudinal cracks that form are in a favorable orientation parallel to the stress field and have little effect on the performance of the member.

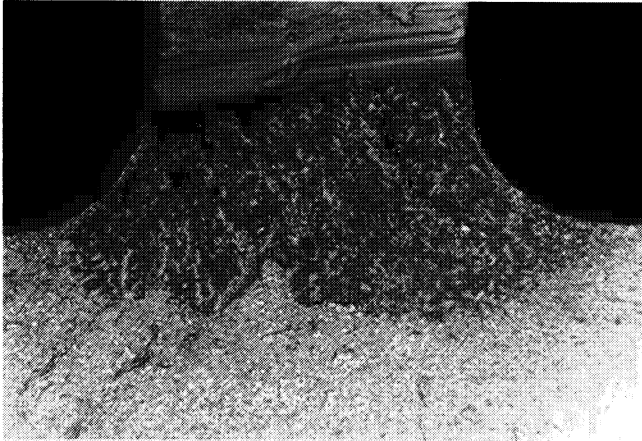
S.W. fracture surface

(b). Close-up view of initial crack at web cope

Fig. 6. Crack surface of tension chord (see Fig. 1.)

The crack surface of the W14 × 370 section from the truss in Fig. 2 is visible in Fig. 6. A dark, oxide-covered region can be seen in Fig. 6b at the core of the web-flange intersection. In general, the crack surface shows a flat cleavage appearance. Some small shear lips are apparent at the flange tips and the bottom surface of the flange. The dark oxide surface in Fig. 6b is the size of the initial crack that existed at the failure cross section. This crack extended 1.15 in. from the edge of the cope into the flange. Its maximum width was 2.75 in.

Of major importance to the formation of the large initial crack observed on the fracture surface (Fig. 6) was the high stress concentration provided by the flame-cut cope, the low fracture toughness of the beam and the stresses from groove welding the two heavy rolled sections together. The groove welds in the web and flanges at shop splices were prepared as follows. First, the beveled ends were fitted up with about 1/8-in. gap and with the flanges vertical. Root passes were made on both flanges with E7018 electrodes to hold the sections together. The top half of the web groove weld was completed, and then the section was turned over, and the web weld was completed. The section was then turned 90°, and the outside half of a flange weld was completed. The second flange weld was also made on the outside half. Finally, the inside weld halves of the flanges were completed.

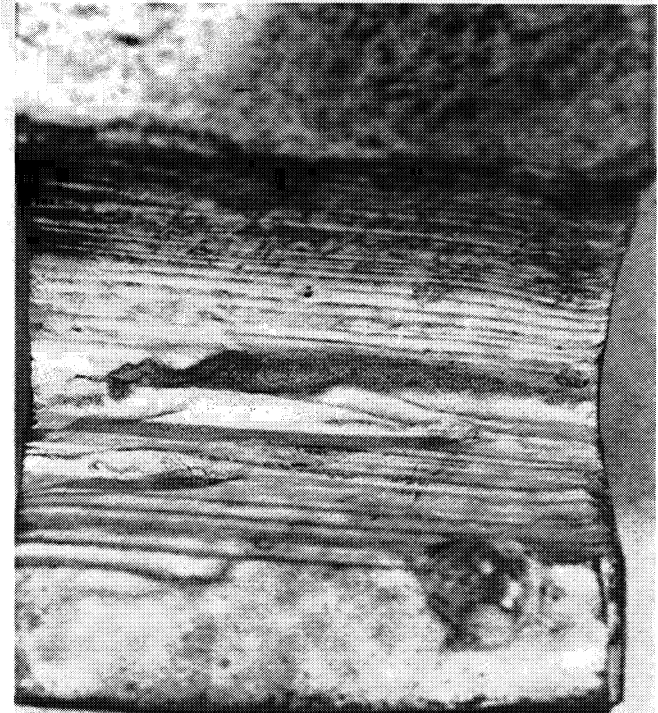
surface treated with liquid penetrant, as seen in Fig. 8. This revealed a crack-like indication. No evidence of cracking was found on either outside surface of the web of this detail.

Fig. 8. Flame-cut cope with liquid penetrant

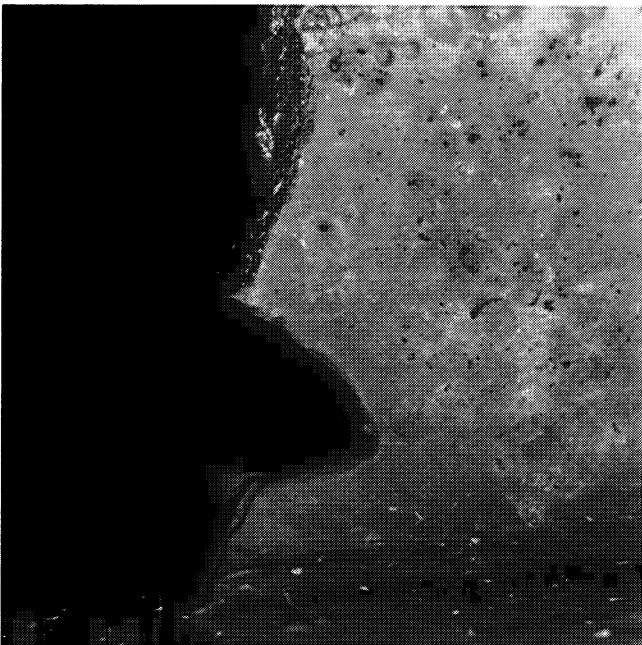
Fig. 7. Cope on east side of flange-groove weld (see Fig. 2.)

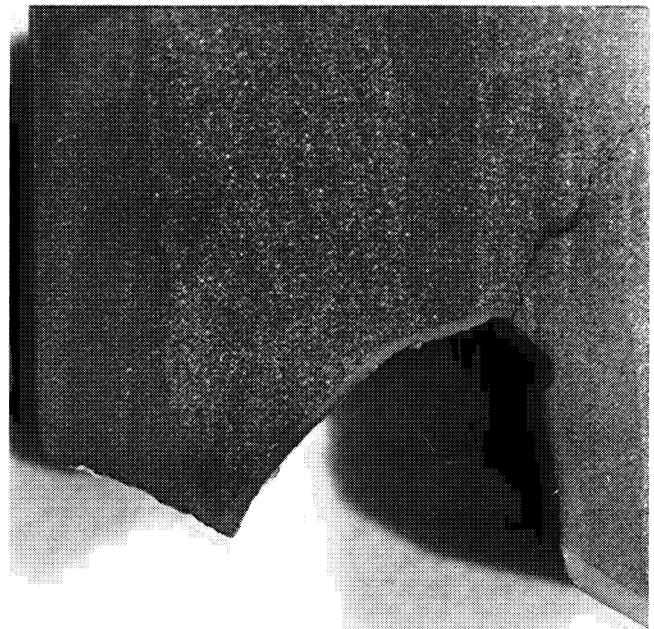
The cope segment was cut into two pieces by sawing at the mid-thickness of the web. This surface was polished and etched as in Fig. 9 which shows the crack originated at the flame-cut edge and extended on an angle into the web-flange core. Figure 10 shows the saw-cut surface of the section where the web was cut from the flange. This crack was found to extend into the flange about the same amount observed at the dark oxide surface in Fig. 6. A martensitic layer can be seen along the flame-cut edge in Fig. 9. A photomicrograph of the crack origin is provided in Fig. 11. The martensitic layer is about 0.025 in. thick. At the crack, the martensite Rockwell hardness (R_c) was 42.5 and varied between 32 and 37 elsewhere along the burned edge.

Fig. 9. Polished and etched section through center of web (see Fig. 8.) showing crack and flame cut edge

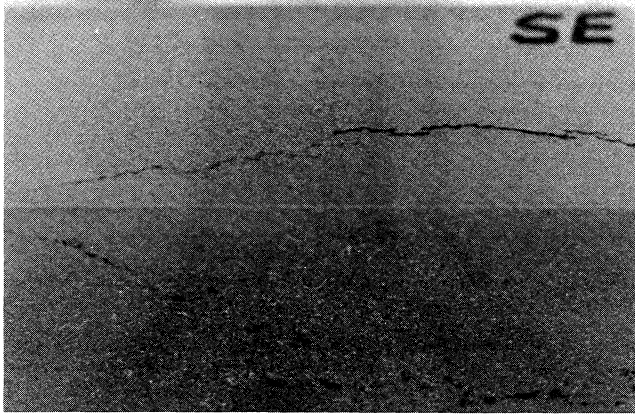
Fig. 10. Liquid penetrant indication showing crack extension into web-flange core

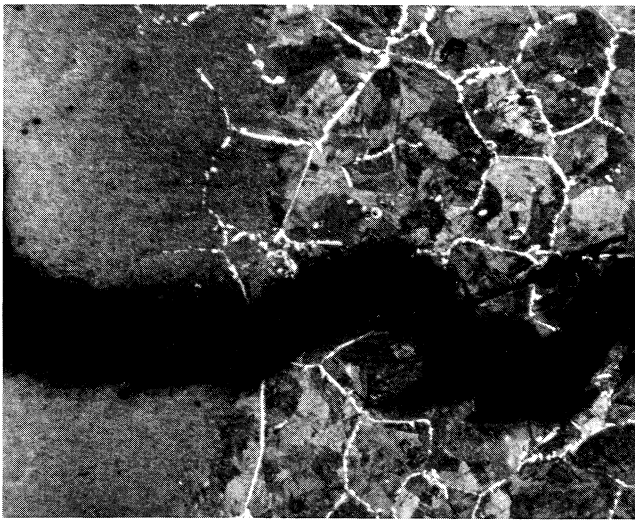
Fig. 11. Photomicrograph showing crack martensite and grain structure @ 40x

Since flame-cutting will often produce a brittle untempered martensite layer about 0.025-in. thick, as in Fig. 11, this can

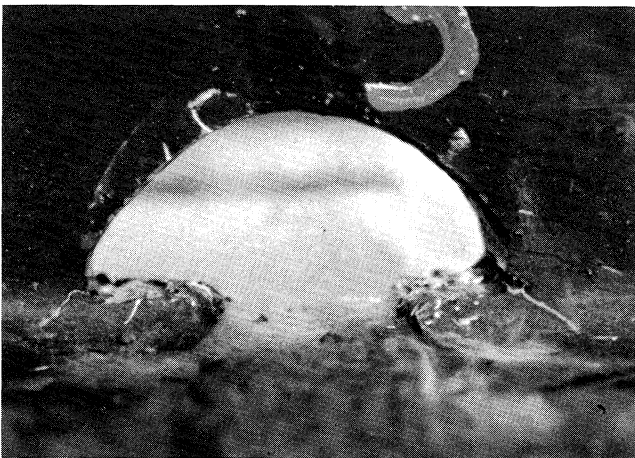
An examination of other flame-cut copes in W14 × 455 and W14 × 500 sections in the structure revealed other cracks, as in Fig. 12. At the section that failed, the web-groove weld was made first, followed by the outside halves

Fig. 12. Crack indications at cope enhanced by magnetic particle

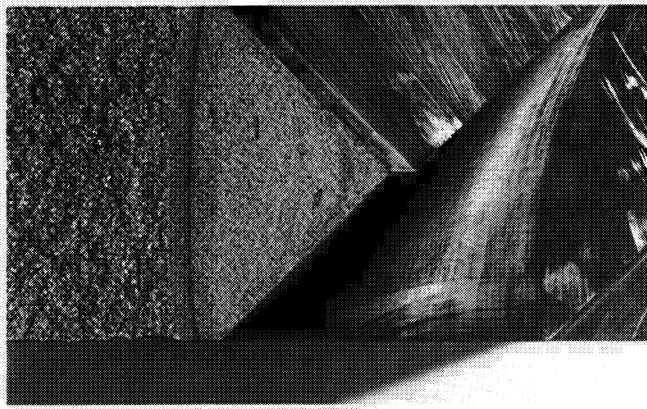
Figure 24 compares the fracture surfaces of the 75° F fracture tests from the W14 × 370 and W14 × 605 shapes. It is apparent crack surfaces show little evidence of ductility. The surface of the W14 × 370 specimen is comparable to the final fracture appearance of the cracked beam flange in Fig. 6. It can be seen that once fracture initiated in the W14 × 605 section that it also exhibited a cleavage fracture appearance over the crack surface.

(a). Fracture surface of compact tension specimen from flange (see Fig. 22. W14 x 370)

Fig. 24. Fracture surfaces of K_{Ic} specimens showing cleavage fracture at 70° F

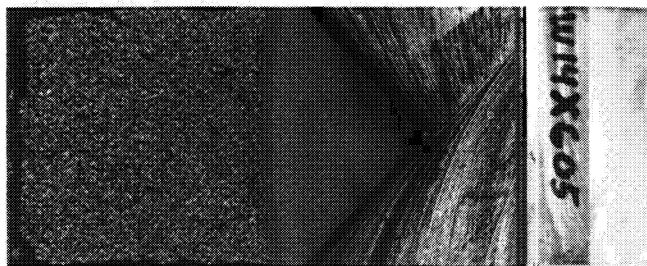
(b). Fracture surface of compact tension specimen from web (see Fig. 22. W14 x 730)

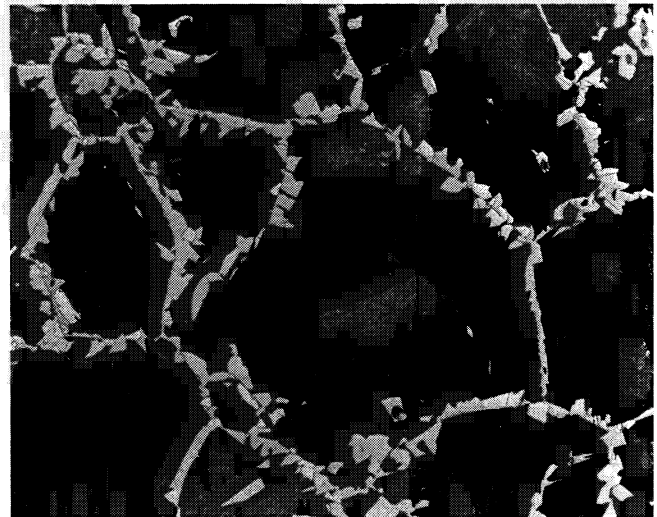
Fig. 25. Microstructure near flange core crack in Fig. 11. @ 100x (W14 x 370)—Supplier A

Figure 25 shows the microstructure of the W14 x 370 section just behind the crack surface in Fig. 6. The ASTM prior austenite grain size (ASTM E112) is between 0 and 1 for the 100x photomicrograph. Figure 26 shows the microstructure adjacent to the crack in the core area in Fig. 9. This also indicated the grain size in the web-flange core

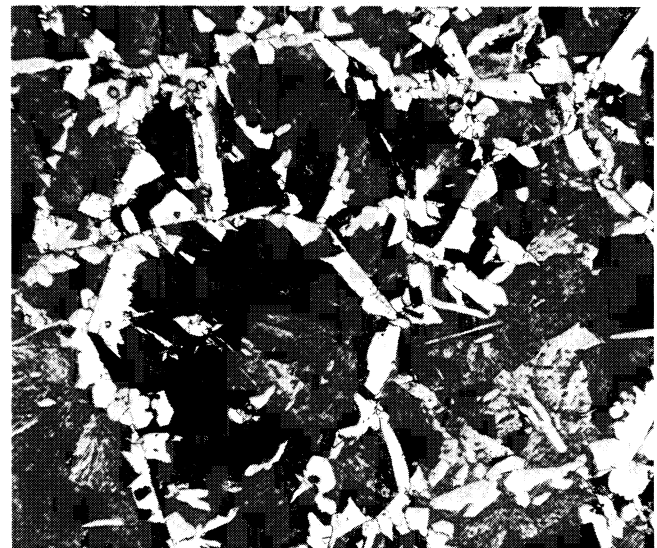
Fig. 26. Microstructure of fractured flange shown in Fig. 6. @ 100x (W14 x 370)—Supplier A

If the pearlite content is unusually high, the prior austenite grain size can be seen. This is the case in Figs. 25 and 26, and to a lesser extent in Fig. 30. The prior austenite grain sizes in both these cases, one of which is a fine-grain prac-

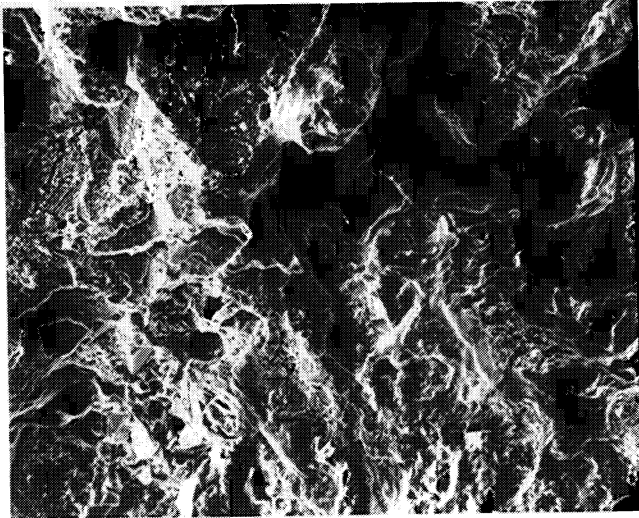
Figures 31 and 32 are fractographs of the darker oxide covered region. Figure 31 (at 200x) shows oxidation, corrosion product and some evidence of cleavage facets. Figure 32, with a higher magnification (2,000x), shows a cleavage facet and some evidence of corrosion. Figure 33 is a view of the cleaner appearing fracture surface that existed over most of the fracture surface. The photomicrograph, adjacent to the darker region, shows fresh fracture with clear cleavage facets. A comparison of Figs. 31 to 33 indicates the darker, oxide-covered fracture region existed for some period of time prior to the final fracture.

Fig. 31. Fractograph of the dark oxide region shown in Fig. 6. showing oxidation, corrosion and cleavage facets @ 200x

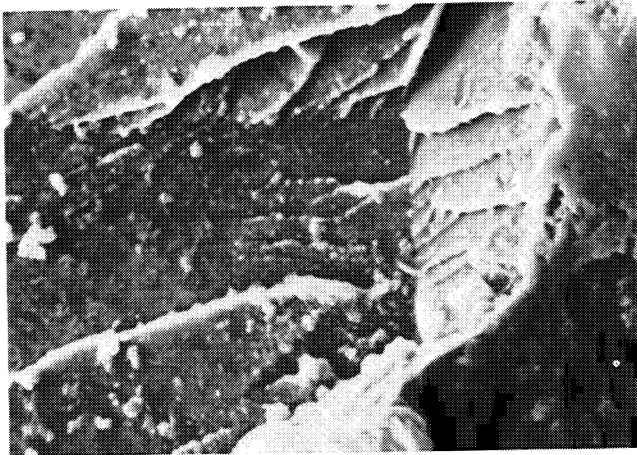
Fig. 32. View of region shown in Fig. 31. @ 2,000x

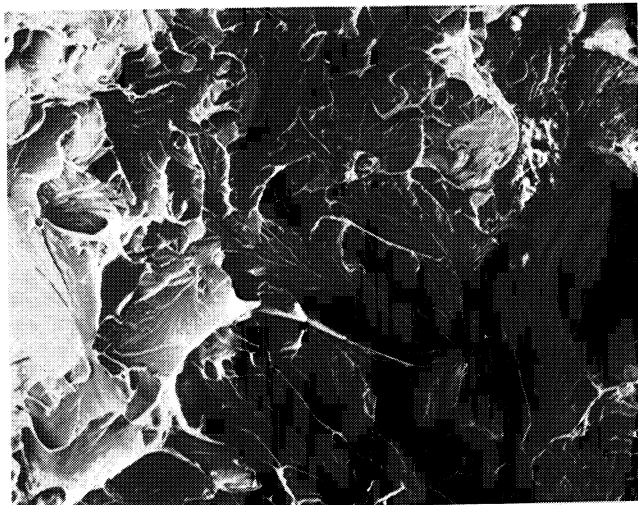
Fig. 33. Fractograph of clean fracture area in Fig. 6 @ 100x showing cleavage facets
