Distortion-Induced Cracking During Transit

W. M. KIM RODDIS

3. CASE STUDY: DISTORTION-INDUCED CRACKING IN BUILDING TRUSSES DURING TRANSIT

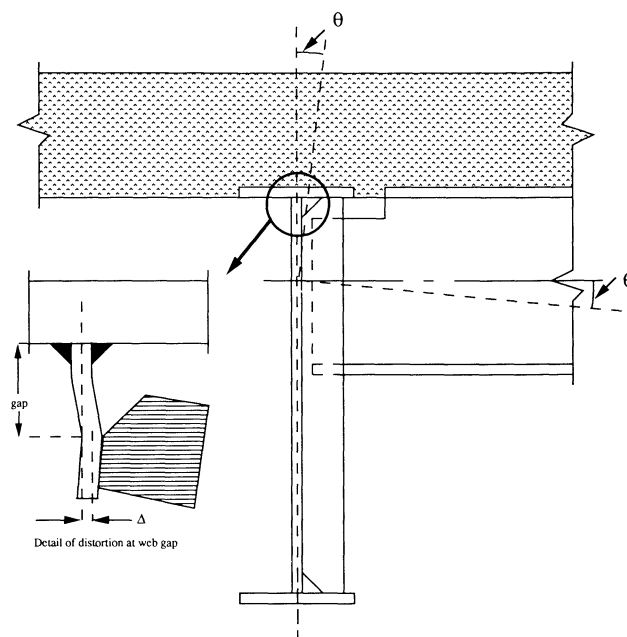
In-service web-gap cracking is illustrated in Figure 3.¹ The floor-beam to girder connection detail shown in Fig. 3 is susceptible to distortion-induced cracking at the small web gap at the top of the floor beam connection plate. As the floor beam carries traffic loads, the end of the beam rotates, forcing the deflection of the girder web out of its normal longitudinal plane. There is a small ($\frac{3}{4}$ -in. to 1 in.) gap between the top of the floor beam connection plate and the top girder flange.

This web gap causes an abrupt change in stiffness, concentrating the rotation-induced distortion within a short length of the girder web. Forcing the distortion to take place in such a small space introduces high stress ranges in the gap. Repeated pumping of this short gap leads to longitudinal cracking of the web at the weld at the top of the connection plate and at the weld connecting the top flange to the web. This type of web-gap cracking at floor beam or floor beam truss connection plates is so prevalent that a survey in one state revealed cracks in half of the bridges with this detail.⁶ Diaphragm and cross-beam connections are frequently the sites of similar web-gaps, but have less severe imposed rotations that the floor beam case illustrated. This kind of web-gap detail usually occurs where the top flange is in tension and arises for the ironic reason that the connection plates were not welded to the flange to eliminate an initiation site for load-in-

Fig. 3. Web-gap cracking during service.

duced fatigue of the tension flange.⁹ To preclude distortion-induced cracking, the connection plate must be either rigidly attached to the flange as required in the AASHTO provisions, or the gap length must be significantly increased. Increasing the gap length does not always solve the problem of distortion-induced cracking. The increased flexibility may lead to increased deformations in the web gap and, consequently, the same stress levels. In-service web-gap cracking has been observed in all of the following types of details:

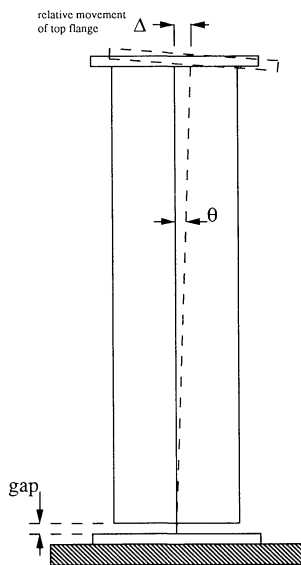
Web-gap cracking happens not only under in-service conditions but also during handling and shipping. Web-gap cracking during transit is illustrated in Fig. 4.¹ The conditions present (a stiffness discontinuity, a periodic displacement, and a weld toe) are conducive to distortion-induced cracking. An abrupt change in stiffness occurs at the short web gap between the inside face of the flange and the beginning of the stiffeners. Such a gap may also occur between the inside face of the flange and the beginning of a connection plate. The periodic force operating within the gap is caused by the cyclic

distortion as the girder sways during shipment. The bottom of the girder is supported on the truck or rail car bed. The upper part of the girder displaces relative to the bottom of the girder due to the rocking motion of transit. These sway displacements can introduce large cyclic bending stresses in web-gap, leading to fatigue cracking in the web. The cracks typically begin at a weld and are oriented longitudinally on the girder, parallel to the primary axial stresses produced by in-service major-axis bending of the girder. This orientation mitigates the effect of the cracking and eases the repairs required to ensure satisfactory service behavior. Web-gap cracking has also been observed in the fabricating shop as the girders were handled and turned. Cracking in the fabrication shop also occurred in a large stiffened web plate where web-gaps existed at the intersection of vertical and transverse stiffeners that were not connected to each other.

Fig. 4. Web-gap cracking during shipping.

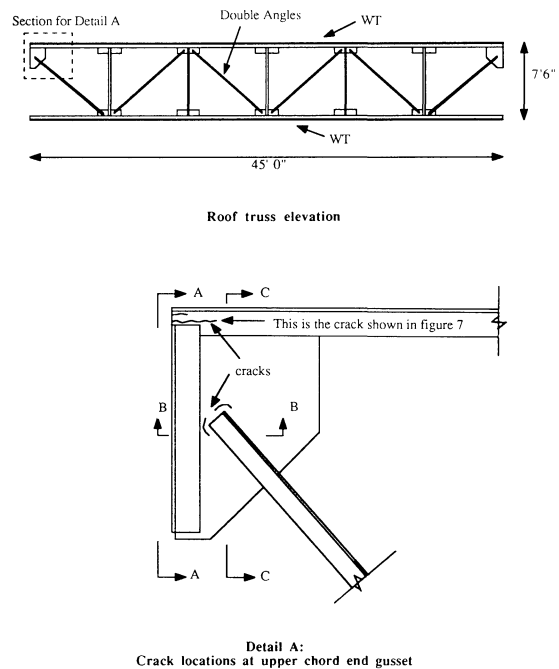
Cracks were first observed in the end gusset plates by ironworkers when unloading and sorting trusses at the erection site during the winter. An initial investigation was made at that time and concluded that the cracks were fatigue cracks caused by vibration of the cantilevered ends of the trusses during truck delivery to the site. The trusses were shipped by truck from the fabrication plant to the construction site for an over-the-road distance of approximately 800 miles. The trusses were shipped in a horizontal position as shown in Fig. 6. Trusses were stacked six high, with a weight limit of 40,000 pounds per truck. The trusses were secured with chains at both ends and at two or three panel points between. The trusses were not originally blocked at the ends but rather were shipped with the ends cantilevered from blocking at the support points, one panel point in from each end. In response to the observed cracks, changes were made to maintain minimum steel temperature during welding and to limit the vibration amplitude of the truss ends during shipping by adding end blocking as shown in Fig. 6. These changes reduced, but did not eliminate, the development of cracks. Even after the blocking changes, the top of the stacked trusses experienced

Fig. 5. Roof truss elevation and details.
Detail A: Crack locations at upper chord end gusset.
Detail B: Crack locations at bottom chord end gusset.

Cracks in the end of gusset plates again were detected visually by ironworkers while bolting end connections of trusses to columns. A visual inspection of the erected trusses identified approximately 170 trusses with cracking. Magnetic particle testing confirmed cracking in the metal for approximately 140 of these trusses. The total number of trusses on the job was approximately 4,000. All cracks were found at the ends of the trusses. No cracks were found at interior panel points. Crack lengths varied between 1/4-in. and 4 in. and were typically about one inch long. Some cracks appeared on both sides of the stem or plate, while other cracks appeared on only one side. Crack locations may be categorized as follows:

1. Stem of tee top or bottom chord at base of rolled radius, running parallel to radius, see Fig. 5, Detail A.
2. Stem of tee top or bottom chord at edge of fillet weld at top of clip angle, running along weld at angle toe, see Fig. 5, Detail A.
3. Top and bottom end gusset plate at edge of fillet weld heel and toe of diagonal angles, see Fig. 5, Detail A.

The probable cause of cracking was therefore concluded to be displacement-induced cyclic stress during shipment. The observed crack locations were in thin plates subject to cyclic bending where short gaps would be expected to result in a geometric amplification of the cyclic stress leading to cracking. The cracks initiated on one or both faces of the plates, most frequently at the toe of fillet welds but sometimes at a rolled radius. The cracks grew by fatigue through the thickness of the plates. Vibration amplitudes of 0.04 in. to 0.2 in. at the end of the clip angle and 0.5 in. to 2.5 in. for sway at the top of stacked trusses are sufficient to produce the observed cracking over the given shipment distance. The vibration amplitudes and number of loading cycles required were in agreement with expected ranges for trusses shipped in this manner. For this case, blocking of the clip angle (Fig. 5, Detail A) would be recommended for proper shipping.

The cracks in the roof trusses were repaired by gouging and rewelding. Although this was an appropriate repair technique for building trusses subject to static loads, gouging and rewelding is not an appropriate repair for bridge members. An alternate suggested repair of drilling holes approximately 1/2-in. in diameter at the ends of the cracks was not used. Either of these repair procedures were appropriate in view of the cause of cracking and the required in-service behavior of the

The cracks in the stem of the tee at the rolled radius and at the top of the clip angle were in regions carrying negligible loads in service. This material could be completely coped out without decreasing the strength of the trusses for in-plane behavior. Gouging and rewelding was a more than adequate fix in this region. Drilling holes at the end of the cracks to eliminate the stress concentration at the sharp crack tip would also have been a satisfactory fix.

The cracks at the ends of the diagonals were in a stressed region of the gusset plate. Gouging and rewelding was an adequate fix in this region. Where sufficient net area and sound weld remained for full load transfer, drilling holes at the ends of the cracks also would have provided a satisfactory repair at the ends of the diagonals. The condition of the crack with end holes would have then been analogous to any other situation resulting in a reduced section at this location such as the presence of bolt holes or a penetration opening through the gusset.

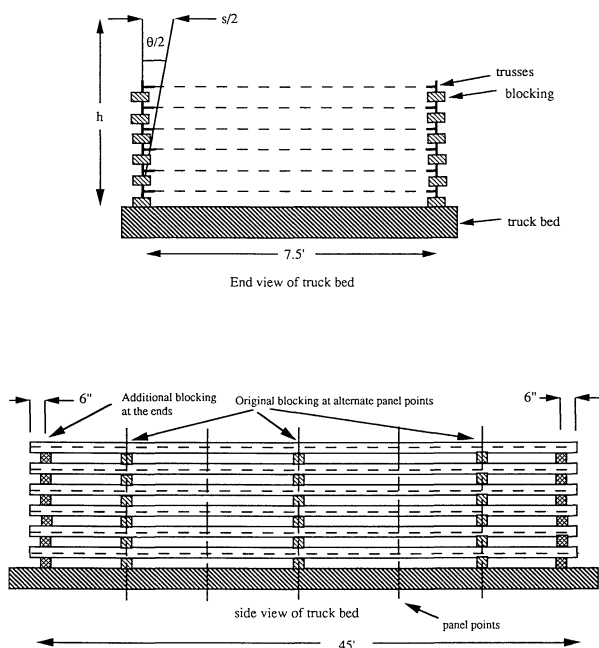
Fig. 6. Schematic of truss shipping arrangement.

To understand the cracking behavior in these trusses, it is necessary to propose a mechanism for fatigue that agrees with the fractographic evidence and then verify by the application of fracture mechanics that known conditions would be reasonably expected to produce the observed cracks. The fatigue mechanism postulated is displacement-induced cyclic stress during shipment. The trusses were shipped by truck in a horizontal position stacked six trusses high as shown in Fig. 6. The top of the stacked trusses swayed and the ends of the trusses vibrated to an extent easily observable by the eye during shipping. Distortion-induced stress would have occurred during transit due to differential rotation across small gaps. The magnitude of the stress range for a particular gap would have been dependant on the amount of rotation occurring across that gap. Gaps and associated rotations are illustrated for all three cracking types identified in Section 3.1 and shown in Fig. 5, Detail A. The size of the gaps for Section A-A and B-B is approximately 1.5 in. The gap in Section C-C is much larger, measuring about one foot. Section A-A marked on Fig. 5, Detail A is drawn in Fig. 8. This section shows how a cyclic vibration at the end of the clip angle leads to a stress range in the gap in the stem of the tee chord between the rolled radius and the fillet at the top of the clip angle. The stress range for the gusset plate at the gap between the toe of the diagonal and the toe of the clip angle on the Section B-B shown in Fig. 5, Detail A may be addressed in a similar way. Section C-C shown in Fig. 5, Detail A, experiences rotation due to the sway of the stacked trusses as shown in Fig. 6.

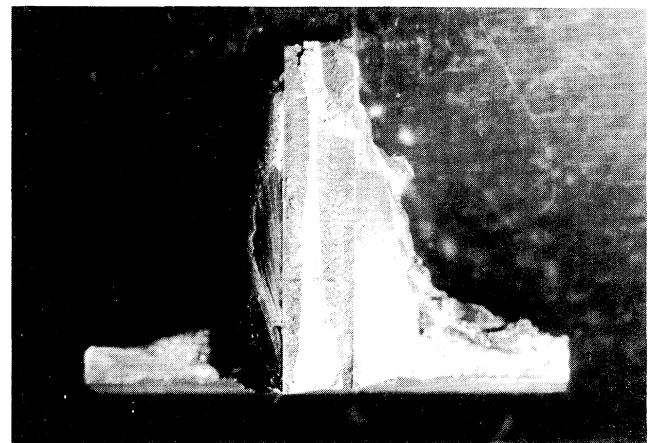
Fig. 7. Fracture surface.

weld at top of clip angle, as noted in Fig. 5, Detail A. This photograph shows the pattern typically observed where the cracks apparently initiated as edge cracks on both faces of the plate and grew to the center, meeting to create through cracks for a portion of their length.

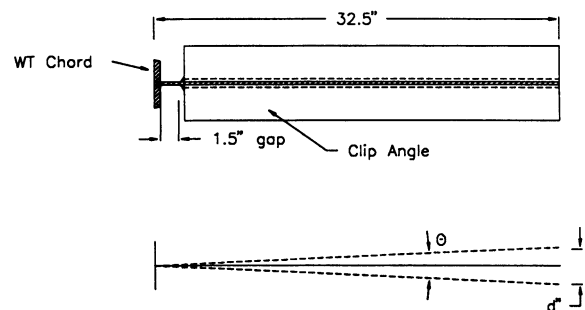
The number of stress cycles may be bracketed by upper and lower limits as follows. The natural frequency of the clip angle extension (Fig. 8) was observed to be about eight cycles per second. At a speed of 50 miles per hour, this gives 567 cycles per mile which compares reasonably to known shipping cycles of 500 cycles per miles for rail.¹ For a shipping distance of 800 miles, this results in 450,000 cycles or approximately half a million cycles as a reasonable upper bound. The sway frequency of the stacked trusses may be roughly guessed at less than one cycle per second. The lower bound may be set at a order of magnitude less than the upper, or approximately 45,000 cycles.

Fig. 8. Deformation in stem of tee, Section A-A from Fig. 5 Detail A.
