The Effects of a Severe Fire on the Steel Frame of an Office Building

ROBERT J. DEXTER and LE-WU LU

ABSTRACT

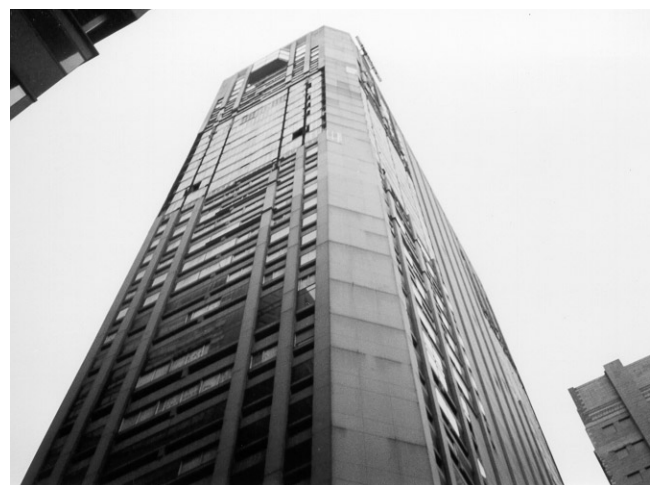
A high-rise office building (Figure 1) suffered a fire that burned for more than 18 hours and involved nine stories near the top of the building, arguably one of the worst high-rise fires in U.S. history. Typically, the fire was burning in as many as three floors at a time as it progressively moved up the building. Based on observations, it is estimated that the most intense part of the fire at each floor occurred over a two-hour period.

Fig. 1. High-rise steel framed building showing boarded up floors near the top where a fire occurred.

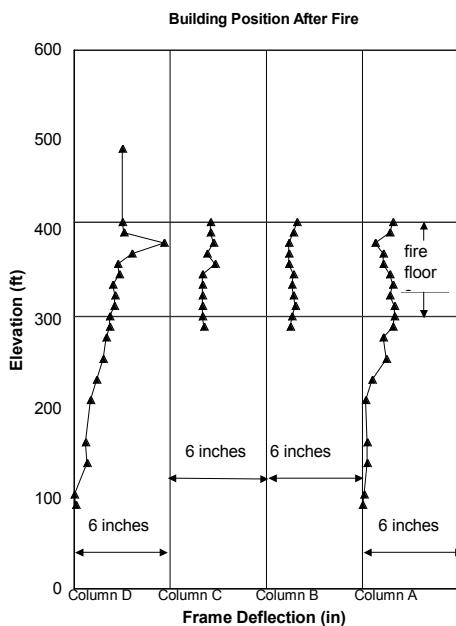
Figure 2 shows the results of a survey of the positions of the columns after the fire. Figure 2 shows that the building leans toward the Column-A side, a trend that begins well below the fire floors, indicating that possibly the building was erected out-of-tolerance or had displaced due to eccentric gravity load. However, it is also apparent that the floor

systems of the fire-affected floors had contracted and were pulling the outer columns inward on these floors.

Many of the columns on the fire floors were well outside the erection tolerances of the AISC *Code of Standard Practice*. Typically, the columns were within an envelope equal to twice the AISC erection tolerances, with one exception at about 380 ft. The displacement at this location was 5.6 in., while the erection tolerance of the AISC *Code of Standard Practice* is 2.4 in. However, more than 8 percent of the columns on the floors well below the fire were also out of tolerance. For example, 65 percent of the columns on floor 13 were found to be out of tolerance, nine stories below the fire.

The interstory displacements on the fire floors were typically less than 1 in., although one column was displaced 1.5 in. in one story, which is much larger than the 0.28-in. ($L/500$) tolerance. (Each story height was 140 in.).

Fig. 2. Surveyed position of the four major columns in one frame.

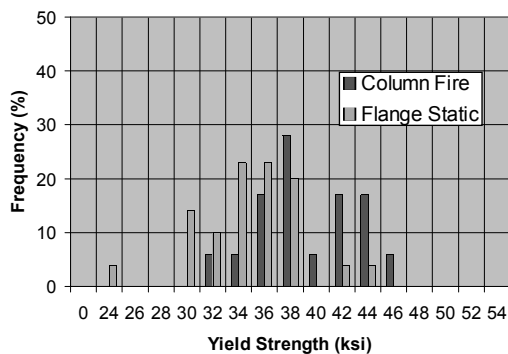
strength due to the fire. The yield strength was measured in typical quasi-static tensile tests. The results are compared to a large database of yield strength values from quasi-static tests of flanges of A36 rolled shapes performed at Lehigh University in the 1960s and 1970s (Tebedge and Tall, 1973; BJORHOVDE, 1972; Tall and Alpsten, 1969). Figure 3 shows the histograms of the distribution of yield strength values from the fire-affected columns compared to the Lehigh database.

In this figure, the bars representing the fire-affected columns are on the left while the data from Lehigh database (labeled "flange static") are on the right. The very low values of 24 ksi and 30 ksi are from the unaffected columns. The yield strengths of a few of the columns that had been exposed to the fire were below the specified minimum yield strength of the A36 specification. However, it can be seen that the rate of occurrence of these lower strength values was no greater than would be expected in the population of rolled shapes unaffected by fire. Therefore, it can be concluded that the fire did not reduce the yield strength of the columns significantly.

Fig. 3. Comparison of yield strength of flanges of column sections after the fire (bars on the left) to distribution of yield strength from flanges of a large number of A36 structural steel sections unaffected by fire (bars on the right).

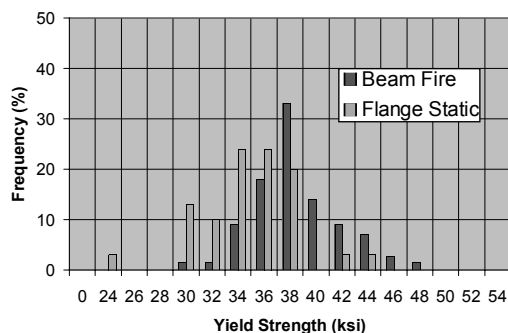
Figure 4 shows a similar comparison for the samples taken from fire-affected beams. The beams were obviously heated to greater temperatures than the columns and suffered a great deal of damage, but even these beams do not show a distribution of yield strength values that would indi-

cate that the yield strength was reduced significantly by the fire.

Fig. 4. Comparison of yield strength of flanges of beam sections after the fire (bars on the left) to distribution of yield strength from flanges of a large number of A36 structural steel sections unaffected by fire (bars on the right).

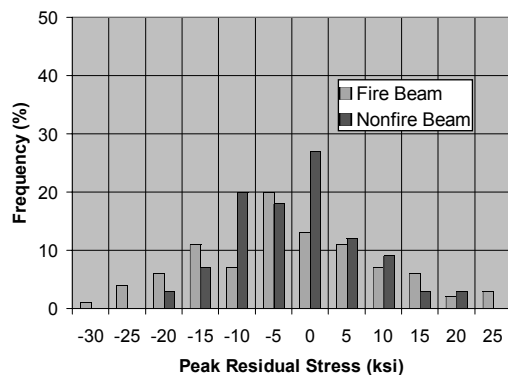
Figure 6 compares the residual stress in the beams from the fire floors to the residual stresses in beams from non-fire floors. It can be seen that the residual stress distributions are not that much different. In the fire floors, the residual stresses of 25 to 30 ksi were measured in compression and values in tension were as high as 25 ksi, whereas on the non-fire floors the residual stresses did not exceed 20 ksi.

Fig. 6. Comparison of residual stresses measured at the tips of beam flanges on the fire floors (bars on the left) compared to data from the non-fire floors (bars on the right).

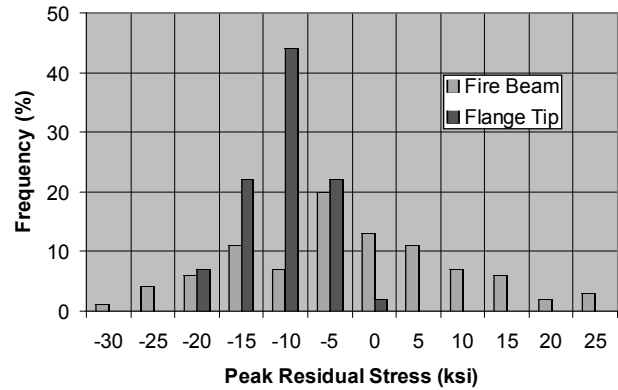
Figure 7 compares the residual stresses from the fire floors to data from a large database of residual stress data from tests performed at Lehigh during the 1960s and 1970s (Tebedge and Tall, 1973; Bjorhovde, 1972; Tall and Alp-

sten, 1969). It is expected that the residual stresses in the members in the building would be similar. The Lehigh data are similar, but they also do not show values greater than 20 ksi in compression. The Lehigh data also do not show very much tension at all, not even as much as is evident on the non-fire floors. It is concluded that the residual stresses in the beams are slightly greater than would be expected for beams that had not been affected by fire, but this is not that surprising considering the level of damage of the beams.

Fig. 7. Comparison of residual stresses measured at the tips of beam flanges on the fire floors (bars on the left) compared to data from the Lehigh database of residual stress measurements (bars on the right, labeled “flange tip”).

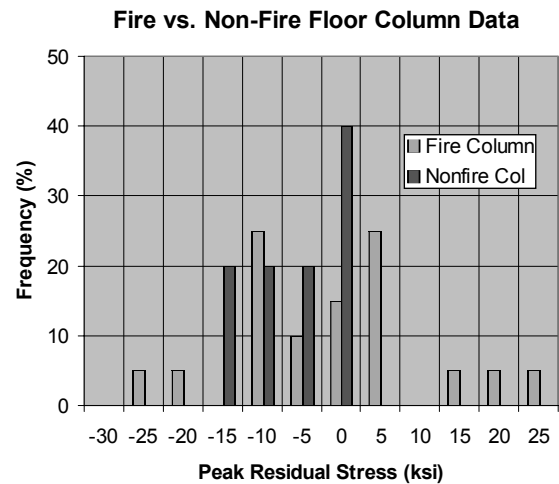
Similarly, residual stress data from columns on the fire floors is compared to non-fire floor column data in Figure 8. Again, the columns on the fire floors show somewhat greater compression, and much greater values of tension. The data from the fire floor columns are compared to the Lehigh database of flange tip data in Figure 9. The results of this comparison are similar; the columns seem to have some residual tensile stress that is not expected. However, it is important to note that residual tensile stress is not detrimental to the compression strength of columns. Similar comparisons were made of residual stresses from the center of the flanges and from the center of the webs. In all cases, the residual stresses were not that much different from the expected residual stresses for new rolled shapes.

Fig. 8. Comparison of residual stresses measured at the tips of column flanges on the fire floors (bars on the left) compared to data from the non-fire floors (bars on the right).

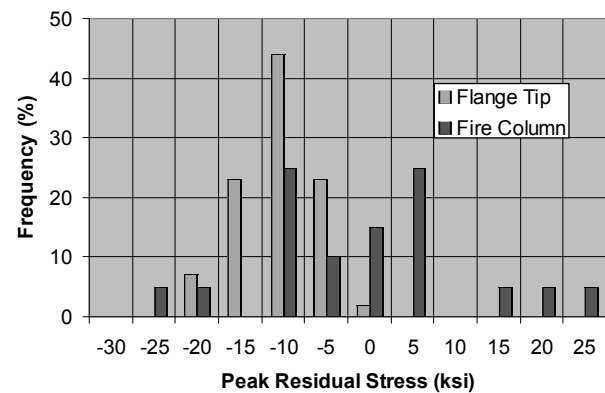
Fig. 9. Comparison of residual stresses measured at the tips of column flanges on the fire floors (bars on the right) compared to data from the Lehigh database of residual stress measurements (bars on the left, labeled “flange tip”).

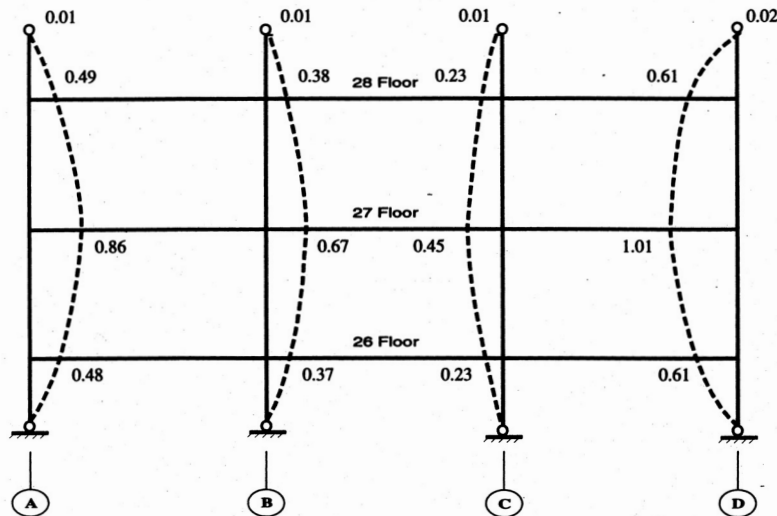
To study the influence of locked-in forces on lateral load-carrying capacity, the structure is analyzed once without locked-in forces and again with locked-in forces. An inelastic finite element program was used to perform the analysis. The locked-in forces (bending moment, axial and shear forces) are again introduced by using a thermal element placed at the mid-span of each girder. The introduction of the locked-in forces occurs when the structure is loaded only by gravity load. The amount of thermal contractions in the girders is adjusted so that the initial distortions of the columns are in approximate agreement with those found in the post-fire inspection (see Figure 2). The initial distortions and the locked-in bending moment distribution assumed in the analysis are shown, respectively, in Figures 18 and 19.

Fig. 18. Column distortions due to locked-in forces.

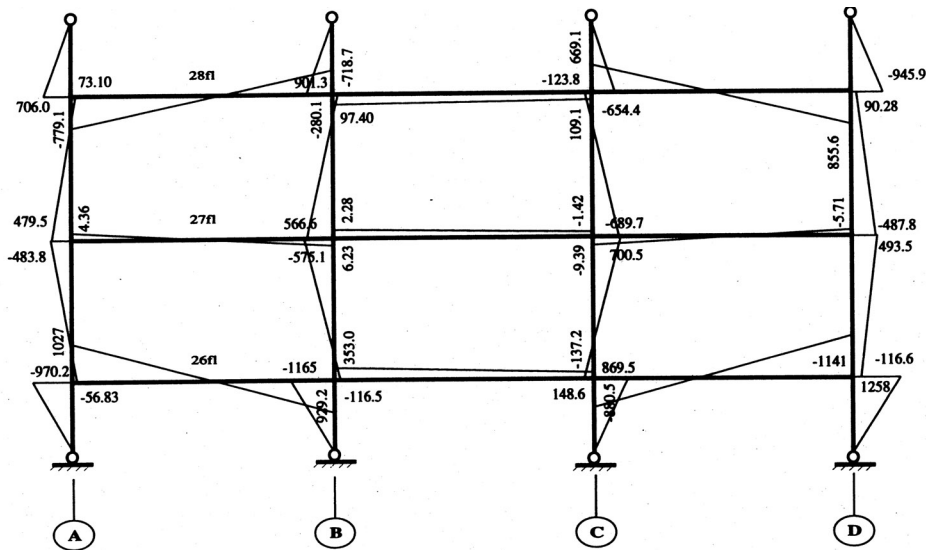
Fig. 19. Locked-in bending moment distribution.

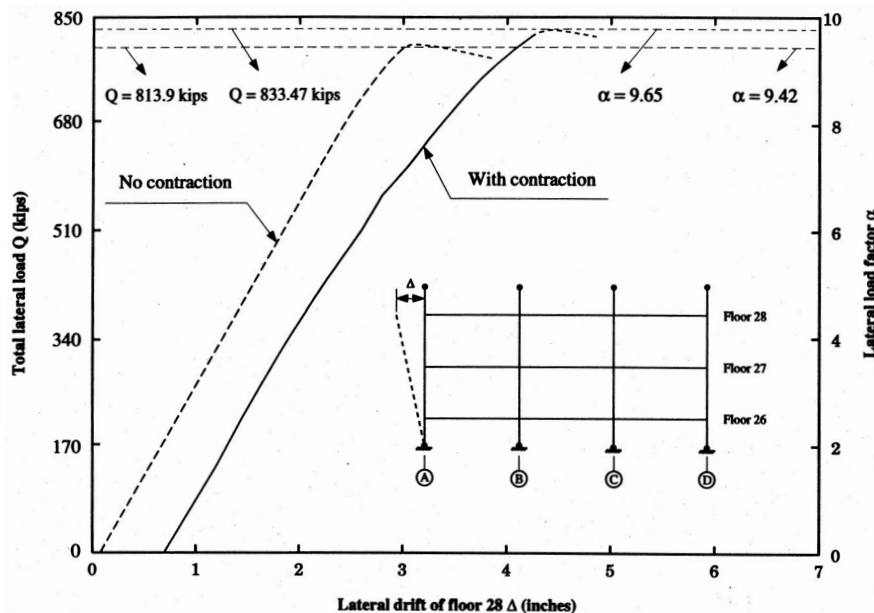
Figure 20 shows a comparison of the lateral load vs. lateral drift relationships obtained from the two analyses. There is a 2.4 percent difference in the maximum lateral load. It is interesting to note that the case with the locked-in forces achieves a slightly higher maximum load. This is most probably due to the different roles played by the instability effects (in one case the columns are essentially straight and in the other case the columns are initially bent). The maximum lateral loads that can be resisted by the structure are more than 9 times the working value. The overall lateral stiffnesses at the working load level of the two cases are very similar. These observations imply that, if the heav-

Fig. 20. Lateral load vs. drift relationships of sub-frame.

ily damaged girders in the building are repaired or replaced, the structure should perform satisfactorily in resisting severe wind storms in the future.
