# Development and Experimental Testing of Connections for the Simple for Dead Load–Continuous for Live Load Steel Bridge System

NICK LAMPE, NAZANIN MOSSAHEBI, AARON YAKEL, REZA FARIMANI and ATOROD AZIZINAMINI

**Keywords:** steel bridges, steel girders, SDCL, simple for dead load–continuous for live load.

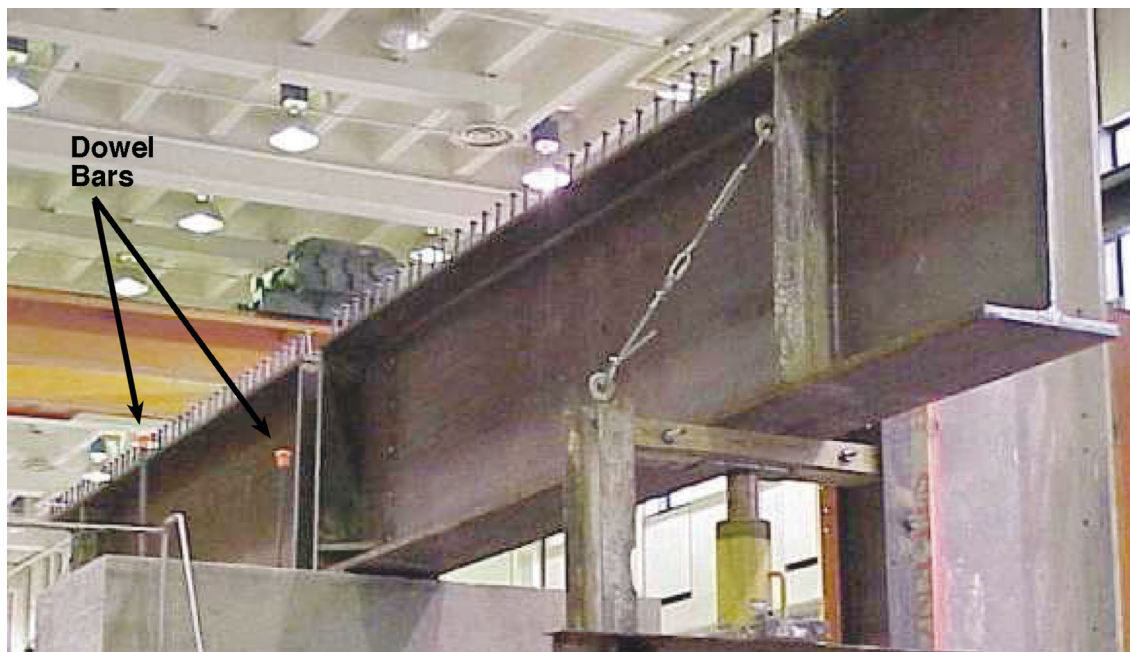
Fig. 5. Photo of the two girders during construction.

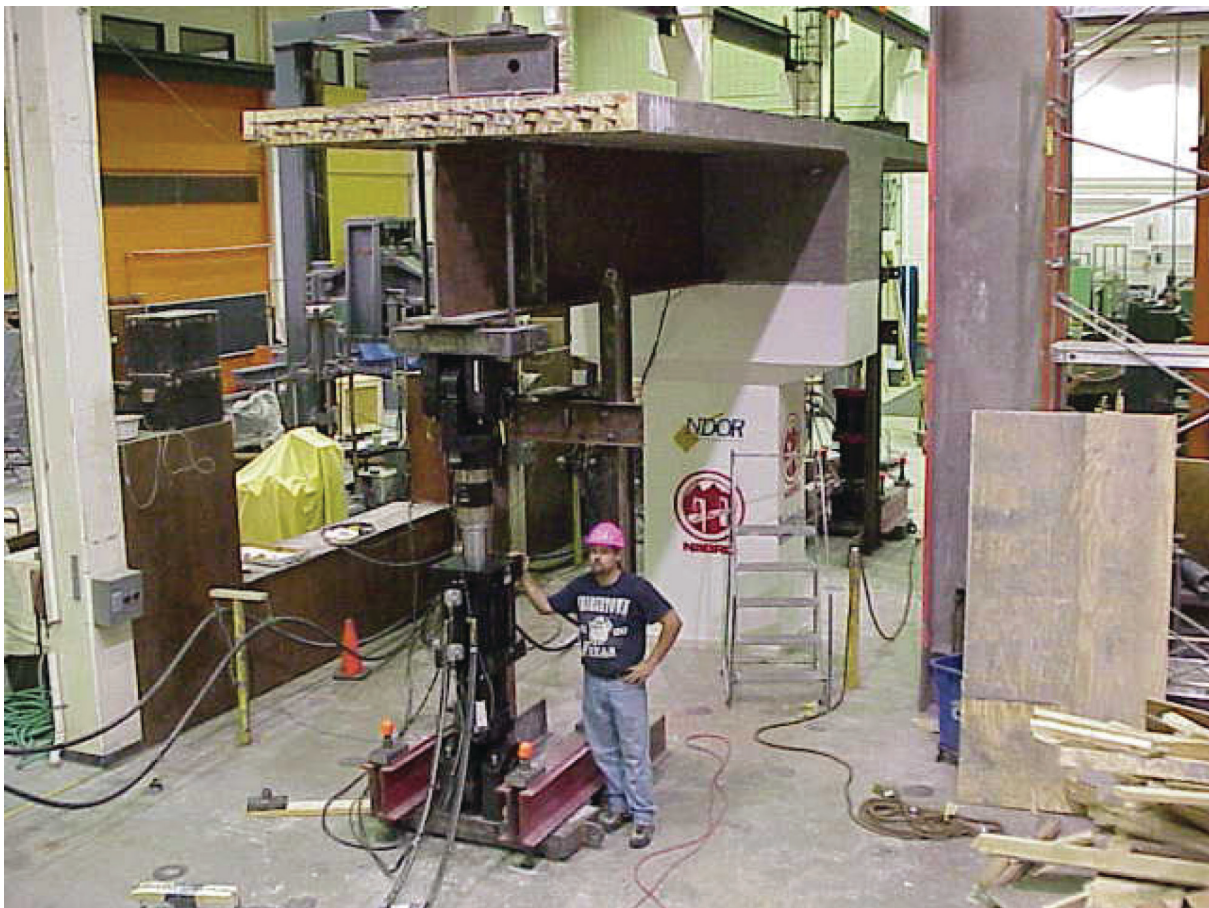
*Fig. 6. Specimen 1 cycling test setup and fixtures.*

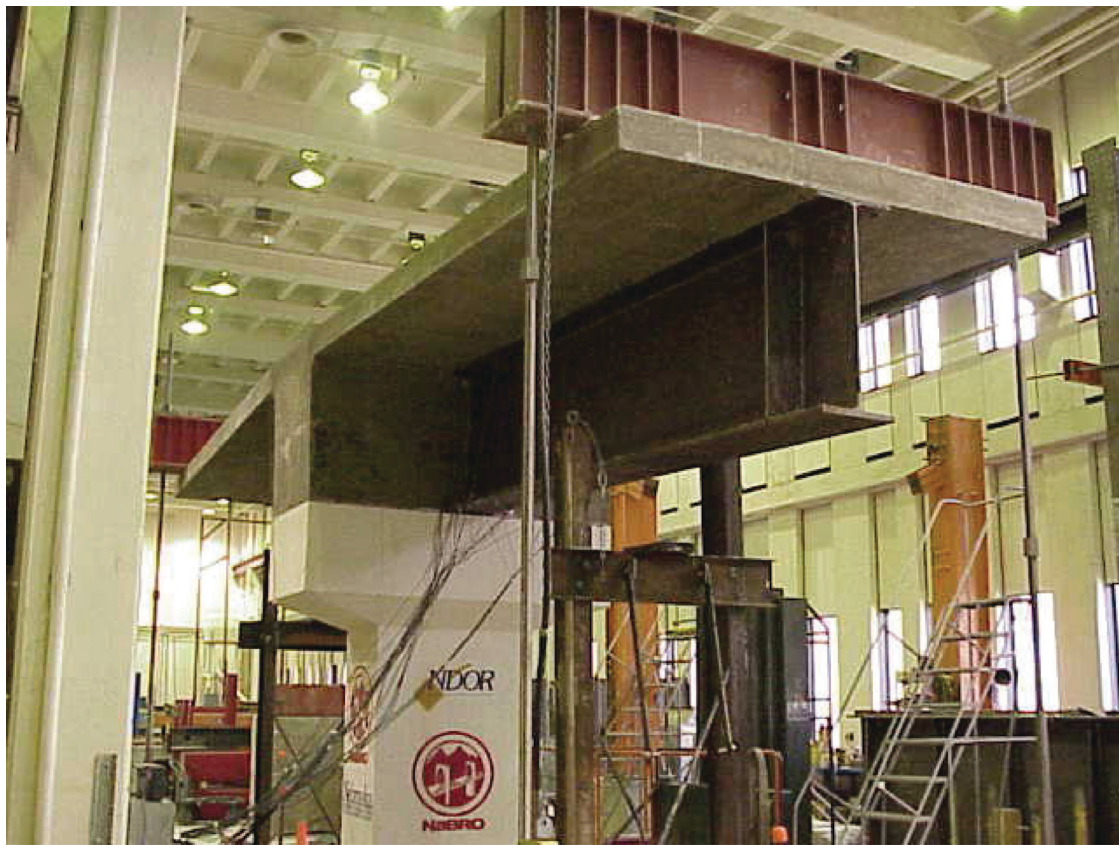
Fig. 13. Specimen 2 ultimate test setup.

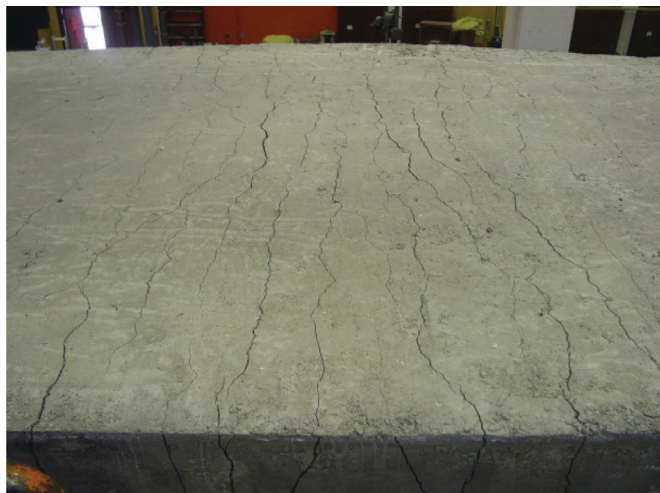
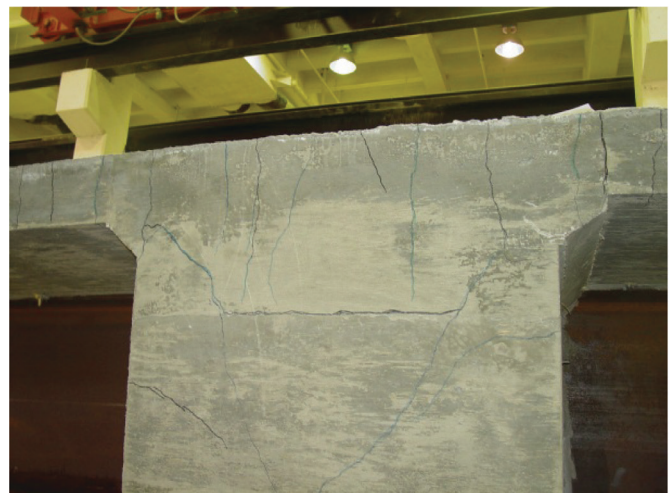
*Fig. 15. Specimen 3 crack patterns at completion of ultimate test: (a) concrete slab, plan view; (b) face of diaphragm.*

All specimens exhibited cracking of the concrete over the pier. As an example, cracking of specimen 3 is shown in Figure 15, which is representative of the general pattern of cracking displayed by all specimens. The results presented are for the ultimate loading. The cracking patterns are being used to interpret the failure modes. As such, the extent and magnitude of cracking are not indicative of what would be found at service levels. The following describes observations specific to each specimen.

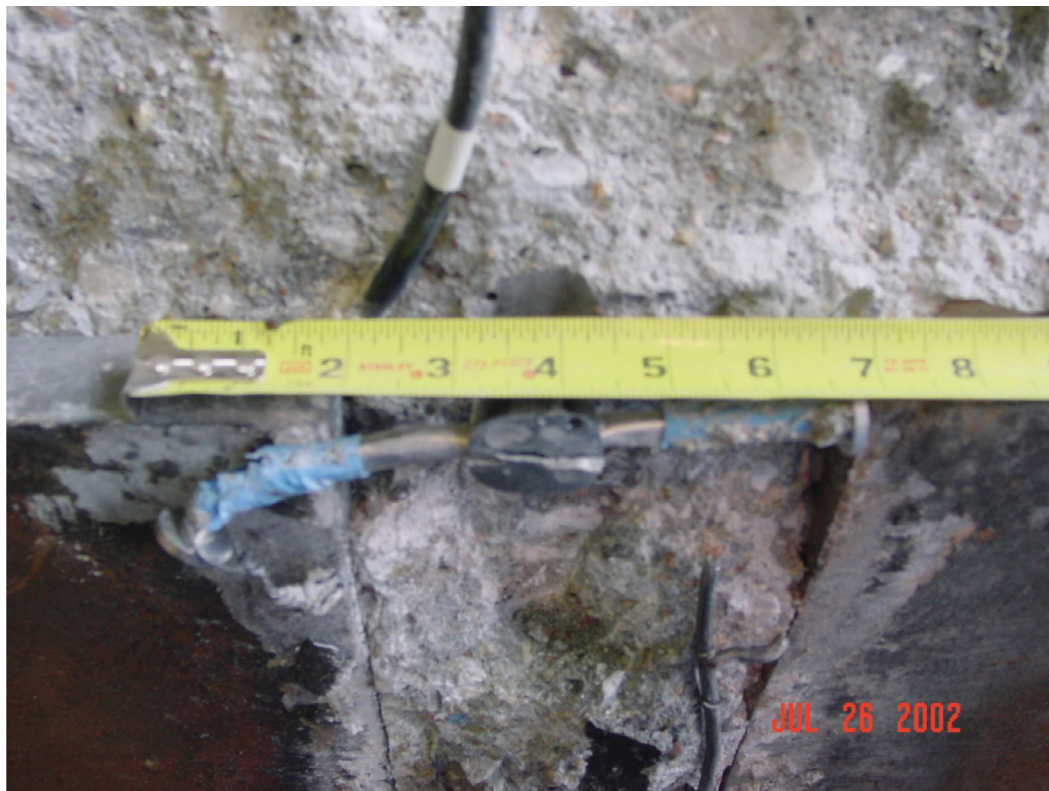
Fig. 18. Gap between bottom flanges.

In specimen 2, crushing of the concrete was evident during the cycling test, and by the end of the ultimate test, the gap between the bottom flanges had reduced from the initial separation of 8 in. to 5 in. (see Figure 18).

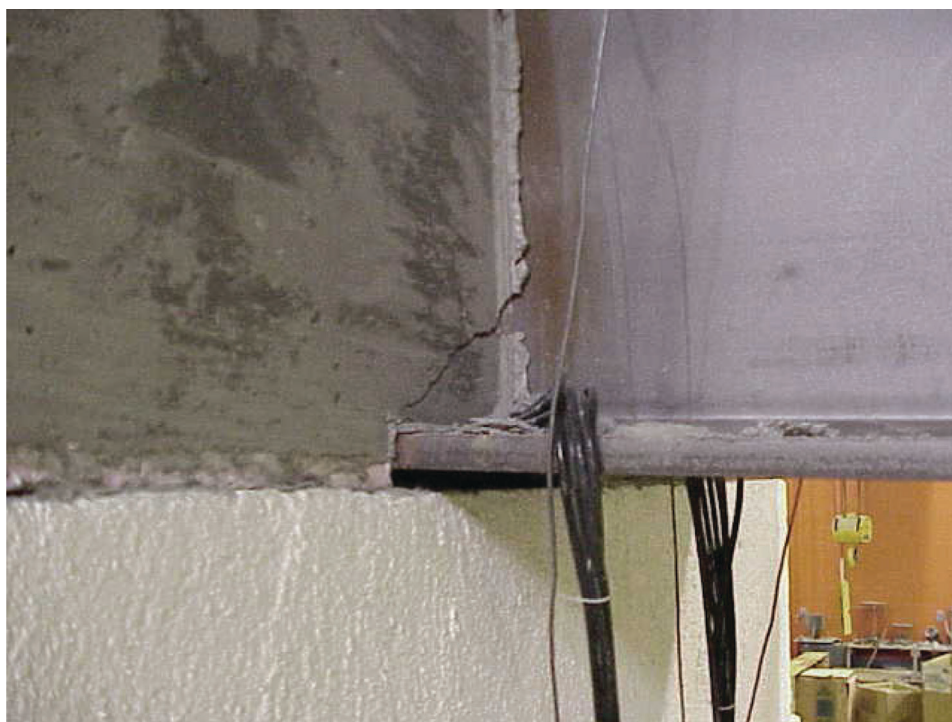
*Fig. 22. Cracking of the concrete diaphragm around the bottom flange—specimen 2.*

In specimen 2, penetration of the bottom flange into the diaphragm, along with the formation of large cracks (see Figure 22) indicates that bonding between the steel girder and concrete diaphragm failed during testing of specimen 2. After conclusion of the ultimate test, the dissection of

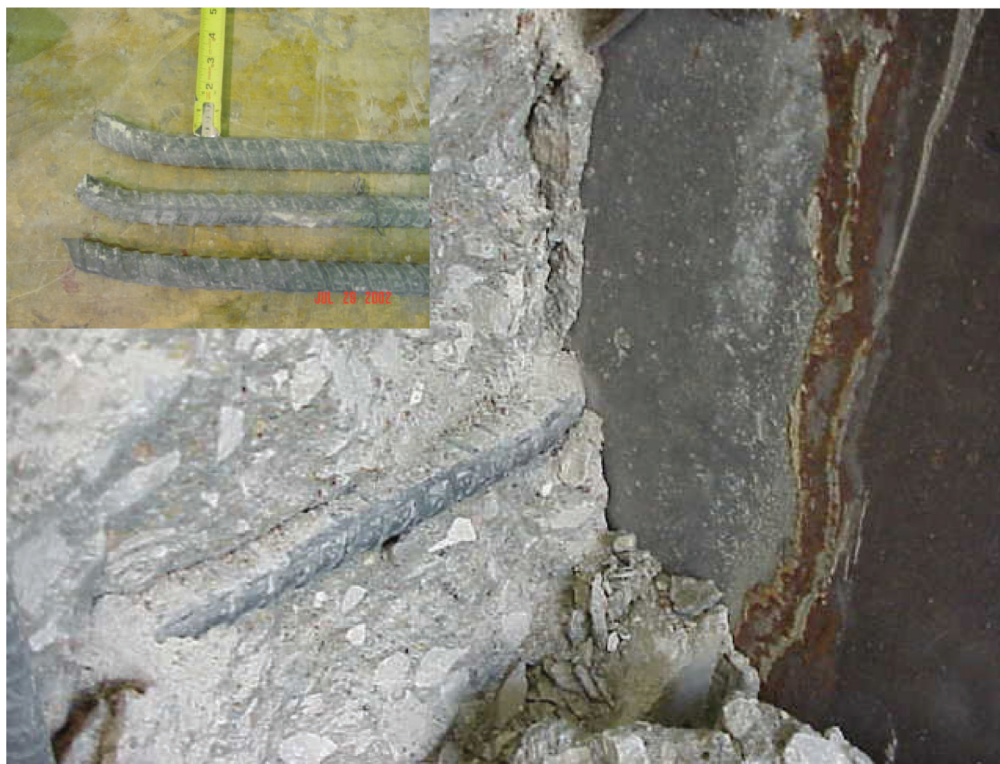
*Fig. 23. Shear failure of the transverse bar inside the diaphragm after the conclusion of the ultimate test—specimen 2.*

specimen 2 revealed that the transverse bars placed through holes in the web had been sheared through, as shown in Figure 23. Recall this specimen was deliberately intended to illustrate the failure mechanisms of simplistic detail and the shearing of reinforcement was not observed in specimens 1 and 3.

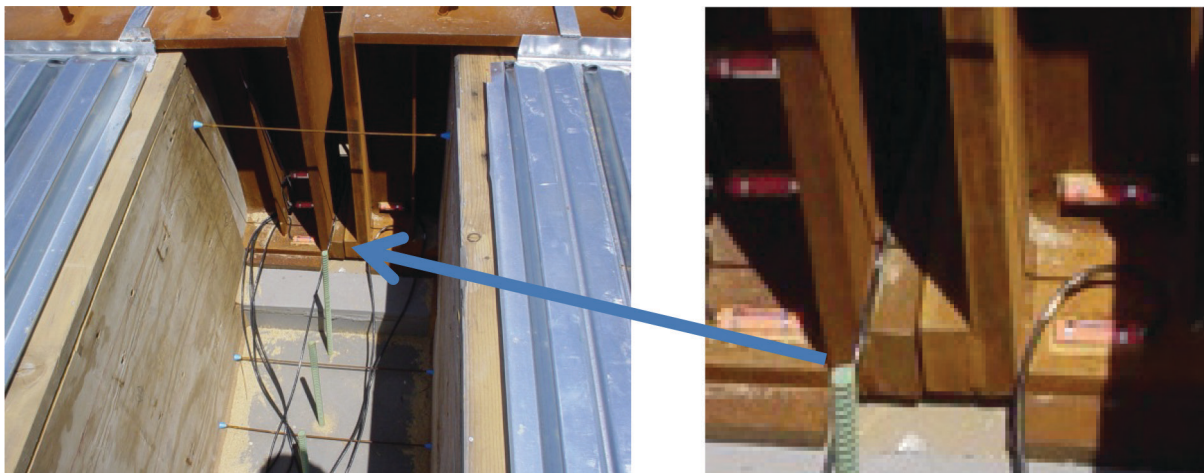
Fig. 28. Bearing block detail.

Test 2 showed that the compressive force is sufficiently concentrated and crushing of the concrete can occur, thus necessitating the force transfer through a steel path. The ultimate performance of specimen 3, which utilized an end plate to distribute the load, was comparable to that of specimen 1, with a continuous steel path. However, there were some differences in the observed data during the cyclic testing. For this reason, the end plate detail is not recommended at this time, though it may actually provide satisfactory performance. Instead, a mechanism should be provided to prevent transfer of compression force from the bottom flanges to the concrete diaphragm. One practical detail that provides a continuous steel path, but is simpler to construct than the detail used in specimen 1, is shown in Figure 28.
