# Behavior and Response of Headed Stud Connectors in Composite Steel Plate Girder Bridges under Cyclic Lateral Deformations

HAMID BAHRAMI, ERIC V. MONZON, AHMAD M. ITANI and IAN G. BUCKLE

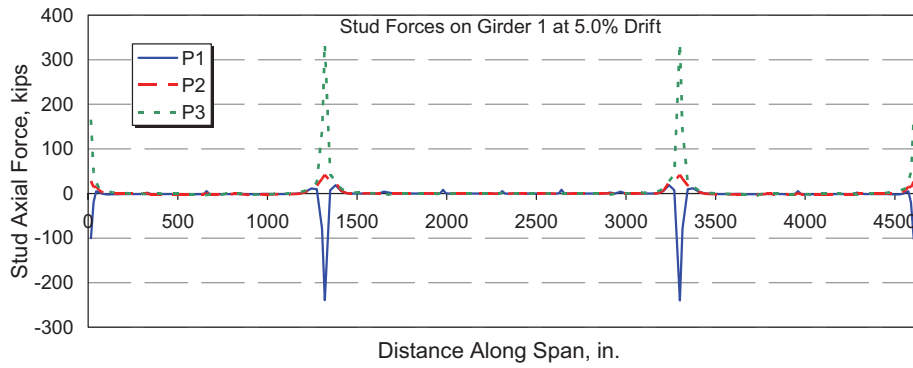
Fig. 5. Stud connector force distribution in girder 1 at 5% superstructure drift.

transverse seismic forces through bending in the plane of the deck. Figure 5c shows the transverse shear force distribution in the connectors in girder 1. This distribution is the result of combined transverse shear force transfer between the reinforced concrete deck and steel girders and torsional moment on the superstructure. The torsional moment causes out-of-plane bending in deck. The bending moment results in equal and opposite transverse shear forces in the connectors on either side of the girder. These opposing forces cancel out once all the forces in a row of connectors are summed up, as shown in Figure 5d. The high peaks near the supports indicate significant force transfer between the reinforced concrete deck and steel girders. The other small peaks seen in this plot are at the location of intermediate cross frames. This shows that the intermediate cross frames attract only a small amount of the transverse seismic forces.

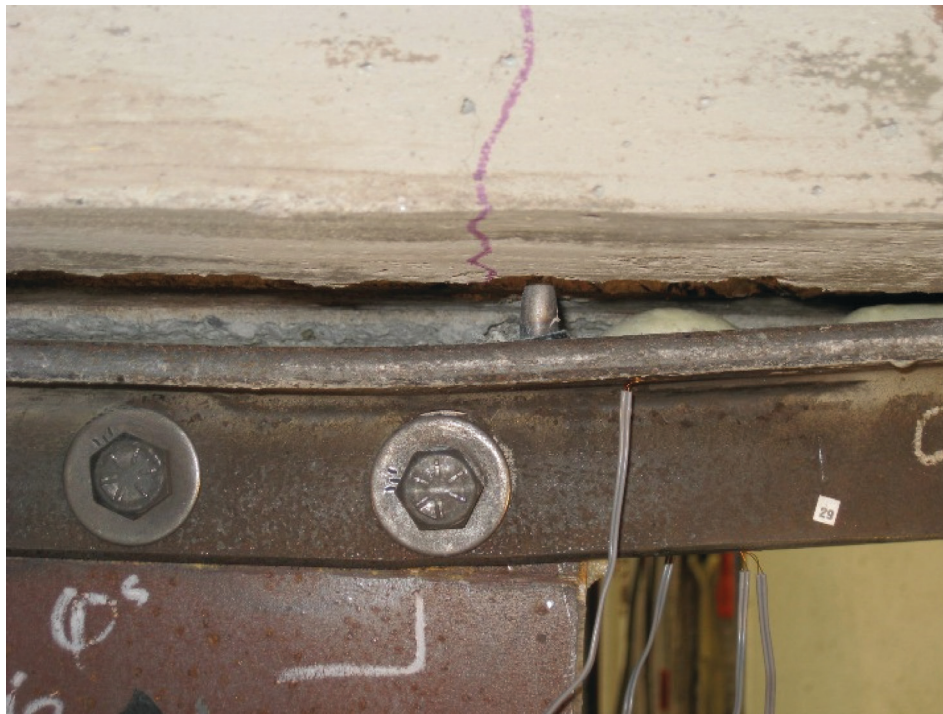
*Fig. 20. Specimen F0B: rupture of stud connectors near the end of the top chord.*

chord occurred near the ends of this connection. Figure 20 shows the separation between the deck and top chord. This separation caused high axial forces in the exterior stud connectors (i.e., connectors that were close to the ends of the deck–top chord connection). As these connectors fail, the connectors next in line and closer to the middle of the chords started to pick up the unbalanced force. At the end of the test, all the stud connectors over the top chords were ruptured, and significant plastic deformation in the top chords was visible. Additionally, the top chords were ruptured at the location of the last bolt hole due to high plastic strain concentration and low cycle fatigue.
