Experimental Investigation of a Steel-Framed Building for Disproportionate Collapse

EBIJI AKAH, CURTIS WOOD, KAI LI and HALIL SEZEN

ABSTRACT

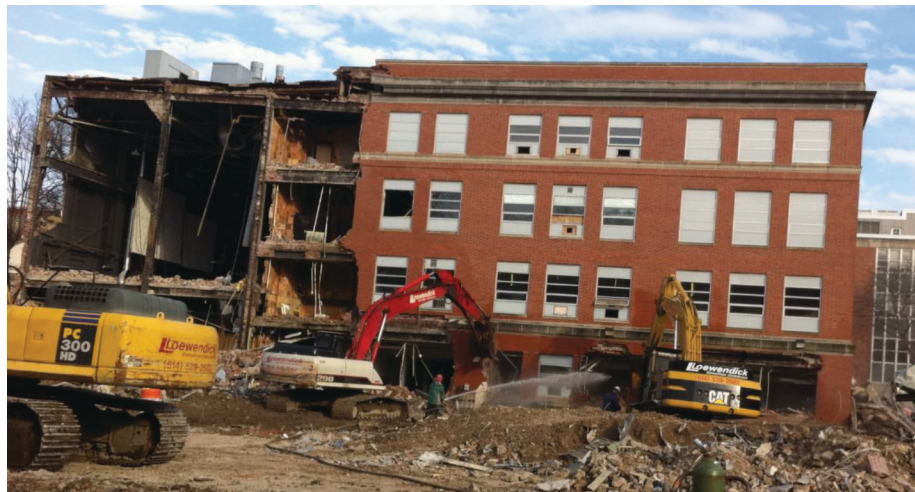
Fig. 1. Haskett Hall.

The term *progressive collapse* can be defined as the partial or total collapse of a structure that may be caused by local structural failure. The General Services Administration (GSA), American Society of Civil Engineers (ASCE), and the U.S. Department of Defense (DoD) have developed guidelines to evaluate, design and improve progressive collapse resistance of existing and new buildings. The GSA (2013) outlines procedures to evaluate whether a building, based on its size and shape, is vulnerable to progressive collapse. ASCE 7 (2010) and the AISC *Seismic Provisions* (AISC, 2010) both outline approaches to maintain structural integrity when a load-carrying member is damaged. Lastly, UFC 4-023-03 outlines how to prevent progressive collapse in multistory buildings (DoD, 2013). This research uses these guidelines to test and analyze whether a given structure is susceptible to progressive collapse. This paper focuses on the instrumentation and testing of Haskett Hall,

shown in Figure 1, to determine the potential for progressive collapse. One column was removed from the building within a short time period, as recommended by the GSA design guidelines, by Loewendick Demolition Contractors in November 2013. The two-dimensional (2D) linear static and nonlinear dynamic structural analyses have been performed using structural analysis programs to compare with the simulated and experimental data. This experiment is part of a larger research program at the Ohio State University (OSU) involving steel frame, reinforced concrete, and masonry buildings. (Akah, 2015; Li, 2017; Song and Sezen, 2013; Song et al., 2014)

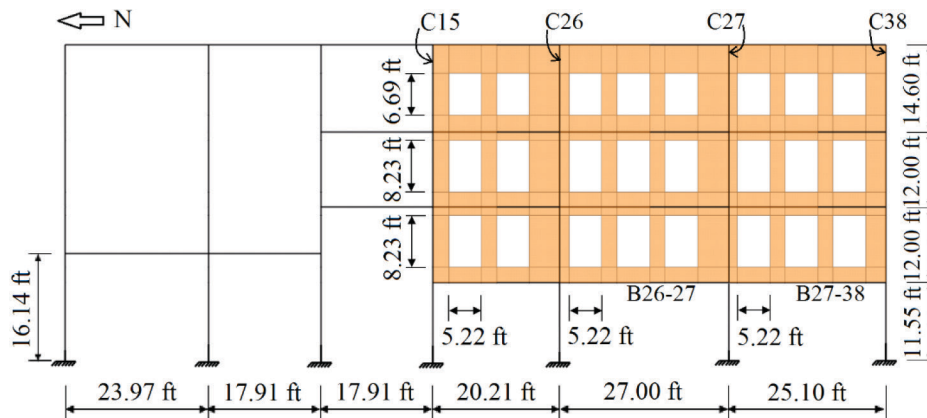
Fig. 2. Haskett Hall western elevation and bay layout.

Infill walls had two types of window openings: 8.23 ft by 5.22 ft and 6.69 ft by 5.22 ft openings in the second and third stories (Figure 2). Figure 4 shows the cross-section cut through the window openings and indicates that only half of

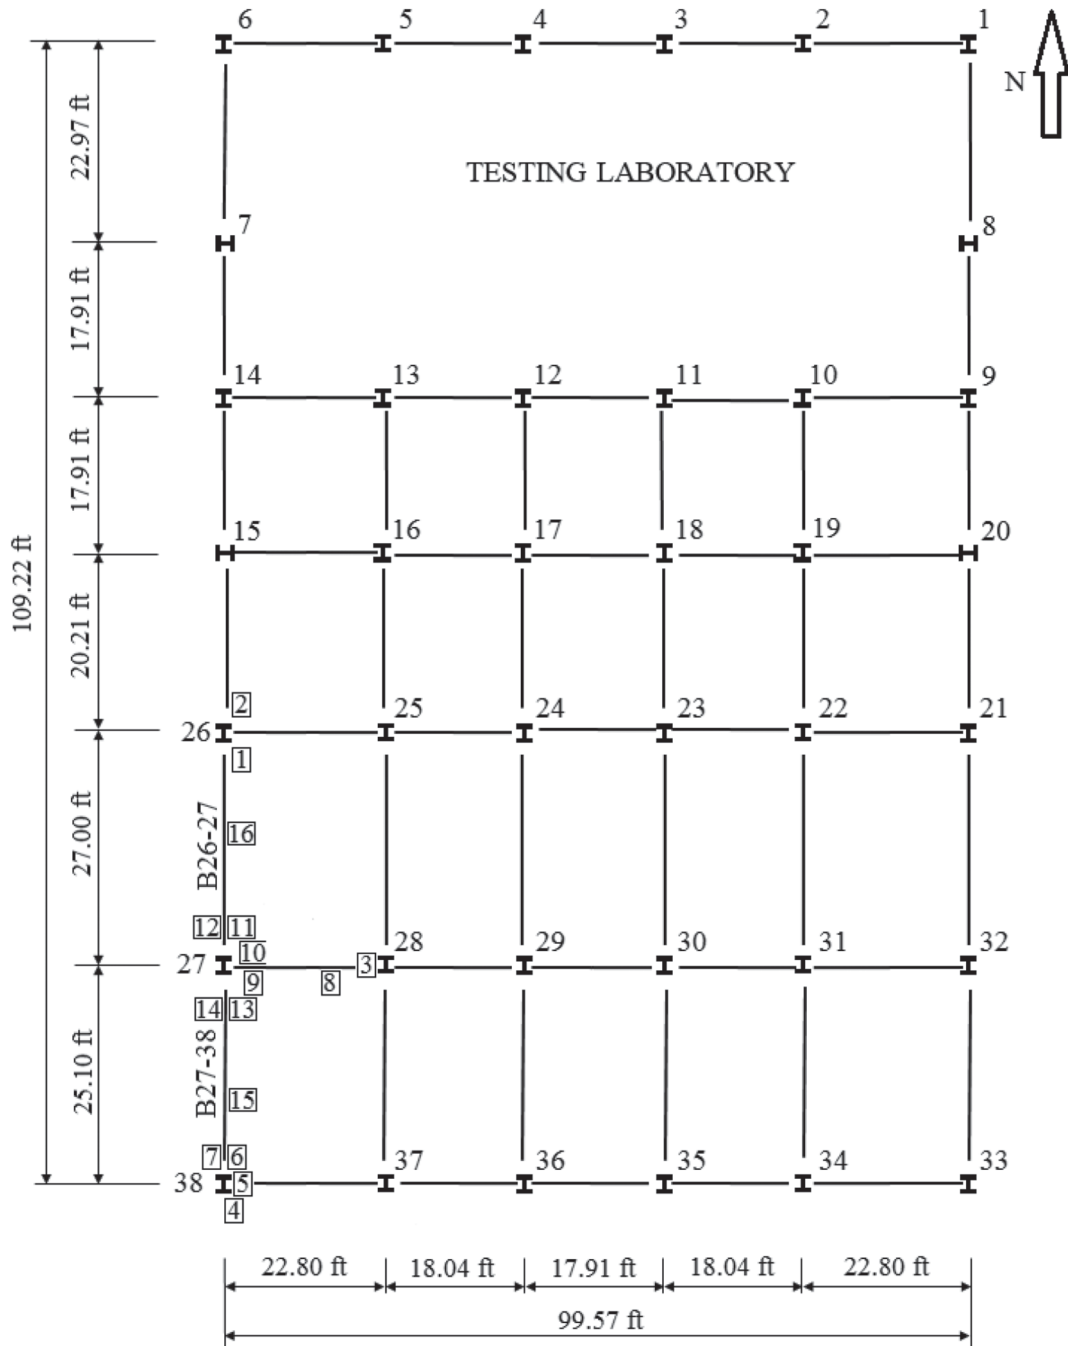
Fig. 3. Haskett Hall simplified layout with strain gauges on columns (numbered 1–7 in rectangle) and beams (8–16).

of the bottom flange. Column 26 had two gauges installed 3.08 ft from the base of the column. Column 38 had three gauges installed 6.17 ft from the base and one gauge 4.58 ft from the base. Column 28 had one gauge placed 4.58 ft from the base. Three LVDT or displacement sensors were used in Haskett Hall. Two LVDT were placed vertically on both side of column 27 and one LVDT was placed horizontally at the beam-column joint. Figures 3 and 6 show strain gauge and LVDT placement.

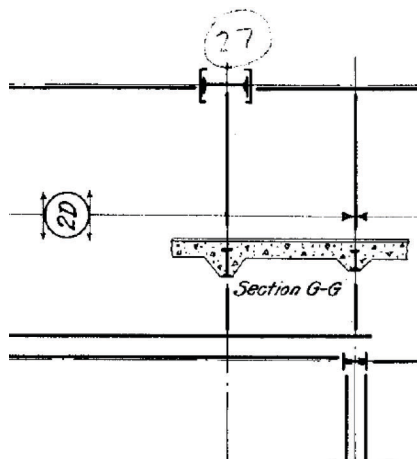
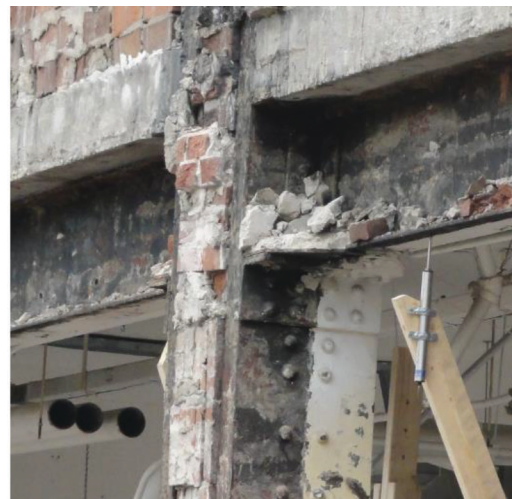
Fig. 4. Close-up detail of column 27 encased in concrete (partial plan view from original drawings), and beam-column connection with rivets through angle on beam bottom flange and web.

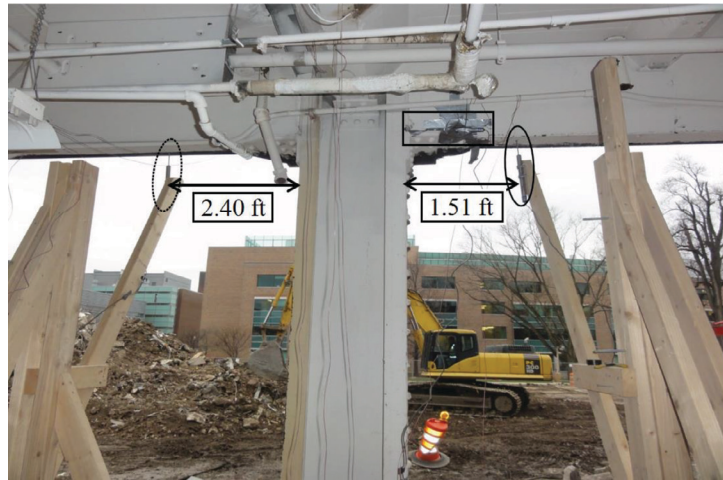
Fig. 6. Vertical LVDT to the south (in circle on left) and north (in circle on right) of the removed column and horizontal LVDT (rectangle) attached to the removed column.

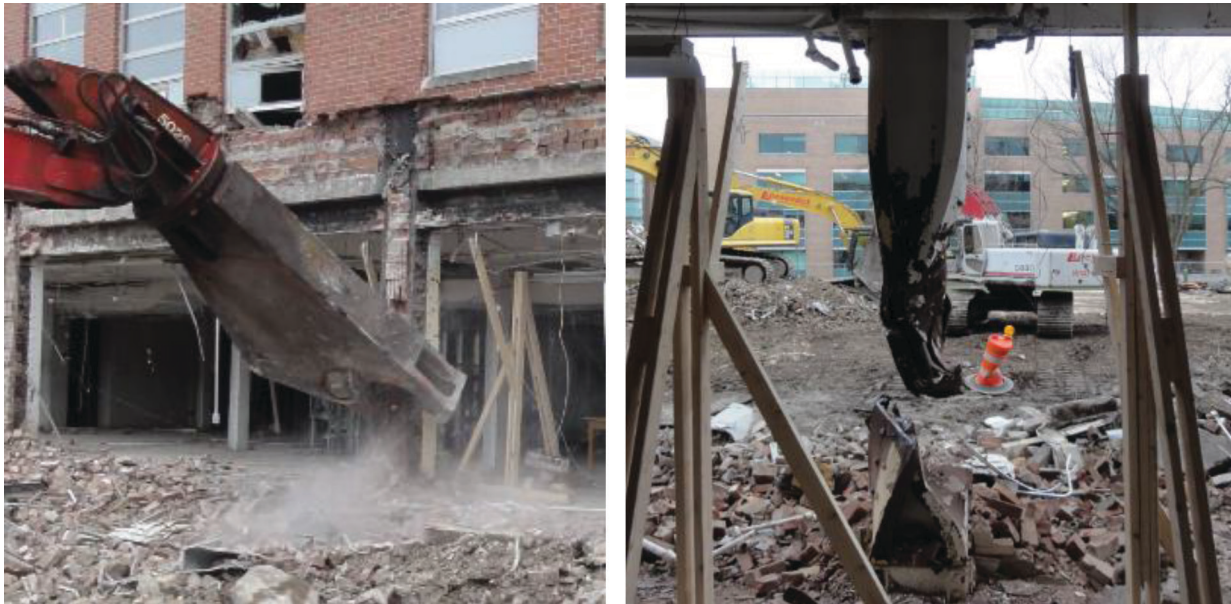
Fig. 7. Column 27 under removal (left) and finished removal (right).

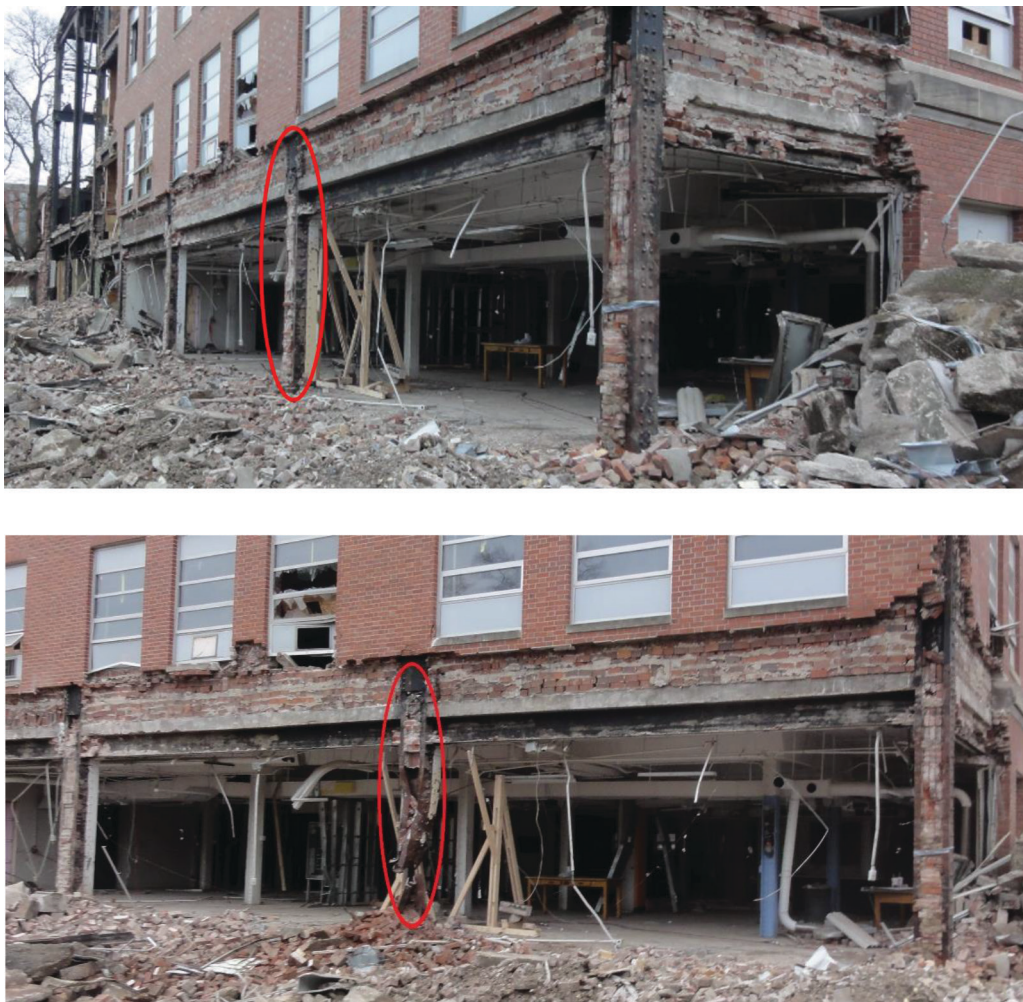
Fig. 8. Penultimate column 27 before removal (top) and after removal (bottom).

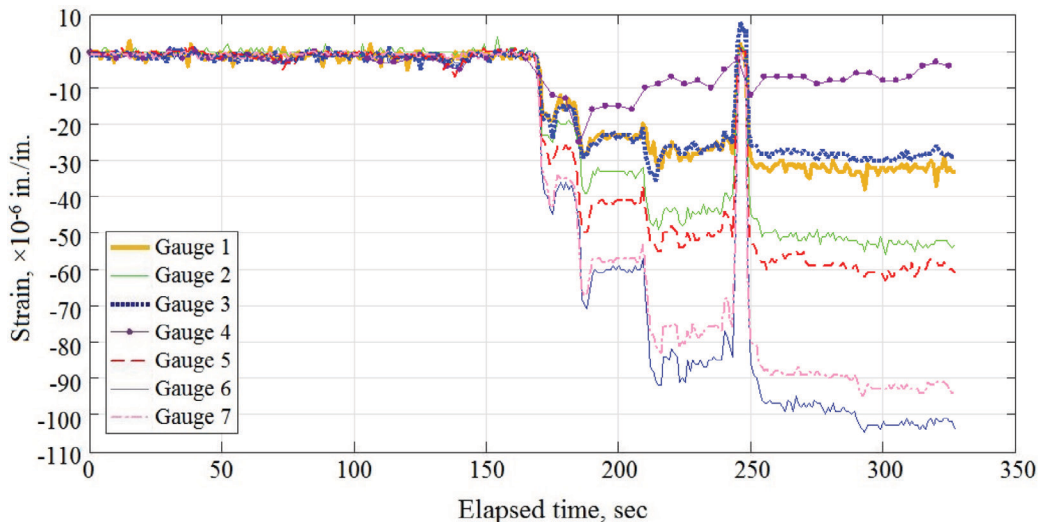
Fig. 9. Strain history measured by strain gauges 1–7 on steel columns.

It should be noted that the test column was cut by altering the position of the processor, meaning there was a three-dimensional cutting plane. In Figure 9, once the column was cut, the measured strain value drastically increased momentarily. Once the processor was no longer in contact with the cut column, the measured strain leveled out at approximately -29×10^{-6} in./in for strain gauge 3. Assuming the steel did not yield, the compressive axial stress increase, Δf , on the east side of column 28 was approximately 0.9 ksi—that is, $\Delta f = E_s \epsilon_s = (29,000 \text{ ksi})(29 \times 10^{-6} \text{ in./in.})$.

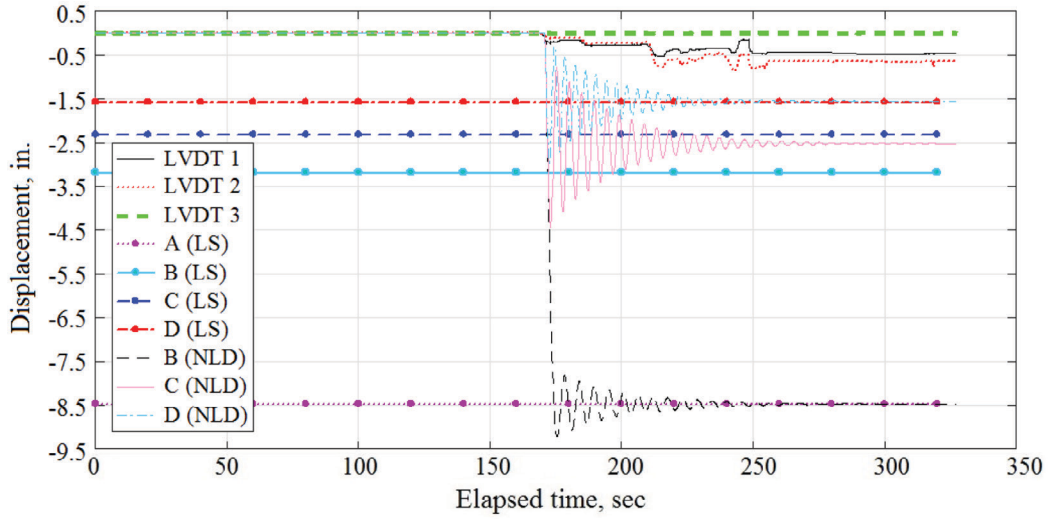
Fig. 10. Comparison of measured LVDT deflections to linear static (LS) and nonlinear dynamic (NLD) calculated deflections of models: A (noncomposite beam, no slab in upper floors); B (composite beams, no slab in upper floors); C (noncomposite beams and ribbed slabs in upper floors); D (composite beams and ribbed slabs in upper floors).

the purpose of presenting data clearly and straightforward, the vertical displacement scales of Figures 10 and 11 are different by a factor of 10.

The calculated outcomes of two infill wall frame models E and F were compared with the measured LVDT deflections in Figure 10. It is clearly shown that the results from both the shell element model and the strut element model have higher agreement on the field test results than that of bare frame models A through D. The masonry infill walls can be simply modeled using equivalent strut element. Moreover, the strut element approach was better at modeling the unreinforced masonry wall because shell elements cannot identify and remove the tensile strength members. Figure 10 shows that both the linear static and nonlinear dynamic analyses results from strut element model F are closer to the field test data than that of shell element model E. More tensile strength contributions are made from shell elements; however, unreinforced masonry wall have little tension capacity.

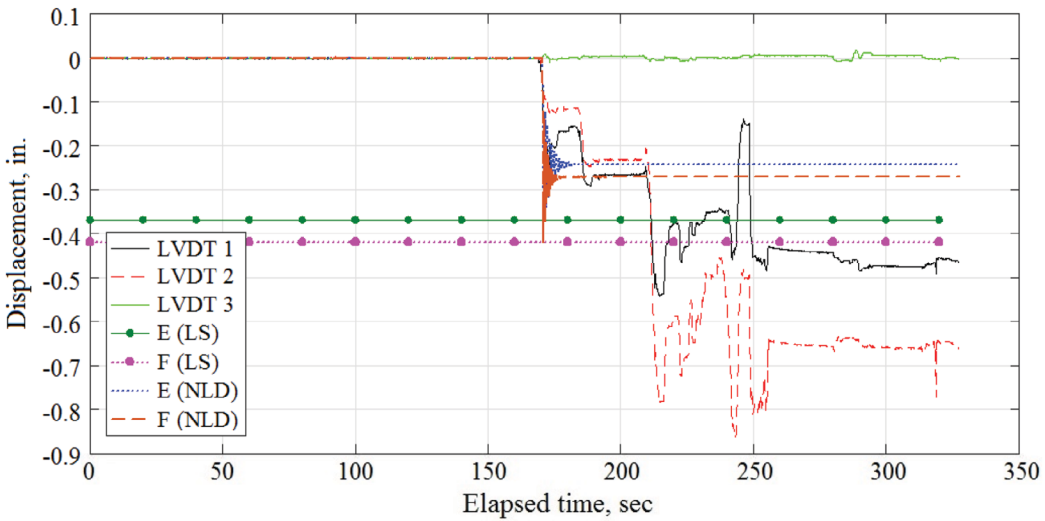
Fig. 11. Comparison of measured LVDT deflections to linear static (LS) and nonlinear dynamic (NLD) calculated deflections of models: E (composite beams and shell elements for infill walls); F (composite beams and tension-only strut elements for infill walls).

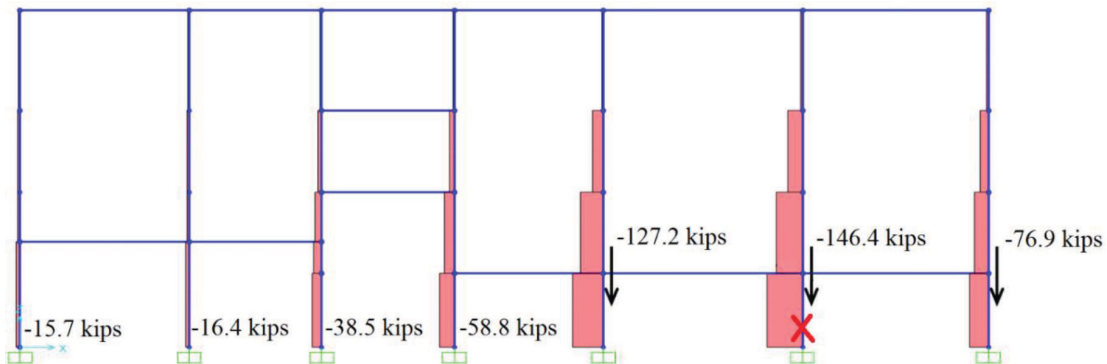
Fig. 12. Calculated axial load distribution for model B (with composite beams and no ribbed slabs) before the test column removal (under red cross).

after removal of the test column C27 for models B and C are shown in Figures 12 through 15. When compared with the calculated axial load in the test column (C27), the ribbed slab models (models C and D in Table 3) have the lowest total change in axial force in neighboring columns C26 and C38—that is, an increase of 0.3% and 1.7%, respectively, in Table 4. As the composite action increases, the total change in axial forces in columns C26 and C38 also increases compared with the test column C27. Specifically, in the non-composite beam model without ribbed slabs (model A), axial forces increase by 2.0%, while in the composite without ribbed slabs (model B), axial forces increase by 5.1%. Comparison of axial forces between the models with and without ribbed slabs show that in the models with ribbed slabs, larger axial forces are transferred to the neighboring columns (C26 and C38).

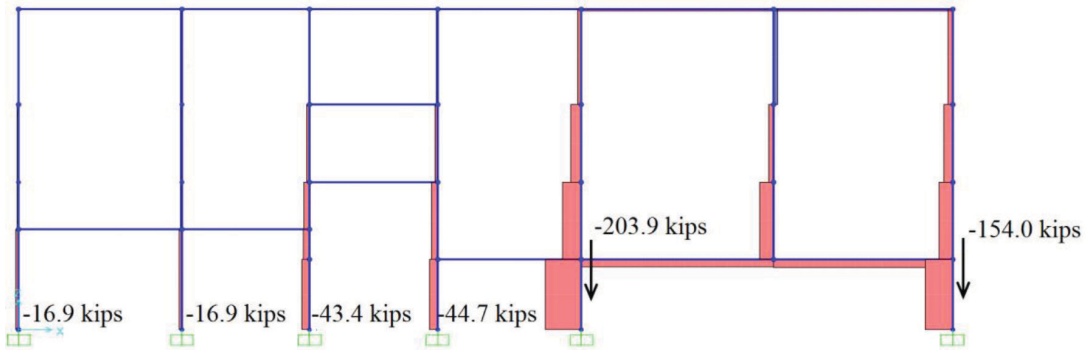
Fig. 13. Calculated axial load distribution for model B (with composite beams and no ribbed slabs) after the test column removal.

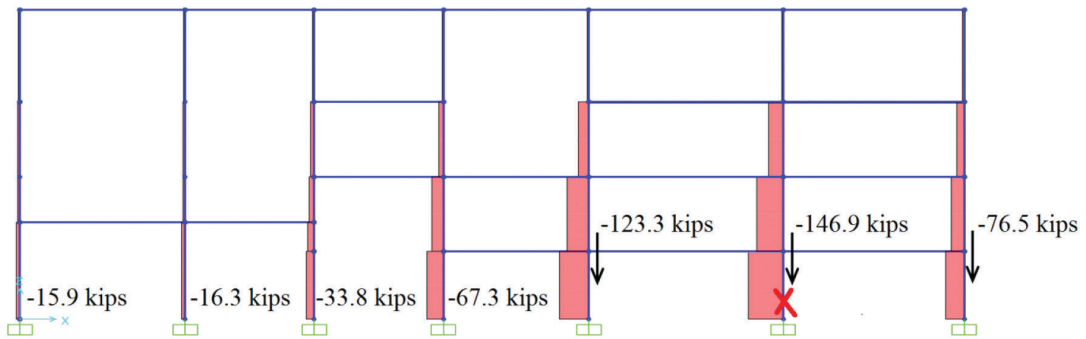
Fig.14. Calculated axial load distribution for model C (with noncomposite beams and ribbed slabs) before the test column removal (under red cross).

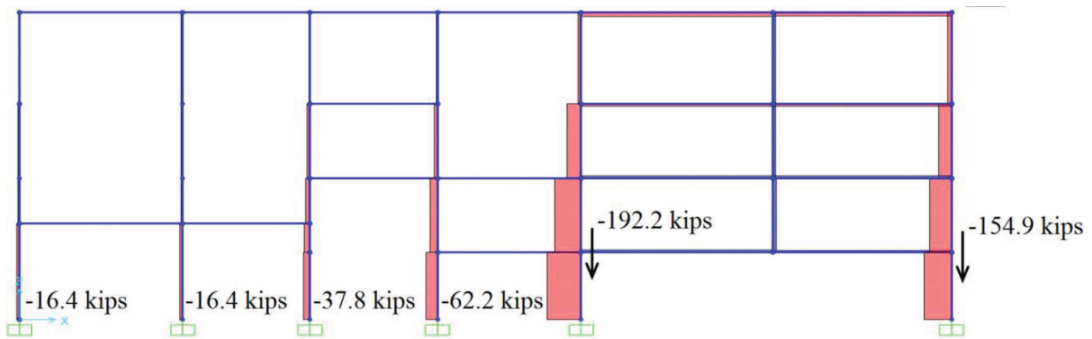
Fig. 15. Calculated axial load distribution for model C (with noncomposite beams and ribbed slabs) after the test column removal.

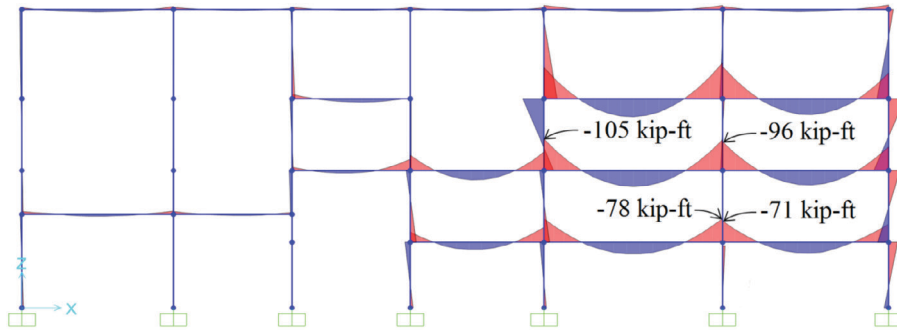
Fig. 16. Moment diagram for noncomposite with ribbed slab model (C) before test column (circled) removal. Values are for maximum moment demands in beams.

load combination with no live load and dead load factored by 1.0. DCR_p is defined as the ratio of calculated maximum moment in a member to its plastic moment capacity, $M_p = F_y Z$, where F_y is yield strength and Z is the plastic section modulus. After column removal, the calculated maximum moments are larger in magnitude for models without ribbed slabs (models A and B) when compared with the models with ribbed slabs (models C and D). This shows that for both cases, the moments in beams in lower floors increase when the ribbed slabs are neglected and that the ribbed slab contributes to load redistribution. Comparison of calculated beam moments with flexural limits shows that the composite action generally led to a decrease in the unfactored DCR_p by increasing the flexural strength. For example, the DCR_p for models without ribbed slabs, beam B27-38 (Figure 2) had a DCR_p of 2.46 and 0.90 in models A and B, respectively. For models with ribbed slabs, the DCR_p for beam B27-38 is 0.88 and 0.49 in models C and D, respectively. In general, models with ribbed slabs have a lower DCR , showing that the ribbed slabs increase the overall flexural resistance of the frame. Moment diagrams before and after removing the test column C27 for model C are shown in Figures 16 and 17, respectively.

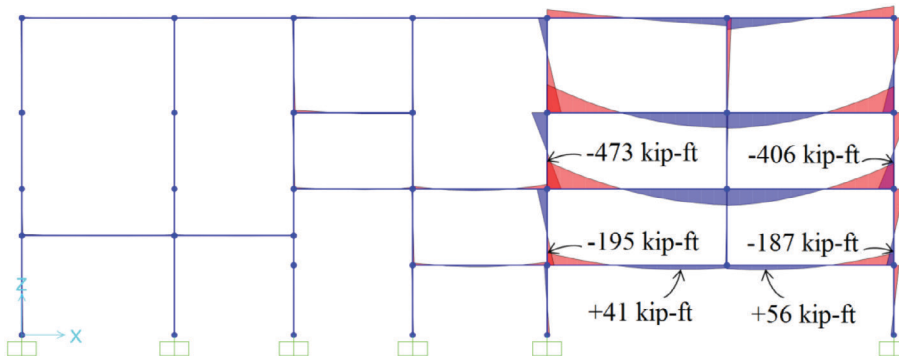
Fig. 17. Moment diagram for noncomposite with ribbed slab (C) model after test column removal. Values are for maximum moment demands in beams.

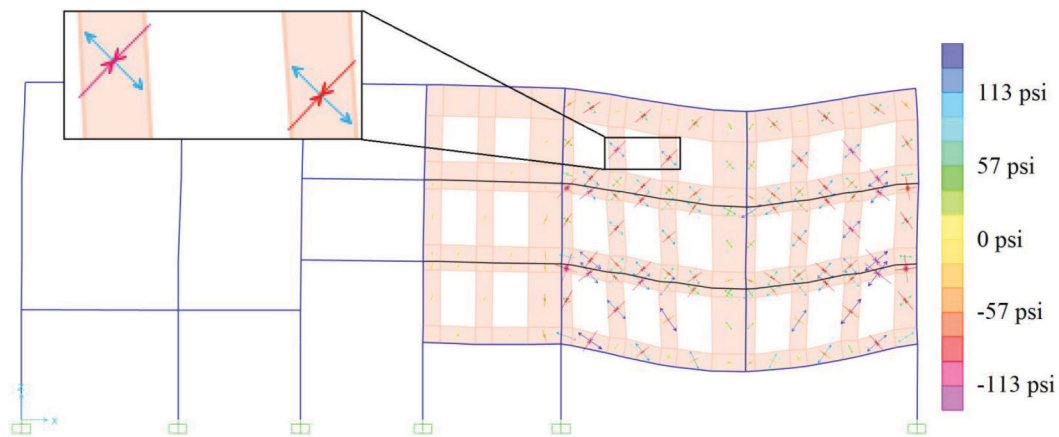
Fig. 18. Maximum stress distribution in model E with infill wall shell elements (and ribbed slabs in upper floors) after test column removal.

The shell element infill wall model is labeled as model E, as shown in Figure 18, and the compression-only strut element infill wall model is marked as model F (Figure 19). The linear static (LS) and nonlinear dynamic (NLD) analyses of infilled steel structure were performed and generated the 2D deflection data in Table 3. By comparison with the deflection data of all four bare steel structure models, the results of infilled steel structure models are much closer to the field

Based on Figure 18, the stress distribution diagram of the infill walls is presented. It is observed that the large-magnitude stresses distribute on the infill walls of the bays in which the column was removed—that is, between axes 26 and 38. Lesser-magnitude stresses are distributed on the infill walls between axes 15 and 26. It indicates that only the infill walls within the bays where structural frames were removed develop compression and tension stresses. In general, the stiffness contribution of the masonry infill wall will be considered when large deformation appears in its attached structural frames. In Haskett Hall, large displacement was observed at column 27. The infill walls between C26 and C27 and C27 and C38 were under significant stresses and contributed in progressive collapse resistance. The DCR_p of the infill wall frame models are shown in Table 5. The maximum DCR_p of infill wall models is 0.39, which is smaller than the DCR_p of all the bare frame models. The comparison shows that the infill walls increase the flexural resistance of the steel structural frame and decrease the progressive collapse probability.

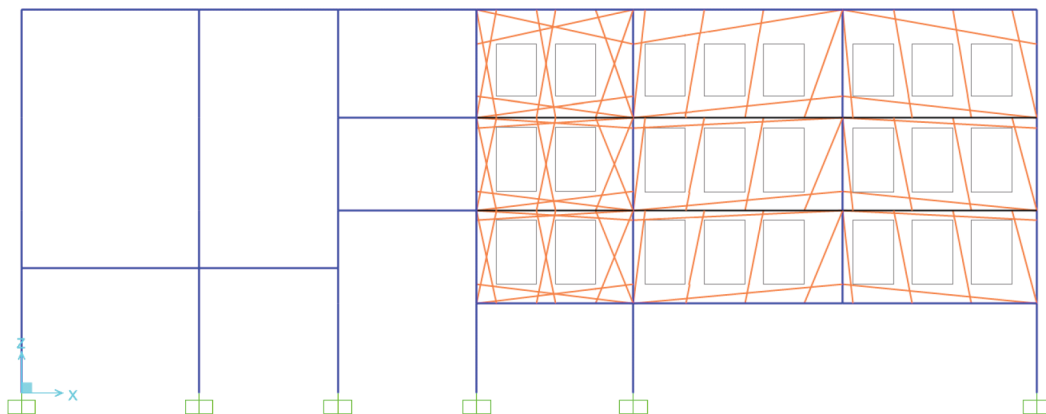
Fig. 19. Haskett House frame structure with compressive strut elements for representing infill walls.
