# Experimental Evaluation on Lateral Torsional Buckling Resistance of Continuous Steel Stringers

C. Shawn Sun, Daniel G. Linzell, Jay A. Puckett, and Ahmed Rageh

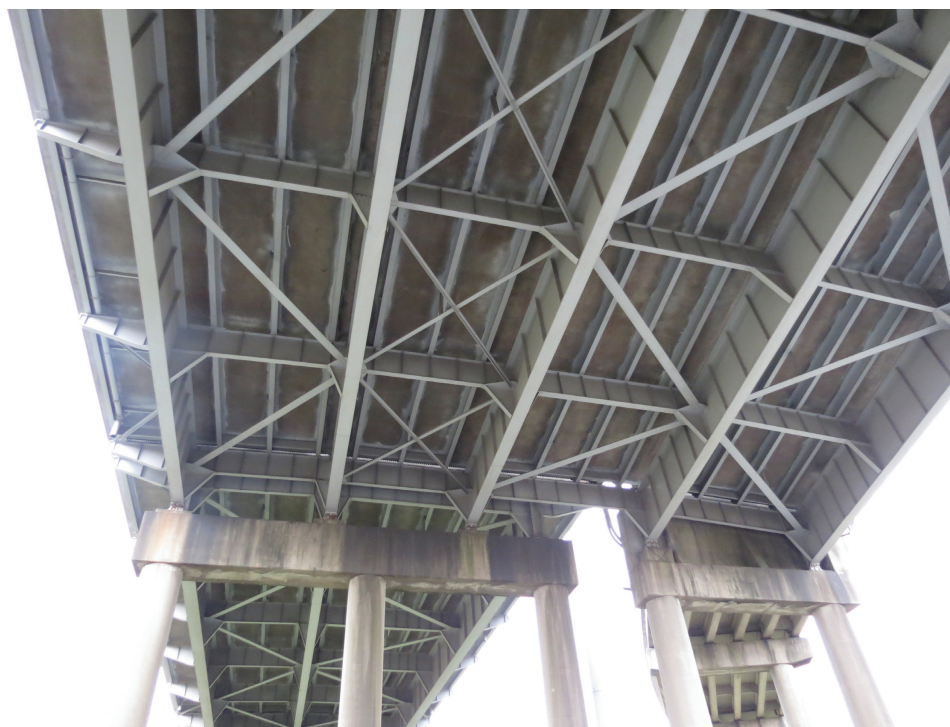
*Fig. 1. I-10 Mississippi River Bridge in Port Allen, La. (photo courtesy of Suba Herath).*

Some of Louisiana's bridges built in the 1950s and 1960s used two-girder or truss systems, in which floor beams are supported by main longitudinal members that then support continuous stringers (Figure 1). When the continuous stringers are load-rated, lateral torsional buckling (LTB) resistance is calculated in accordance with the *AASHTO LRFD Bridge Design Specifications* (AASHTO BDS) (AASHTO, 2020), which does not attempt to account for bracing effects that could be provided by a noncomposite deck. Consequently, LTB resistance can be underestimated and may necessitate load restrictions via unnecessarily conservative postings (Sun et al., 2021). This study, funded by the Louisiana Transportation Research Center (LTRC), was conducted to explore the development of more

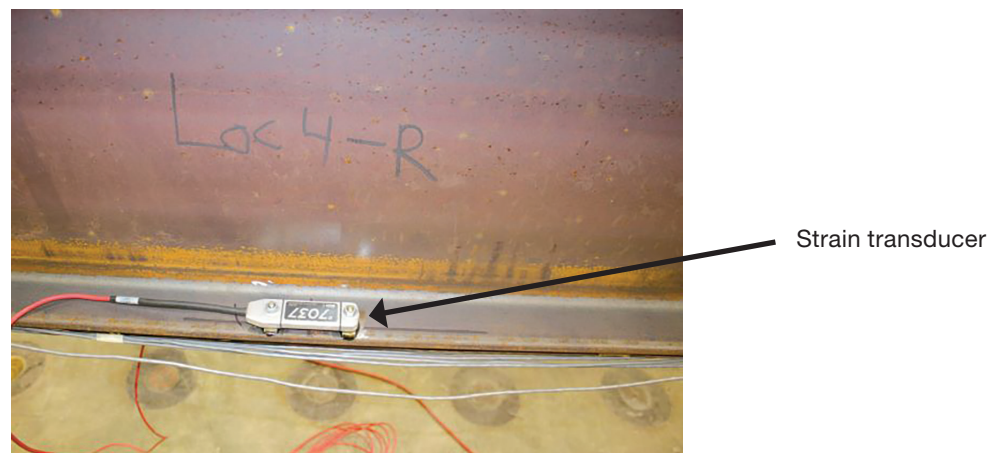
Fig. 12. Strain gage, Location 4.

Load and pressure cells, strain gages and transducers, and linear variable differential transformers (LVDTs) measured applied forces and structural response. Instrument locations are detailed in Figure 10. Strain gages and transducers were placed at multiple sections on the interior stringer and transducers at critical exterior stringer sections to capture effects due to primary, weak-axis, and lateral bending moments, as well as axial loads. Transducers were installed on both the top and bottom flanges. LVDTs were placed at midspan of the interior stringer in both spans and were oriented to capture vertical and lateral deflections. Load and pressure cells were provided at the spreader beams to apply load. Results were commonly reported at four critical locations as described in Table 2. Figures 11 and 12 detail LVDTs, strain gages, and transducers at Locations 10 and 4 (see Figure 10), respectively.
