Mechanical Properties of ASTM A992 Steel After Fire

JINWOO LEE, MICHAEL D. ENGELHARDT and ERIC M. TALEFF

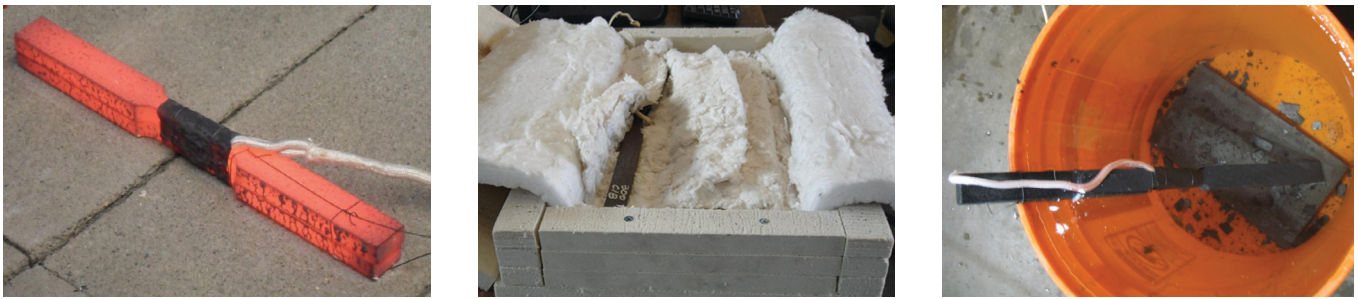
Fig. 3. Cooled-in-air (CIA), cooled-in-blanket (CIB) and cooled-in-water (CIW).

The actual cooling rates for structural steel after a fire can depend on a number of factors, including the cooling rate of the fire itself, whether or not the steel is insulated, whether or not the steel is exposed to water from fire-fighting operations or sprinklers, and others. Three different cooling methods were used for the test coupons in an attempt to provide a range of cooling rates that might reasonably bracket realistic conditions. The three cooling methods are referred to as cooled-in-blanket (CIB), cooled-in-air (CIA) and cooled-in-water (CIW). Figure 3 shows photos of coupons being cooled by these methods. The CIB method provided the slowest cooling. For this method, the coupon was wrapped in a ceramic fiber blanket after removal from the furnace and allowed to cool to room temperature. For the CIA method, the coupon was removed from the furnace and allowed to cool to room temperature while exposed to ambient air. For the CIW method, the coupon was removed

from the furnace and placed in a container of water for very rapid cooling. The time required for the coupons at 1,000 °C to return to room temperature was on the order of 14 hours for CIB, 4 hours for CIA and 1 minute for CIW. The actual cooling rates were monitored for each coupon. Typical cooling data are shown in Figure 4. Figure 4a plots temperature versus time for both the heating and cooling of the coupons heated to 1,000 °C. All three cooling methods are shown in the plot. Figure 4b shows the cooling rate (in °C/min) for coupons heated to various temperatures and then cooled by the CIB method. The actual cooling rate varied over time for each cooling method. An example of cooling rates measured 1-minute after removal of the coupon from the furnace for the CIA and CIB methods is given in Table 2.

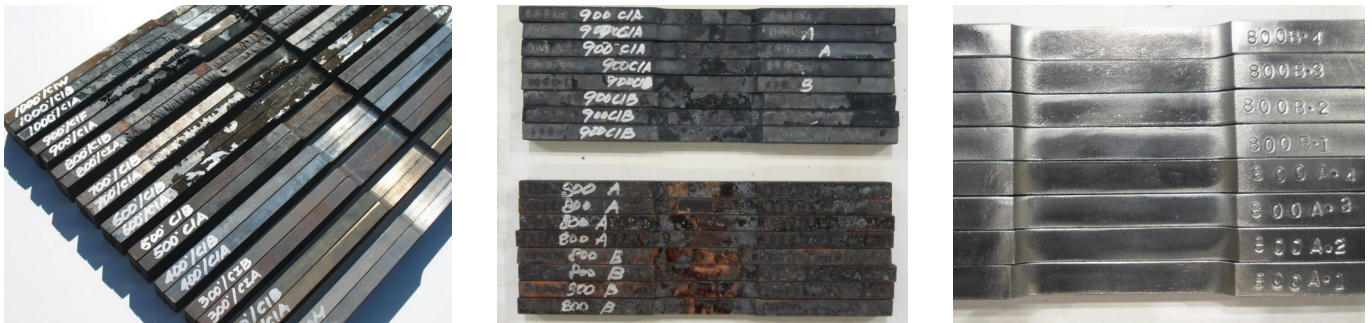
Fig. 5. Coupons before and after cleaning.

allow for accurate measurement of cross-section area and for secure attachment of the extensometer, the coupons were cleaned with a wire brush grinder prior to testing. Figure 5 shows photos of typical coupons before and after cleaning.
