# Experimental Evaluation of the Influence of Connection Typology on the Behavior of Steel Structures Under Fire

ALDINA SANTIAGO, LUIS SIMÕES DA SILVA, PAULO VILA REAL, GILBERTO VAZ  
and ANTÓNIO GAMERIO LOPES

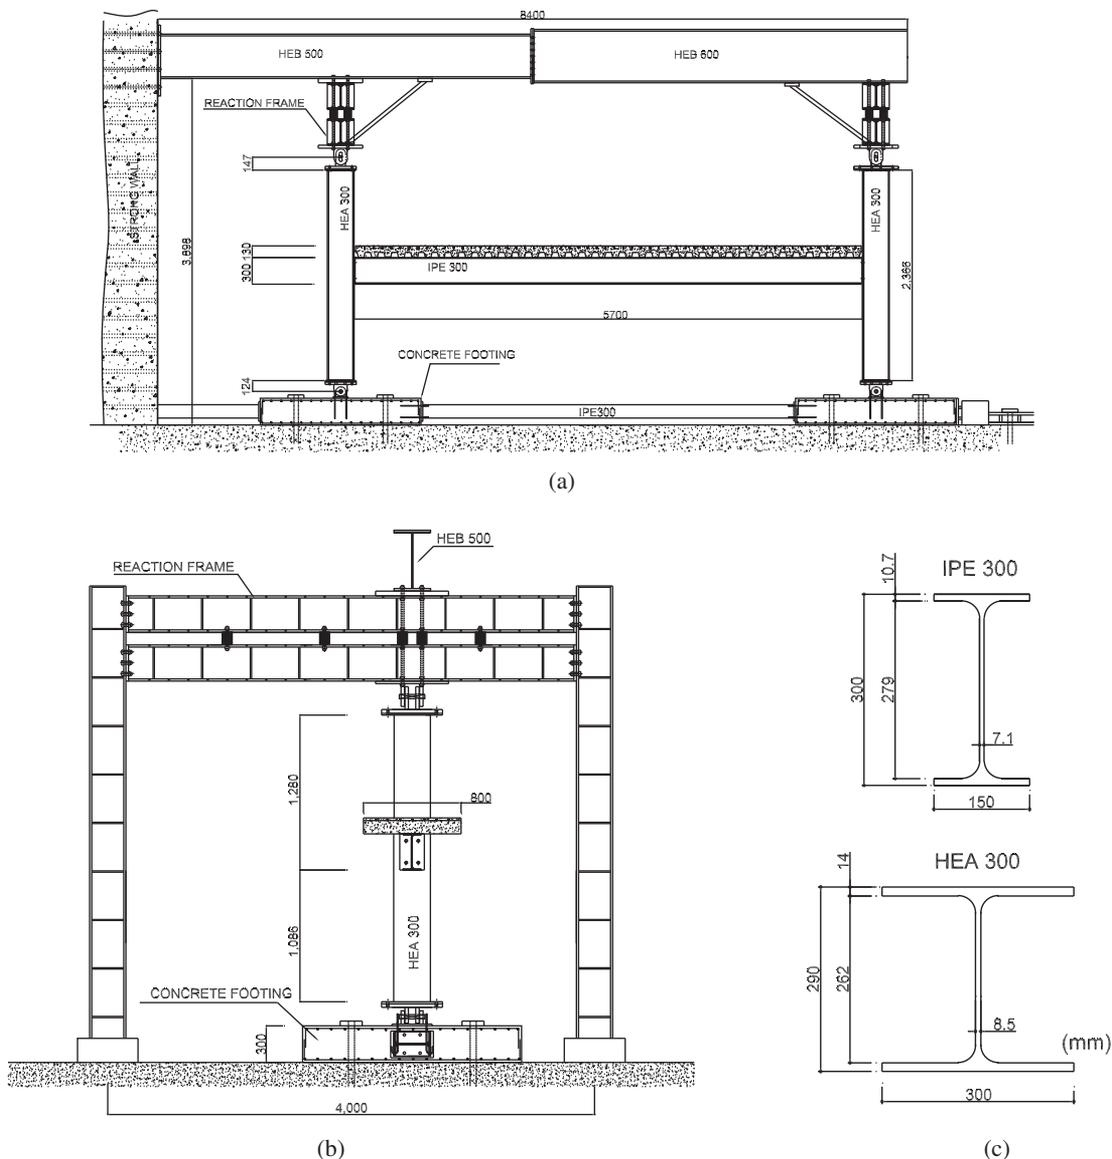
Fig. 1. General layout: (a) longitudinal view; (b) lateral view; (c) geometry of the profiles (1 in. = 25.4 mm).

The steel subframe was supported by two reaction frames (Figure 1) perpendicular to the plane of the frame. They provided pinned supports at the top of the columns, allowing free axial movement; the bottom of the columns was hinged and fixed to a reinforced concrete footing that was secured

The two reaction frames were horizontally restrained at the top by connecting HEB 500 and HEB 600 profiles to the strong wall (Figure 1a). In order to avoid parasitic rotations at the top of the reaction frames and, consequently, mistakes in the measurements, bracing struts were positioned between the top of the reaction frames and the top beam acting as longitudinal bracing.

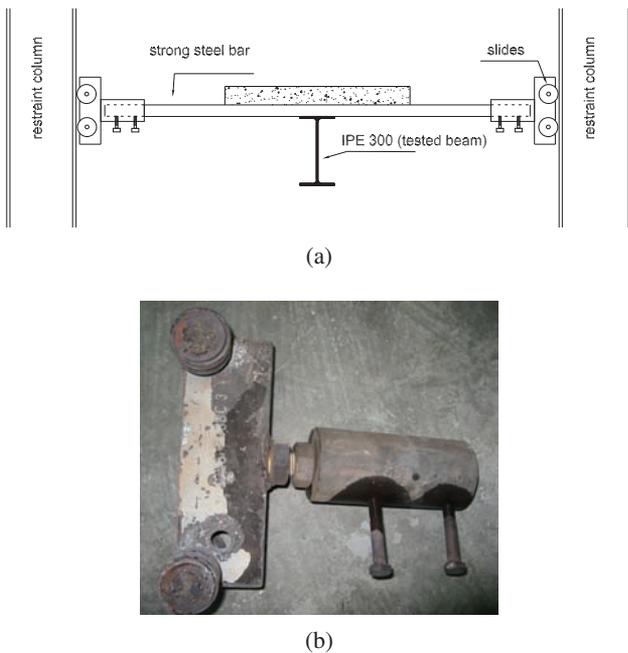
Fig. 2. (a) Lateral restraint system; (b) Detail of slide.

1500 mm (59.1 in.) to the left side from the midspan, and at 1500 mm to the right side from the midspan. The restraint system is illustrated in Figure 2 and vertical sliding movement is allowed.

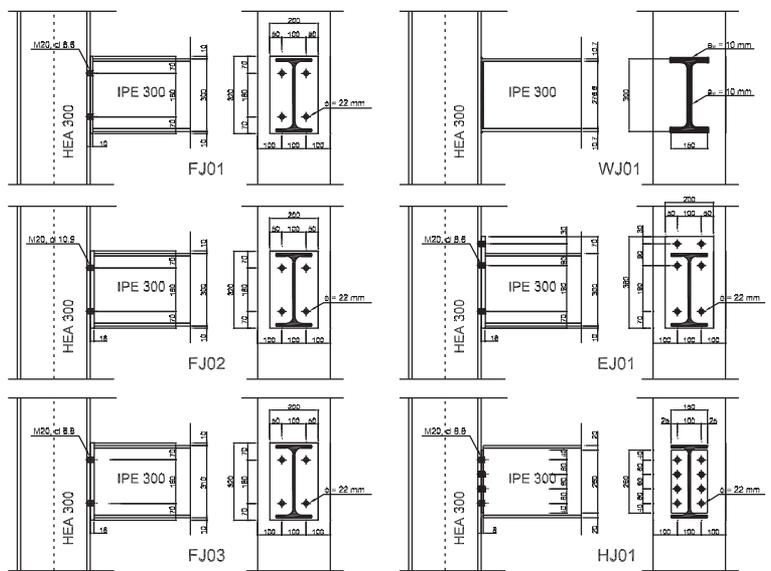
Fig. 3. Geometry of the joints (1 in. = 25.4 mm).

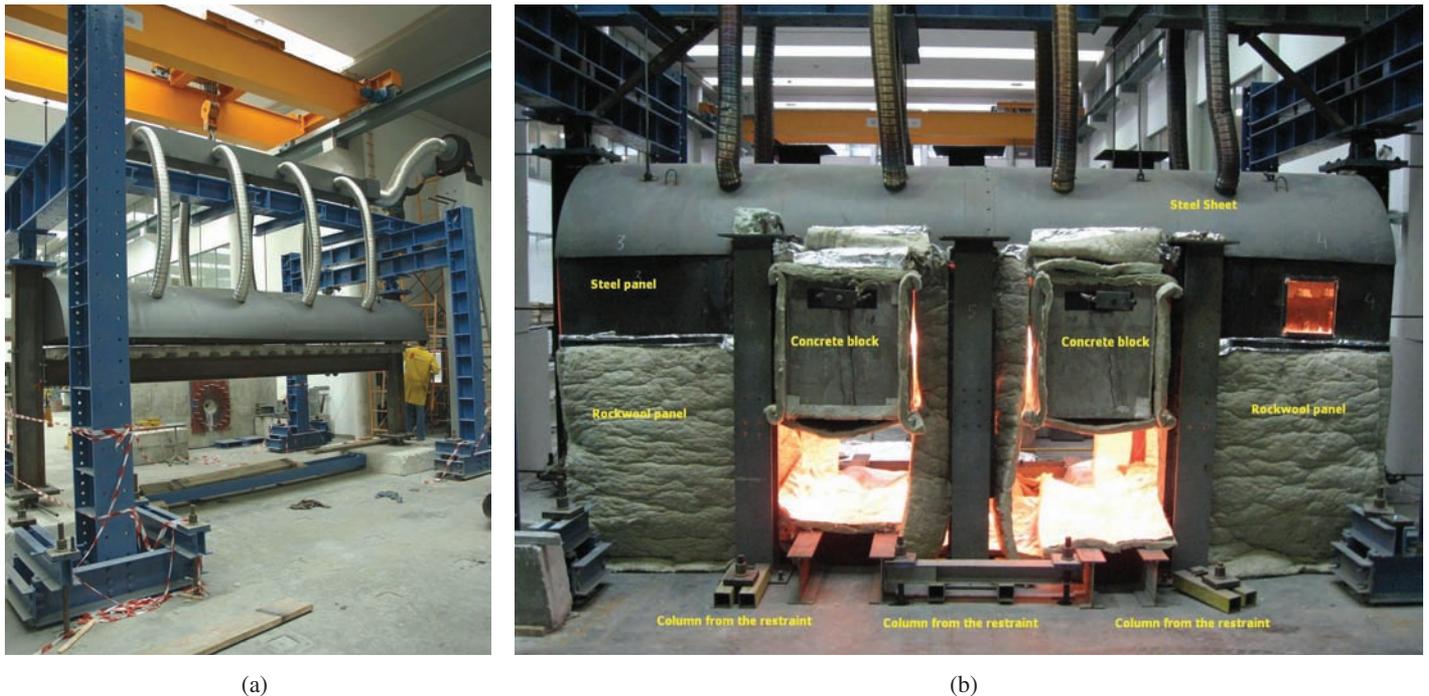
Fig. 4. General layout: (a) preparation; (b) during a fire test.

The mechanical loading was applied at two points of the top flange of the noncomposite beam, 700 mm (27.6 in.) to either side of the beam midspan. Each concentrated load was equal to 20 kN (4,500 lbf), which corresponds to a live load ratio of 0.2. The load ratio is here defined as the ratio of the live load at fire limit state [ $M_{f,d} = 46 \text{ kN-m}$  (40.7 lbf-in.)] to the load-carrying capacity as a simply supported beam at room temperature [ $M_{Rd} = 223 \text{ kN-m}$  (197 lbf-in.)] based on a yield stress of 355 MPa (51,500 psi). This mechanical loading was applied using two pairs of concrete blocks at room temperature (Figure 4).

gases, the system shown in Figure 4 was used. This exhaust system, fixed to the supporting structure, consists of a semi-circular steel shell around the top of the composite slab and closed at the ends. This semi-circular steel shell drove the combustion gases through flexible steel pipes to a ventilator that forced out these gases to the outside of the laboratory through an opening in the roof.

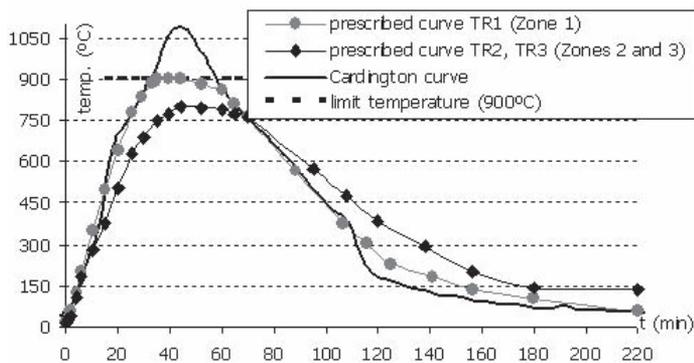
Zone 2 TR2	Zone 1 TR1	Zone 3 TR3
1000	5680	1000

Fig. 5. Thermal loading: (a) definition of heating zones; (b) steel time-temperature curves of beam bottom flange.

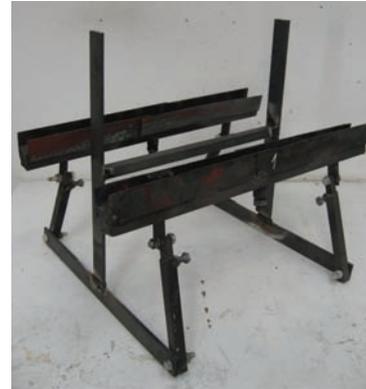
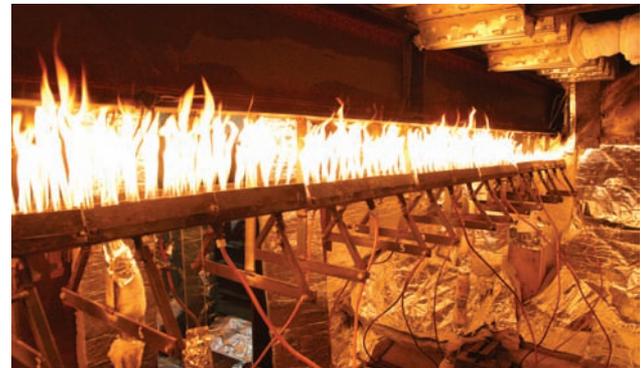
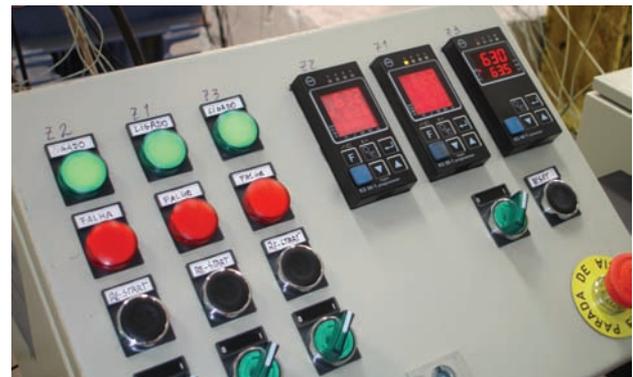
Fig. 6. (a) Individual gas burner; (b) heating system; (c) temperature control system.

valves that controlled each zone individually and allowed specifying the range of the flame intensity, and thus reproduce the thermal load strategy (Figure 6). At the same time, control thermocouples at each zone were installed to measure instantaneously the temperature inside the steel. The gas delivered to the system was adjusted by comparing the thermal load strategy with the instantaneous temperature at each control thermocouple. The burners were fed by propane gas through flexible copper pipes (to allow adjustments at the support structure) and were supplied by a battery of gas reservoirs located outside the laboratory. Propane gas allows a definition of a yellow turbulent diffusion flame, common in urban fires. The main reasons this heating system was preferred to a furnace or an electric blanket were the possibility to achieve a direct heating by flame, allowing an easy control of the local thermal load; as the facility is open to the surroundings, a natural convection cooling flow is obtained and the overall setup is easier; and the temperature gradient along the beam is similar to what is observed in an urban fire, as already discussed.

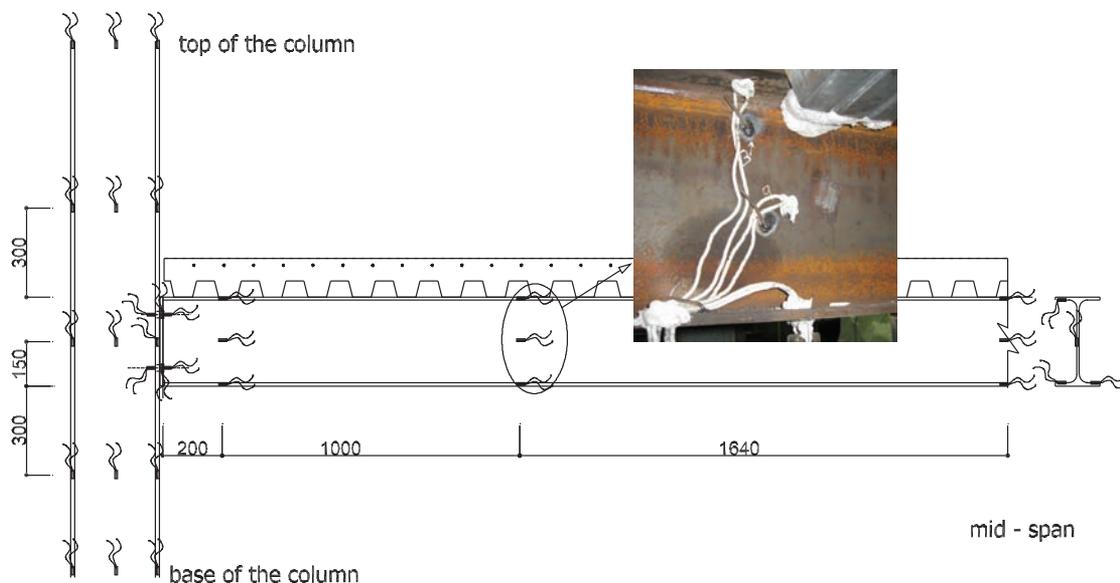
Fig. 7. Location of thermocouples and detail of thermocouples in the beam.

The results were recorded by means of the following instrumentation: thermocouples, displacement transducers and thermographic cameras. Roughly 75 thermocouples of K type with two 0.5-mm (0.02-in.) wires were positioned inside the steel to monitor the temperature in the connected elements (end plate and bolts) and the temperature profiles across the beam and protected columns. The exact number of thermocouples depends on the joint geometry. In order to avoid the direct contact with the flames, the thermocouples attached to the heated beam and the connections were protected by ceramic rods (Figure 7).

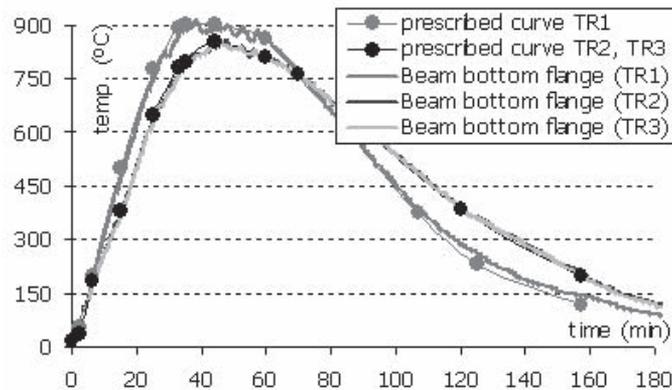
Fig. 8. Measured beam temperature versus prescribed fire curves (test FJ01).

Figure 8 compares the prescribed fire curves (control system) with the temperatures measured at the beam reference points (TR1, TR2 and TR3) for test EJ01. Good agreement was observed. Similar results were observed for the other five tests.

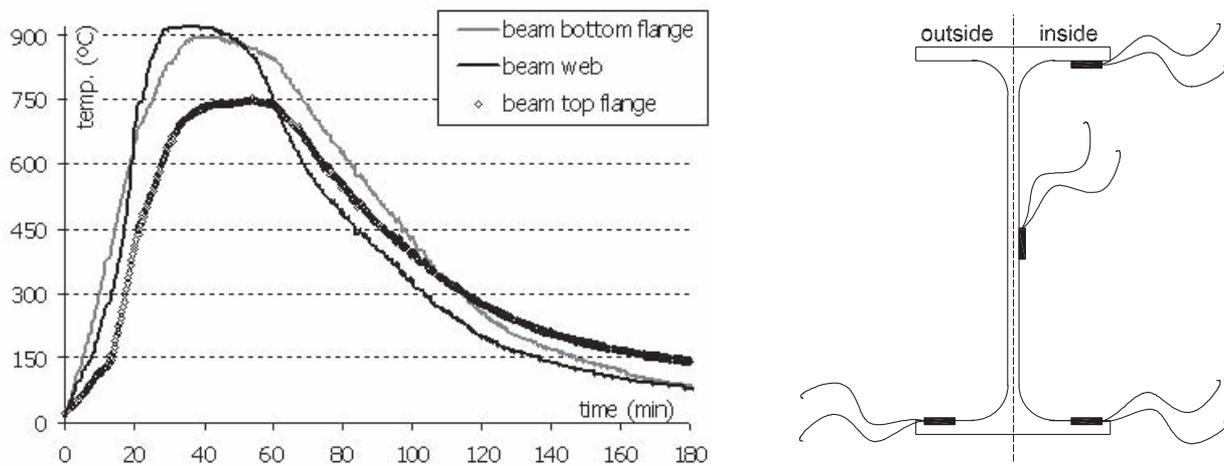
Fig. 9. Temperature distribution across the beam mid-span (test EJ01).

Figure 9 depicts the temperature distribution across the beam mid-span cross section for test EJ01. Temperature measurements at mid-span of the beams were taken in the bottom flange (both sides), web and top flange. During the heating phase, the web and bottom flange temperatures are quite similar, despite the fact that the flames surround the bottom flange earlier, the reduced web thickness allowing a faster temperature increase. In the cooling phase, the web temperature decreases faster than the bottom flange temperature for the two following reasons: the reduced thickness corresponds to a lower thermal inertia; and during this phase, the length of flames reduces, and, from a certain moment in time onwards, they only surround the bottom flange. Because of the thermal inertia of the slab and its flame protection effect, the top flange showed the lowest temperature during the

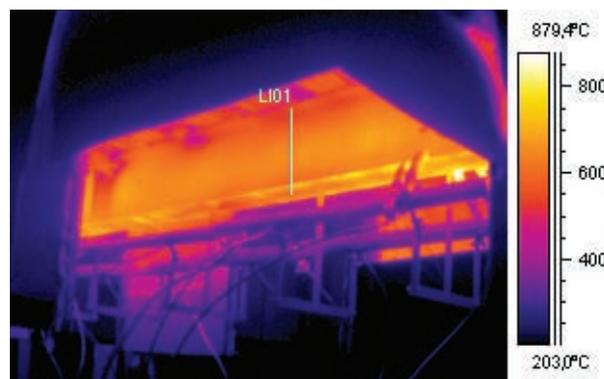
Fig. 10. Thermographic image of the temperature distribution in the beam during the heating phase.

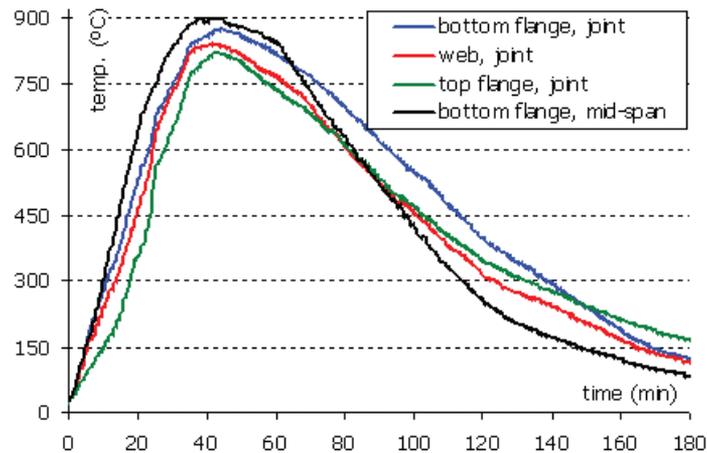
Fig. 11. Temperature in the beam near the joint Z3 (test EJ01).

Figure 11 compares the temperature-time variation across the depth of the beam 200 mm (7.9 in.) away from the connection Z3 with the bottom flange temperature at mid-span

(test EJ01). During the heating phase, the joint temperature was significantly lower than the mid-span bottom flange, which is usually the critical element that defines the limiting temperature of the beam. In contrast, the cooling down in the joint was slower, in accordance with what happens in a real fire situation (Wald et al., 2006b). The maximum temperature near the joints was measured in the bottom flange and corresponded to about 90% of the maximum temperature at mid-span.

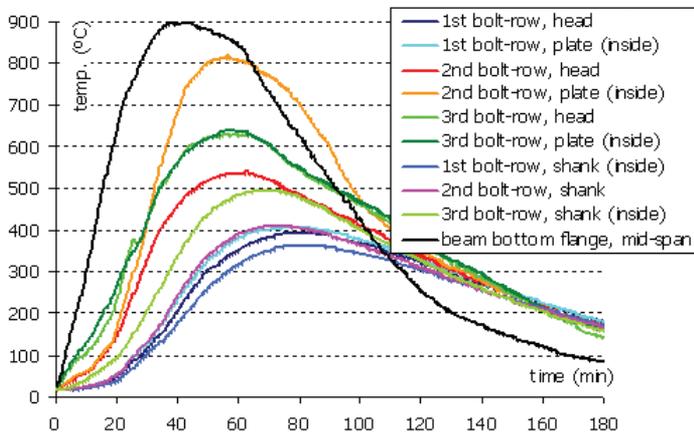
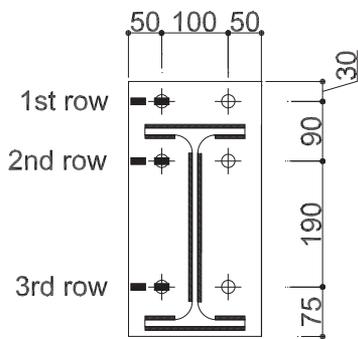
Fig. 12. Temperature within the joint Z3 (test EJ01).

Figure 12 compares the temperature curves for the various connection elements of joints in zone Z3 (test EJ01). Measurements were made for each bolt row as follows: in the bolt (beam side); in the bolt shank under the nut (column

side); and in the end plate at the same level of the bolt. Again, in the heating phase, the connection temperature was significantly lower than the remote bottom flange at mid-span; in contrast, the cooling down in the joint elements was slower, because of thermal inertia of the adjacent column and connection elements, and the different prescribed thermal loading applied at the joints section. The maximum temperature at the connection is thus reached during the cooling phase.

The first bolt row from the top was significantly cooler than the lower bolts, because the adjacent slab prevents the direct contact from the flames. Furthermore, the thermal inertia of the adjacent column acts as a heat sink. The end plate temperature was quite similar to that of the bolts head at the same level. Exception is made at the level of the second bolt row; in this case, the flames engaged the plate thermocouple more than the bolt head thermocouple and the end plate received more heat than the bolt head. This measurement should not be considered as representative of the average plate temperature at this level. Temperature gradient along the bolts was also measured: the maximum temperature in the head of the third bolt row was about 150 to 200 °C

(302 to 392 °F) higher than the corresponding shank; a maximum temperature of about 400 °C (752 °F) was measured in the shanks. For the first bolt row, a difference of about 60 °C (140 °F) on the maximum temperature is observed; this difference could be due to the temperature variation within the beam cross section. The effect of the heat transfer by conduction on the joint element is also evident: the bolt heads and plate heat up first, followed by the corresponding shanks.

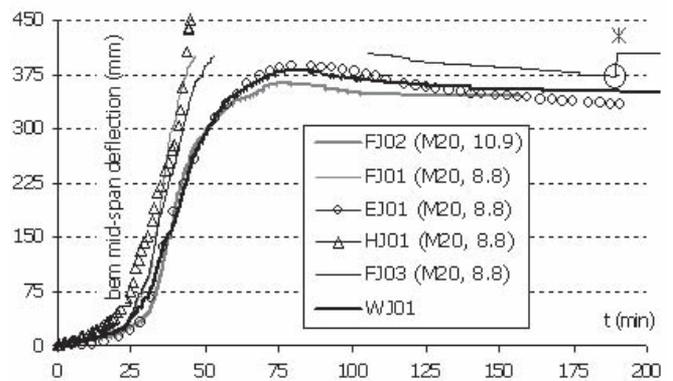
Fig. 13. Mid-span deflection of the beams.

Figure 13 compares the evolution of the mid-span deflections during the fire. Most of the beams were able to sustain the load with reduced deflection up to 10 min [ $\theta_0 < 150$  °C (302 °F)]; during this stage, the deflection was mainly due to the mechanical loading. Beyond that, due to the loss of stiffness, the midspan deflection increased gradually. Beyond 20 min, a further rise in temperature [ $\theta_0 > 550$  °C (1022 °F)] led to a progressive run-away of the beam deflection as the loss of stiffness and strength accelerated. In the case of the FJ02, EJ01 and WJ01 tests, a maximum deflection of 375 mm (14.8 in.) was approximately reached (these values were measured already during the cooling phase). For the HJ01 test, Z3 joint collapsed during the heating phase of the fire [ $\theta_0 = 900$  °C (1652 °F)] as a result of the run-away deflection at high temperatures [ $\delta_{beam} = 393$  mm (15.5 in.)]. Once the cooling phase started, the heated beams began to recover strength and stiffness from an inelastic state, together with a reduction of thermal strains. This induced tensile, axial forces and the reversal of the deflection. Because of the limited range of the displacement transducers (400 mm), FJ01 curve was incomplete; however, a maximum deflection of 428 mm (16.9 in.) was measured at the end of the fire.

For the same reason, the maximum deflection at the mid-span of beam FJ03 was not measured, but during the cooling phase the deflection reduced to values lower than 400 mm

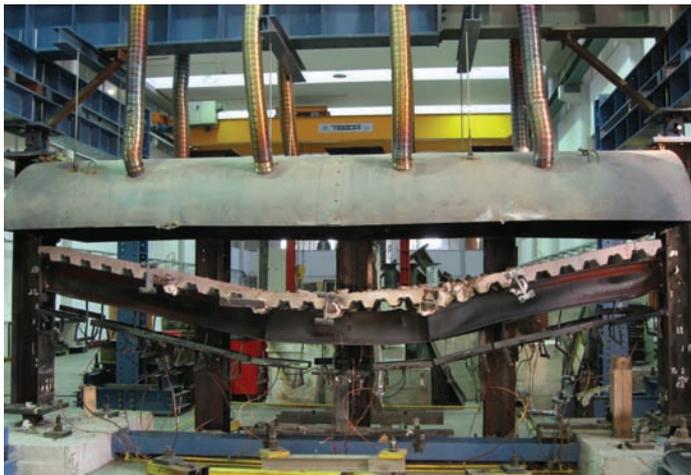
Fig. 14. Deformed structure after test FJ01.

(15.7 in.); moreover, it was possible to identify the failure of the bottom bolt row at  $t = 190$  min after the beginning of the fire; the top bolt row fractured later ( $t = 382$  min). Figure 14 shows the deformed structure at the end of the FJ01 test.

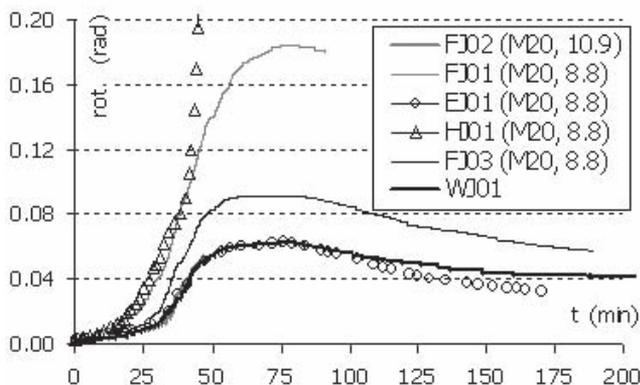
Fig. 15. Joint rotation.

Based on the vertical displacement measured 300 mm (11.8 in.) away from the column end plate surface,  $d_{z3}$ , the joint rotation,  $\phi$ , is defined as:

$$\phi = \alpha + (\theta_b - \theta_c) = \tan^{-1} \left( \frac{d_{z3}}{300} \right) \quad (1)$$

where  $\alpha$  is the contribution from the shear deformation of the column web, and  $(\theta_b - \theta_c)$  the change in angle between the centerlines of the beam and column. In these tests, the column hardly deforms as it behaves as a rigid element. Then, both  $\alpha$  and  $\theta_c$  are neglected. Figure 15 shows the corresponding rotation curves.

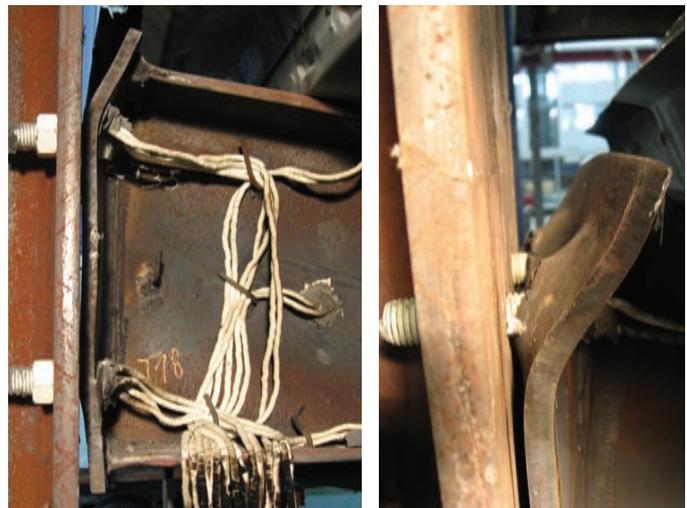
Fig. 16. Joint deformation at test FJ01.

Deformation of the end plate was observed, accompanied by local buckling of the beam bottom flange and shear buckling of the beam web (Figure 16). The deformation at the top of the end plate was mainly observed during the heating phase, while deformation at the bottom developed during the cooling phase, due to the tensile force in this zone. Bearing failure of the end plate around the bolts, particularly near the top flange, was also observed. Bolts did not suffer any damage. This failure mode was not surprising due to the reduced thickness of the end plate [10 mm (0.39 in.)].

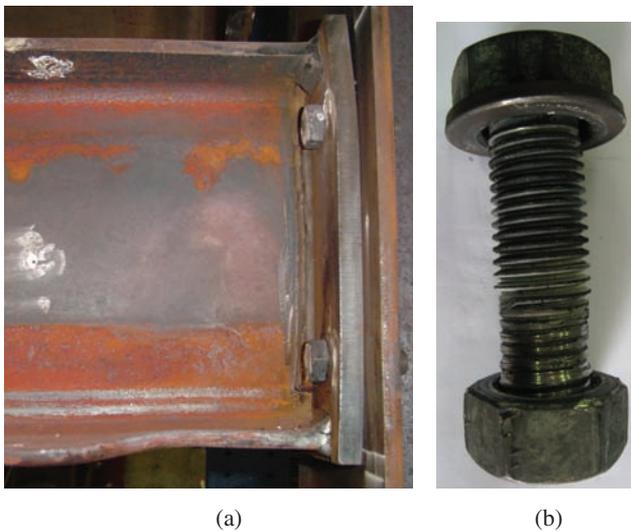
Fig. 17. (a) End plate deformation; (b) bolt stripping at FJ02.

Failure modes were apparently similar to those observed for test FJ01: end plate deformation accompanied by local buckling on the beam bottom flange and shear buckling of the beam web (Figure 17a). The end plate deformation was smaller than for test FJ01, because of a thicker end plate [16 mm (0.63 in.)]. However, a clear difference was noted, in the form of nut stripping of the bolts (Figure 17b). This indicated a clear change in failure modes, whereby the bolts became critical in tension during cooling, despite being class 10.9.

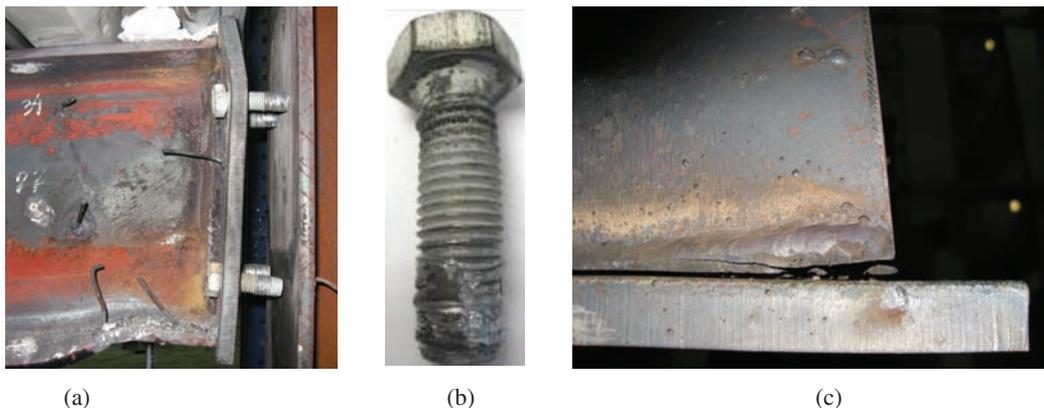
Fig. 18. (a) End plate deformation; (b) bolt stripping; (c) weld failure at test FJ03 (view from the top of the beam).

During the heating phase, local buckling on the bottom flange and shear failure at the web were noticed. At the same time, and due to the large joint bending moment, end plate deformation at top developed and the weld on the top flange was broken (Figure 18b). During cooling and due to the large tensile forces that developed during this phase, minor cracks on the weld at the bottom flange (both joints) were observed together with bolt failure in joint Z2 (Figure 18a). The bolt failure mode was by nut stripping: after 190 min. from the beginning of fire, the bottom bolt row fails while the top bolt row broke later ( $t = 382$  min).

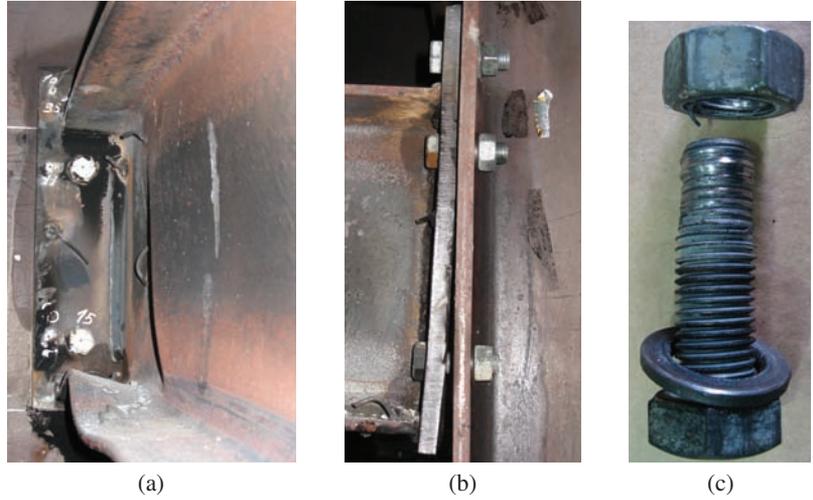
Fig. 19. (a) Local buckling on the beam bottom flange and web; (b) deformation at the bottom of the end plate; (c) nut and bolt stripping—bottom bolt row at test EJ01.

During the heating phase, due to the end plate thickness of 16 mm (0.63 in.) and the connection configuration (three bolt rows), no significant end plate deformation developed; only deformation of the beam was observed: local buckling of the beam bottom flange and shear buckling of the beam web. However, during the cooling phase and due to the large tensile forces developed during this phase, localized deformation at the bottom of the end plate and failure (nut stripping) of the bottom bolt row was observed (Figure 19).

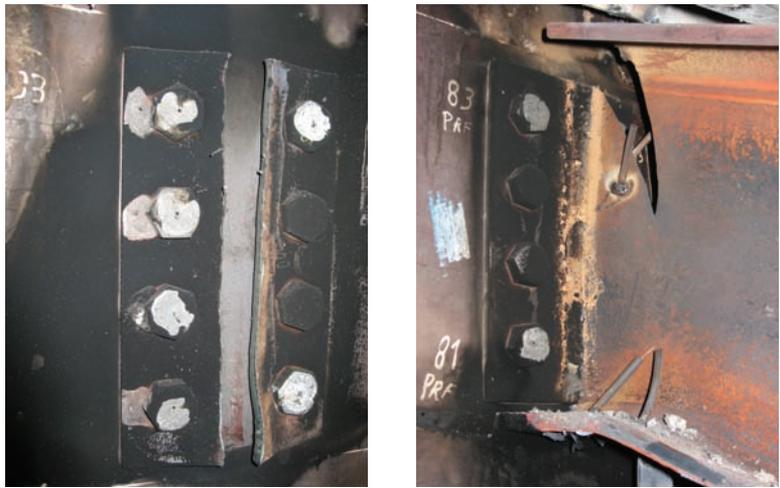
Fig. 20. (a) End plate failure (joint Z2); (b) beam failure (joint Z3) at test HJ01.

During the heating phase, local buckling on the bottom flange was observed; shear failure at the beam web was insignificant. At the maximum joint temperature of 850 °C (1,562 °F), the end plate broke along both beam web welds (joint Z3), because its tensile resistance is low and it had considerable rotation before the beam and column flange came into contact (Figure 20a). Rapidly, the beam suffered a large deflection, and shear forces were developed near the joint Z2, leading to beam rupture (Figure 20b). No damage to the bolts was observed. This failure mode was not observed in the other bolted joint, because they exhibit larger bending resistance.

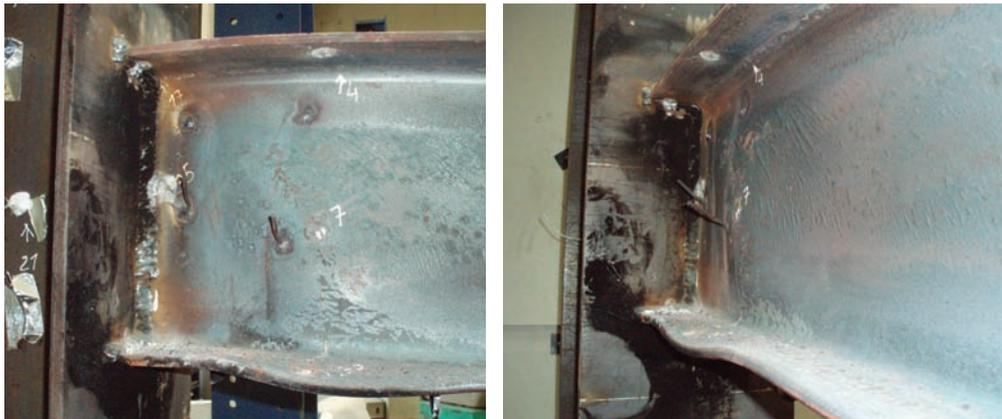
Fig. 21. Local buckling on the beam bottom flange and shear buckling of the beam web (joint Z2).

During the heating phase, local buckling on the bottom flange was observed; shear failure at the beam web was minor (Figure 21). No damage to the welds was observed.

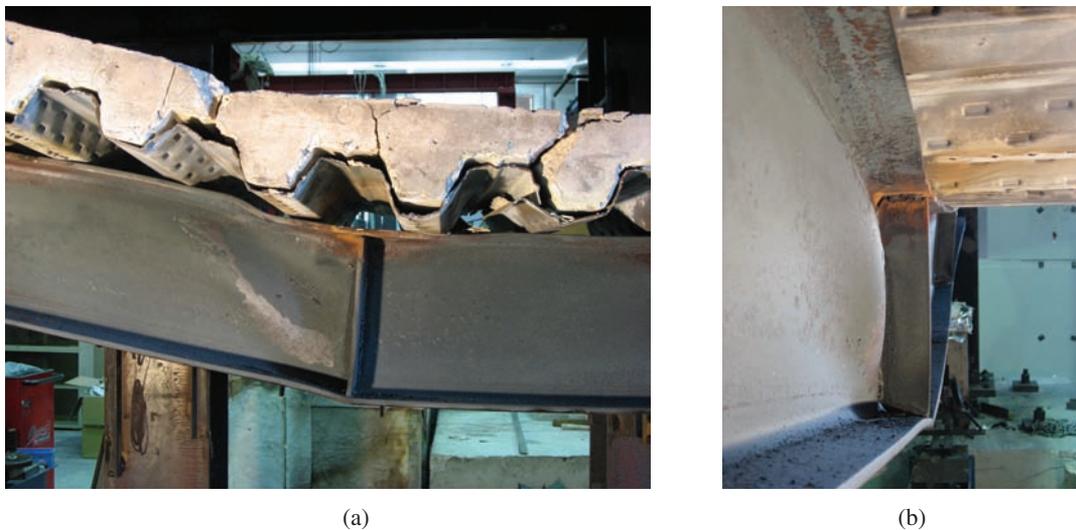
Fig. 22. Shear buckling of the beam web near the load points.

Furthermore, other failure modes were observed in the beam and in the concrete slab: shear buckling of the beam web near the load points; bursting of the concrete slab; large

cracks on the concrete slab due to the separation of the shear studs from the concrete slab; major cracks perpendicular to the slab that occurred as a result of the beam and joints deformation (Figure 22). Due to the considerable size of the columns, column deformations are irrelevant.

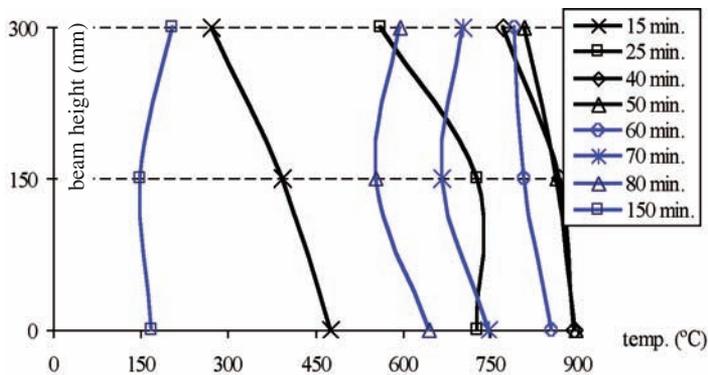
Fig. 23. Temperature profiles across the depth of the beam near the joint.

According to part 1-2 of Eurocode 3 (CEN, 2005c), the beam temperature is calculated as an average temperature within the cross-section that depends on the section factor and the temperature profile is assumed constant within the cross-section. These tests highlight the validity of this simplification adopted by the Eurocode, but only at elevated temperatures; at low temperature ( $t < 25$  min and  $t > 80$  min) the temperature profile is variable (Figure 23). Based on the

temperature at mid-span, for the same time (Table 8). The experimental results show that the thermal gradient is not constant during a fire, changing from convex to concave with time. Figure 24 illustrates the proposed temperature gradients of EN 1993-1-2 (CEN, 2005c) that only depend on the beam height. It can be seen that the proposed Eurocode thermal gradients approximate the experimental results in the range 20 min < t < 40 min, which corresponds to a bottom flange temperature of circa  $\theta_0 = 830$  °C (1,526 °F).

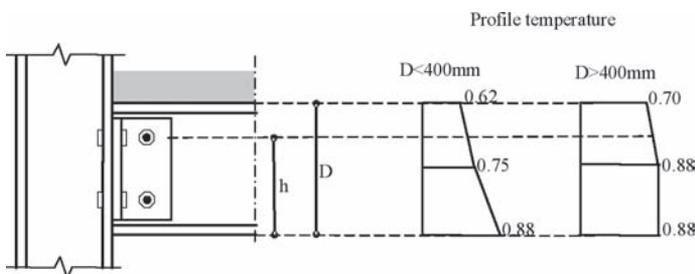
Fig. 24. Thermal gradient across the depth of a composite joint (CEN, 2005c).

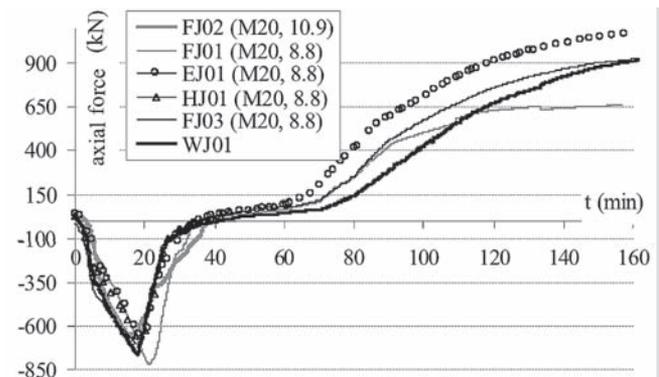
Fig. 25. Axial forces using the average temperature at the beam mid-span.

Based on the measured axial and vertical displacements of the beam and the axial stiffness of the beam and end restraints, it is possible to estimate the axial force in the beam and the bending moment at the joints. Figures 25 and 26 illustrate the variation of the axial force and bending moment with time.

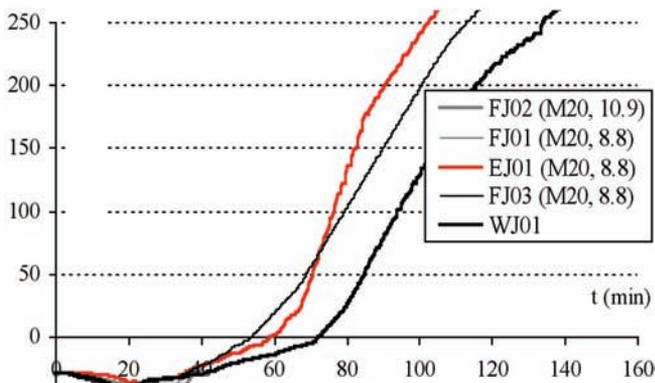
Fig. 26. Internal bending moment at the joints.

It can be seen that the joints are subjected to a varying axial force and bending moment throughout the fire event, from an initial state of pure bending. This complex stress state, combined with the M-N resistance interaction diagram for a given temperature profile in the joint, explains the observed behavior of each joint.
