# A Stub-Girder System for High-Rise Buildings

JOSEPH P. COLACO

*This paper was presented at the AISC National Engineering Conference, New York, N. Y., in May 1972.*

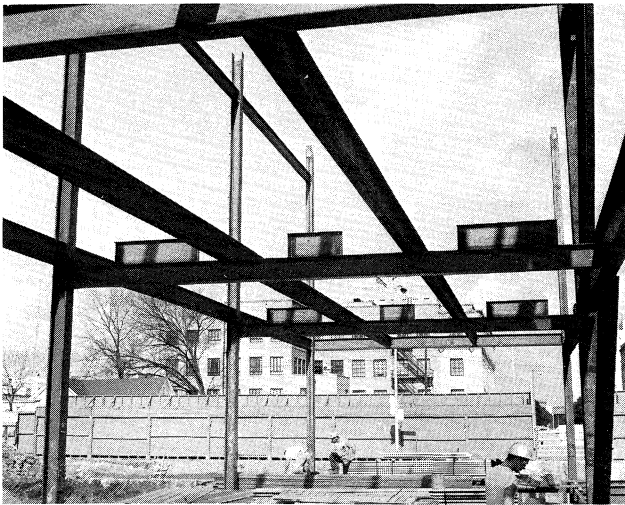
Steel erection was started on November 1, 1970. Figure 9 shows the erection of the first tier of structural steel which includes the stub-girders. Figure 10 gives an underside view of the system after the placement of the 22-gage C-2 Cofar galvanized metal deck. In Fig. 11 a view is shown of the floor system after the welding of the shear connectors. The reinforcing steel for the floor slab was placed and 3 1/4 in. of lightweight concrete was placed over the deck while the girder was shored. Structural steel construction progressed at a rapid pace and the structural steel was topped out in October, 1971. The lateral stiffness is obtained by a

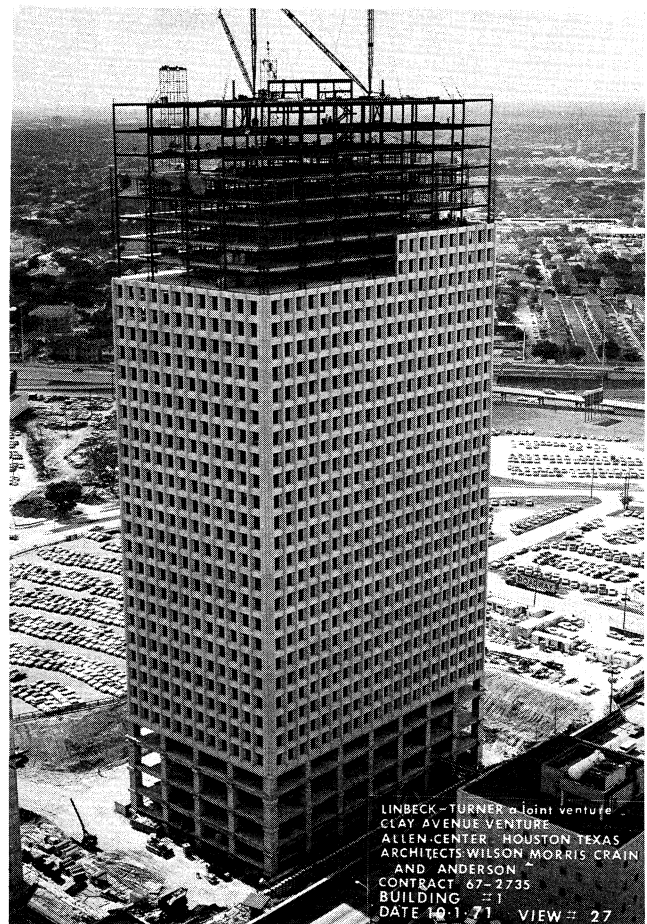
Figure 12

composite exterior frame consisting of steel erection columns and a cast-in-place concrete frame. Precast concrete panels were used for the exterior facade of the building and also to form the concrete columns and spandrels as shown in Fig. 12. The total structure including the exterior panels was completed 12 months after the start of steel erection.
