Full-Scale Tests of Butt-Welded Splices in Heavy-Rolled Steel Sections Subjected to Primary Tensile Stresses

MICHEL BRUNEAU and STEPHEN A. MAHIN

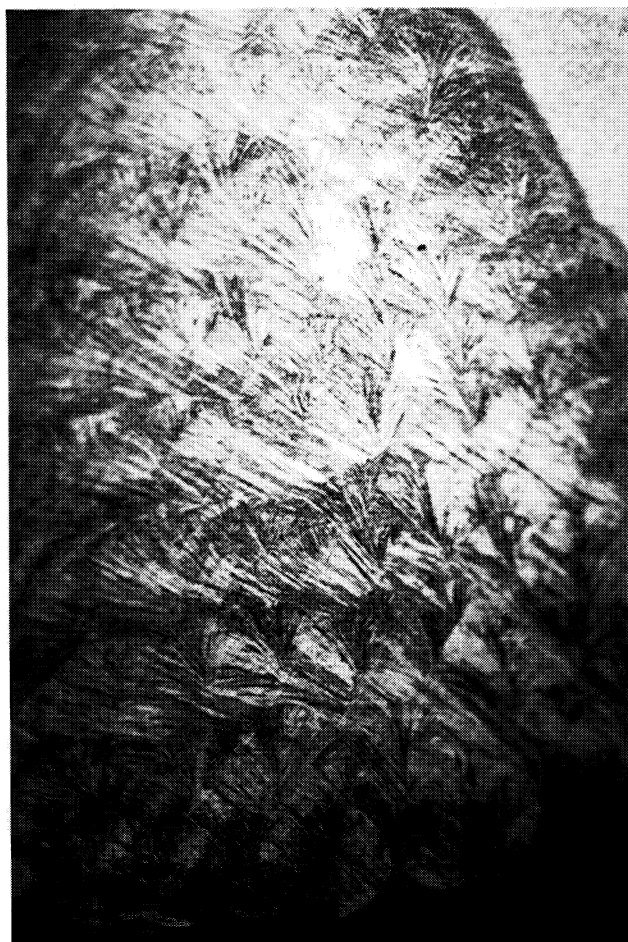
Fig. 6. Dendritic crystalline formation on a polished and etched full penetration weld on a thick flange.

A short stub column was welded and cut in order to allow visual observation of the weld. The weld surfaces were polished and etched. The dendritic crystalline formation is clearly visible on the full penetration flange weld of Fig. 6. The flange shown is 3.5 in. thick. It is very interesting to see the crack-like effect at the toe of a typical partial penetration weld. Figure 7 shows a half penetration weld of a 3.5 in. thick flange. Some of the welds contained small voids that could act like stress raisers.

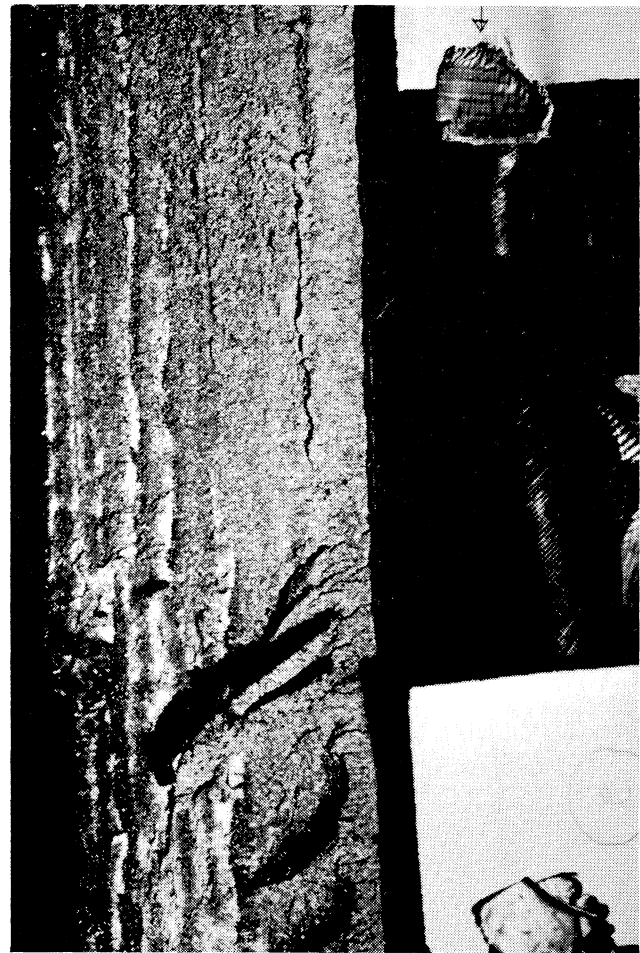
Fig. 10. Failure surface of partial penetration welded splice—center of bottom flange.

Since failure occurred through the weld (Fig. 10), the failure surface was carefully investigated. The failure surface was nearly planar and followed the juncture of the two sections. At this location the weld was thickest, extending from the mid-depth of the thinner flange to the top of the thicker flange. After inspecting the failure surface, a welding consultant⁸ indicated the following:

- The welds were rated as poor welds because of lack of fusion between passes (individual passes were very pronounced and the passes in the surface of the welds had valleys between passes and most of the fracture surfaces were between passes), lack of penetration and fusion of root passes (as much as $\frac{1}{8}$ in. of the prepared 45° bevel being unfused in several places), and some other minor controversial metallurgical items (large columnar grain growth in some of the weld beads).
- The brittle mode of failure was virtually assured by the lateral restraint of the welds being welded to the large

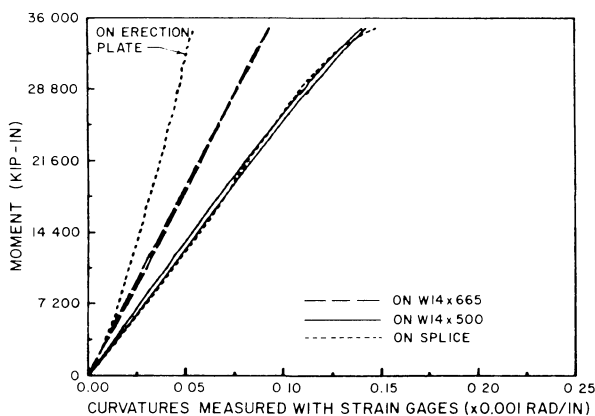
Fig. 12. Moment-curvature from strain gages on partial penetration specimen.

gages were placed on the erection plate). In the elastic range, moment-curvature relationships obtained from pairs of gages located on web (Fig. 12) are all equal to those predicted theoretically, within an acceptable accuracy. These relationships remained linear for most gaged sections except for the set on the W14×500's web near the splice which shows a slight softening near failure. This non-linearity recorded just before failure is an indicator of the initiation of yielding near the splice. The ratio of the maximum strain at this section to that further down the W14×500 (elastic) was only 1.05. This ratio can be an acceptable approximation of curvature ductility for small values of ductility. Nevertheless, the actual amount of yielding near the weld may have been larger than measured, as the gages were located 2¾ in. from the face of the splice.

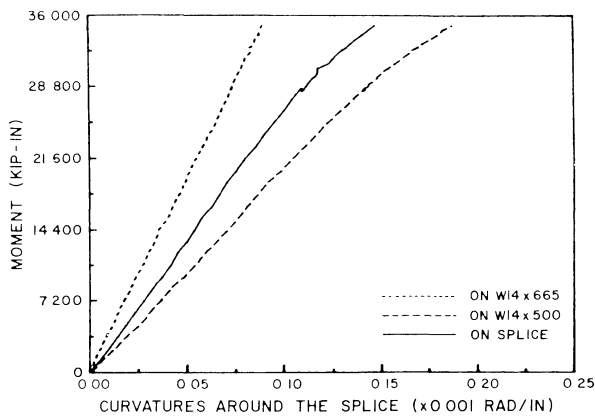
Fig. 15. Moment-curvature from clip gages on partial penetration specimen.

The most meaningful information was provided by three pairs of clip gages with gage lengths of approximately 6 in. (Fig. 15). All measured moment-curvature relationships in the elastic range are almost perfectly equal to their theoretically calculated ones, with the W14×665 shown to remain perfectly elastic until failure of the specimen. Also, as the loads get above the 1200 kips level (equivalent to the 28,800 kip-in. moment level), a slight softening of the moment-curvature relation can be observed on the W14×500 near the

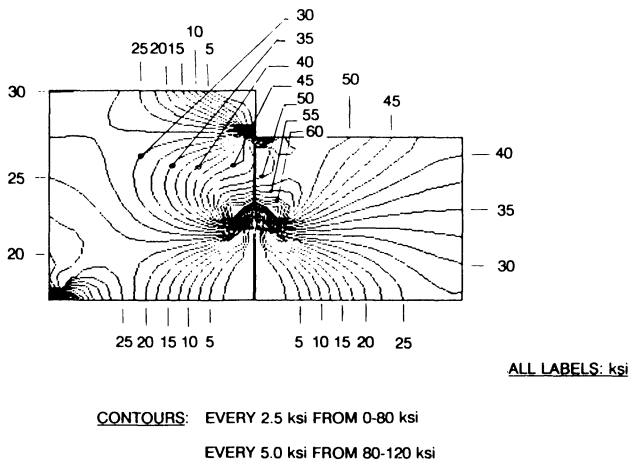
Fig. 17. σ_{11} stress contours for finite element analysis of Model 1.

Two different models of the flange were investigated and their respective behavior compared. Nodal loads approximating the states of stress in the flanges away from the splice at the time of failure were imposed to each model. In Model 1 (Fig. 17) the two steel sections are welded and left with the change of flange thicknesses unsmoothed. Less experienced welders have been observed leaving welds finished as in Model 1. A mesh of 576 regular elements was generated for this model. The distribution of principal stress σ_1 shown in Fig. 17 indicates a substantial stress concentration at the tip of the crack and at the discontinuous edge joining the two sections. Figure 18 re-emphasizes the fact that while uniformly varying stresses would be expected away from the weld, very high stresses would concentrate at the tip of the crack. Stresses much higher than yield are predicted, thereby violating the assumptions in the analyses.

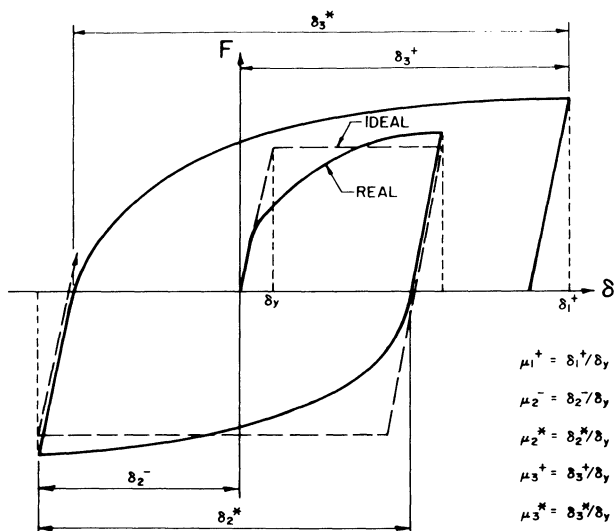
Fig. 25. Ductility definitions used.
