# Repair of Existing Steel Moment Frame Buildings Damaged from Earthquakes Using Fracture Tough Weld Overlays

WARNER SIMON, JAMES ANDERSON, JACK COMPTON, WALTER HAYES, and PETER MARANIAN

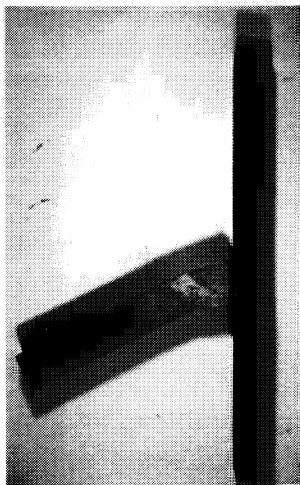
Fig. 7. Drop weight test on a pre-Northridge weld.

The testing approach adopted was to first carry out small component tests. The standard Charpy test, although useful for studies on transition temperatures on individual materials (i.e. parent metal and weld-metal), does not apply to a composite joint. Therefore it was necessary to develop a test approach that could better accomplish this and this led to the adoption of drop weight and low cycle fatigue tests. The drop weight test was developed at the Naval Research Laboratory in 1952 and has been used extensively to investigate the conditions required for initiation of brittle fractures in structural steels. The test has been an important factor in discovering the cause of catastrophic failures. In our testing, we adopted "tee" specimens in lieu of horizontal plate specimens used in conventional drop weight tests per ASTM E208-95a. Figure 7 shows a drop weight test on a pre-Northridge weld specimen with failure in the weld.

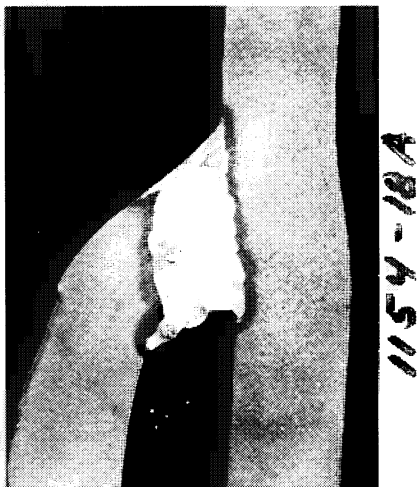
Fig. 8. SMAW overlay over FCAW core with ceramic implants.

implied that an internal defect could cause dynamic instability (Kaufman et al., 1996); a DLW layer will counteract the instability. For the drop weight and low cycle fatigue tests carried out by the task group, artificial implants of concrete and ceramic were inserted into the weld and tested. Figure 8 shows a low cycle fatigue test specimen with a Pre-Northridge weld having failure in the weld. In all these tests, the implant had no bearing on the fracture path, thereby confirming the theoretical investigations of fracture initiation.

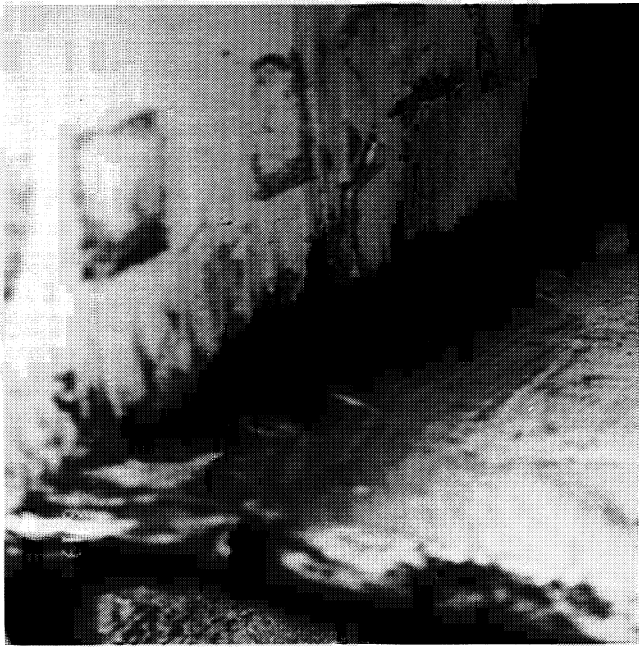
Fig. 17. Crack in top flange of beam.  
Full Size Test Specimen No. 1.

Specimen performance was excellent. The specimen reached a total rotation of 5.5 percent. It was observed that most of the deformation was occurring in the panel zone. During the second cycle at 5.5 percent total rotation a crack occurred in the top flange of the beam at the interface of the weld and the parent metal (Figure 17). At the same time a crack (slit) had started from the web cope and propagated along the k-line at the bottom flange of the beam. However, both of these slits did not propagate rapidly and appeared to have little influence on the overall connection behavior. Failure occurred when the crack in the top flange of the beam propagated from the center to the sides.
