Constrained Through-Thickness Strength of Column Flanges of Various Grades and Chemistries

ROBERT J. DEXTER, SARA D. PROCHNOW, and MINERVA I. PEREZ

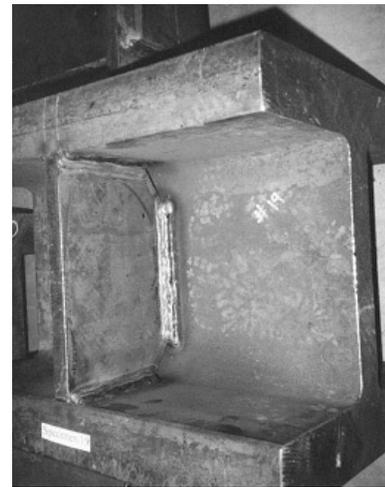
5a) specimen with groove-welded continuity plates and AISC recommended cutouts in the continuity plates (AISC, 1997)

Fig. 5. Comparison of continuity plate details.

The specimens with fillet welded continuity plates were also fabricated with inadequate cutouts, as shown in Figure 5b. Cutouts should be used in the corners of the flange/web junction to provide for termination of the web welds and the flange weld. In the basic specimen, the weld was terminated 55.6 mm (2.2 inches) from the inner flange face as shown in Figure 3 and in Figure 5a.

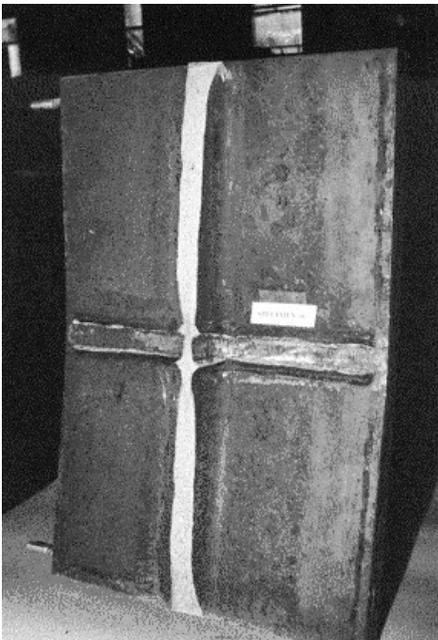
Fig. 7. Continuity plate and web failure for specimen 6. (Note, the fractured web is vertical in this photograph, and the remains of the fillet welds can be seen horizontally in the middle of the plate.)

Specimen 6 had continuity plates with fillet welds and with an inadequate cutout detail, as shown in Figure 5b. There were several distinct load drops in the stress vs. elongation curve for specimen 6 (see Figure 6) due to failure in the continuity plate-to-flange connection. After the continuity plate failures, the web began to tear and finally a brittle fracture occurred along the flange-web core region of the web (Figure 7). This specimen experienced a peak stress of 701 MPa (101 ksi) in the pull-plate and exhibited reason-

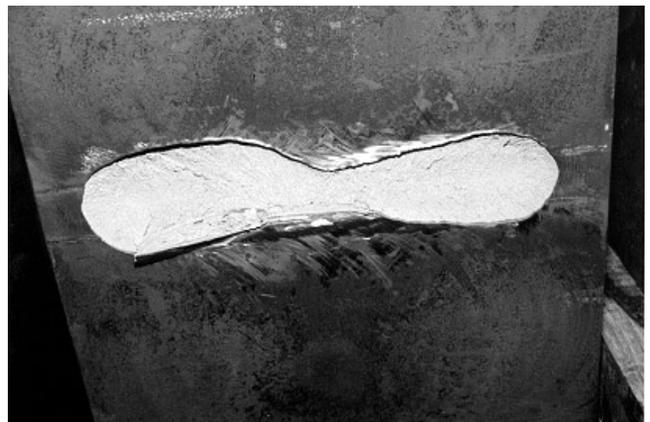
Fig. 8. View of divot-type fracture of column flange in specimen with no continuity plates. (Note, this view shows the brittle fracture on the surface of the column flange where the pull plate was. Chevron patterns are apparent on the fracture surface and point back toward the center of the flange, an indication of the origin of the fracture.)

Specimen 33 also had a 305 mm (12-inch) wide pull plate but was fabricated without continuity plates. This specimen exhibited a divot-type failure of the column flange material, albeit at very high nominal stress levels (698 MPa or 101 ksi), as shown in Table 10. No unusual features such as lamellar defects were observed on the fracture surface of this specimen, as shown in Figure 8. The fracture initiated from small inclusions in the column flange not visible to the unaided eye.

ings during the earthquake originated in the weld at the tip of the backing bar notch, whereas the divot fracture shown in Figure 8 originated in the column flange material. It seems that the divot is a characteristic of propagation of the fractures in the column under through-thickness tension, i.e. it doesn't depend on the origin of the fractures.
