# Behavior of Built-Up Shear Links Under Large Cyclic Displacement

A.M. ITANI, S. ELFASS, and B.M. DOUGLAS

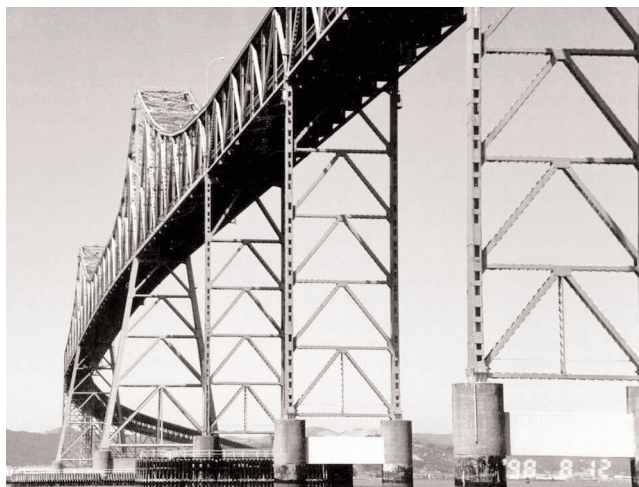
Fig. 1b. View of Richmond San Rafael towers.

The existing towers of the RSRB consisted of chevron braced frames as shown in Figure 1. The chevron braces consist of built-up sections that are connected through double gusset plates. The design for seismic upgrading of these towers was prepared by the California Department of Transportation (Caltrans) by the Gerwick, Severdrup, DMLM Joint Venture (Vincent, 1996). The seismic upgrade consists of removing most of the existing chevron braces and installing dual eccentric braced towers. Thus, the lateral forces are transferred through the new eccentric braced towers while the gravity load is transferred through the existing towers legs. Figure 2 shows the elevation view of the proposed eccentrically braced tower that consists of built-up beams. During severe earthquakes, the links between the eccentric braces become activated and dissipate the input energy by shear yielding. With this controlled yielding, the ultimate capacity and the maximum drift can be quantified to a known level (Vincent, 1996).

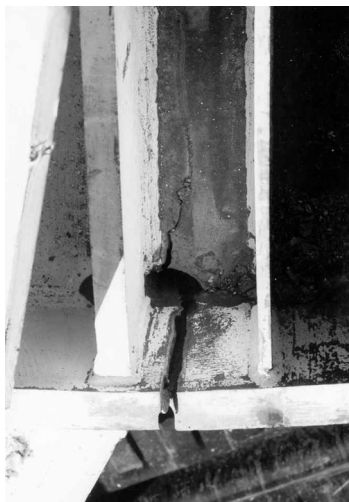
Fig. 14. Bottom flange fracture of BU30.

Upon completion of the first cycle at  $6.4\delta_y$  and proceeding to the push excursion of the second cycle, a sudden fracture occurred in the bottom flange of the shear link next to the eccentric braced weld. The bottom flange of the shear link was completely fractured as shown in Figure 14. The crack then propagated through the web of the first panel to almost one-third of the web depth. After the fracture, the load dropped to almost zero and the test was stopped.

The fracture occurred in the lower flange, immediately adjacent to the complete-joint-penetration groove weld joint at the eccentric diagonal intersection. The fracture propagated completely through the bottom flange of the shear link. It arrested after it propagated approximately 6 in. in the web.

The fracture surfaces were examined visually, and with the aid of optical scanning electron microscopes. The fracture features observed indicated a mixed mode of failure. Ductile shear rupture and brittle cleavage zones were both observed in the fracture zone. The fracture features were smeared/crushed along the center-bottom edge of the flange, which may be attributed to compressive load cycling after initial cracking occurred in the bottom flange.

Chevron features on the fracture surface indicate the brittle cleavage zone of fracture initiated near the mid-thickness of the flange directly below the web-cope area. Immediately above and below this point is a zone of ductile shear rupture. It is significant to note that the brittle cleavage fracture did not initiate at a weld defect.

With respect to weld quality, a slight overlap defect was observed at the toe of the weld that connects the web to the link bottom flange at the cope area. Also it appeared that the web cope weld access hole was flame cut without finish grinding. These workmanship flaws do not appear to have presented a significant stress riser to act as an initiation site for brittle fracture.

maximum stress concentration just below the web/cope area adjacent to the CJP weld. This stress concentration creates a substantial demand for localized strain/ductility. It is apparent that the connection exhibited some initial ductility as evidenced by the areas on the surface that show ductile shear rupture. Once the demand ductility increased, large tri-axial stresses developed from strain hardening near the web/cope area that resisted further plastic flow, ultimately causing the final brittle cleavage fracture.

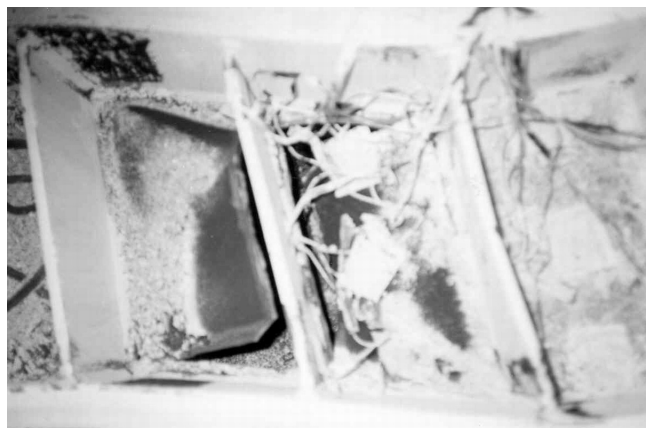
Fig. 16. Web fracture of BU16.

the pull excursion of the second cycle, a fracture occurred in the third and fourth web panel as shown in Figure 16. Severe flexural distortion at the flanges of the shear link occurred at the fractured web location. The load capacity deteriorated and reached almost 200 kips. At that level, the test was stopped. After the test, a hairline crack was noticed at the welded connection between the bottom flange and eccentric brace connection.
