# Effect of Straightening Method on the Cyclic Behavior of k-Area in Steel Rolled Shapes

BRANDON CHI and CHIA-MING UANG

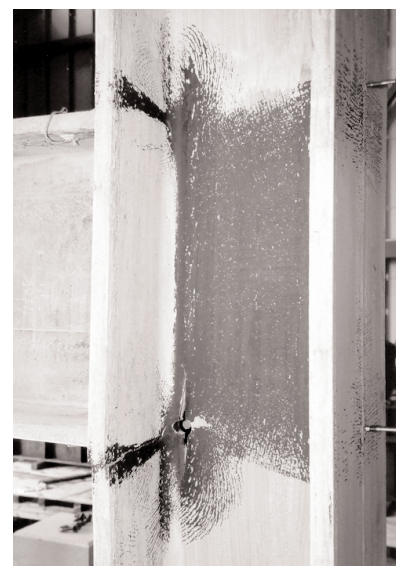
Fig. 5. Crack development and failure mode of specimen K3 (5% drift).

(a) Crack Development

(b) Column Flange Fracture

cracks developed at the toe of the beam flange groove welds at this drift level; significant kinking of the column flange was also observed. Figure 5a depicts the typical crack initiation at the toe of the beam flange groove welds. Local flange bending of the column produced stress concentration and crack initiation at the center of the column flange. The crack then propagated toward the edges of the flange that eventually fractured the column flange across its width. Complete fracture of the column flange occurred at 4 percent drift for Specimen K1 and 5 percent drift for Specimens K2 and K3 (see Figure 5b).

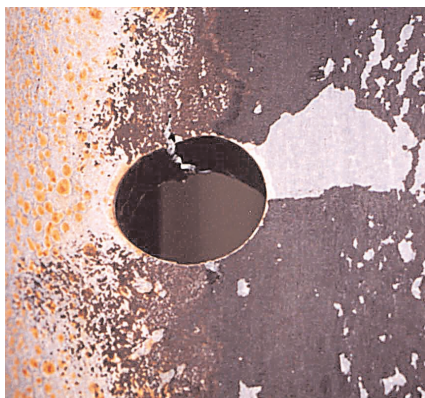
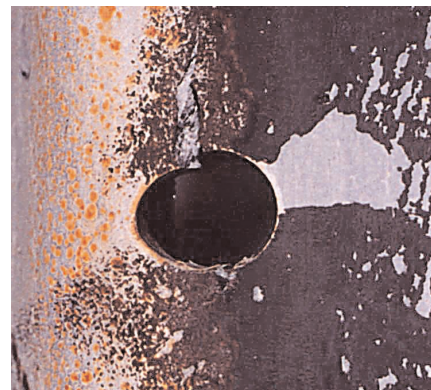
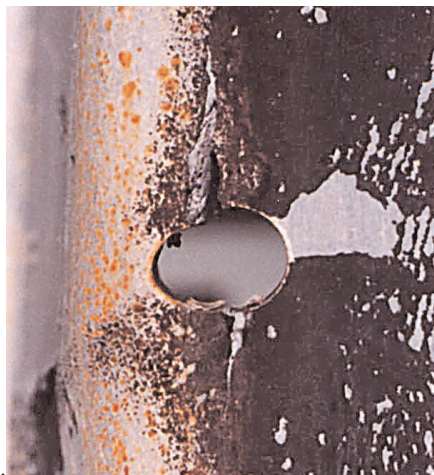
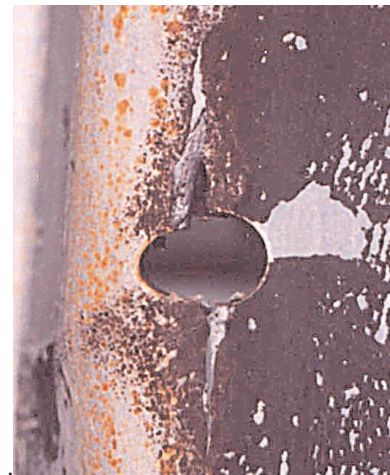
Fig. 7. Fracture propagation in hole region (Specimen K2).

(a) Drift = 7 in.

(b) Drift = 8 in.

(c) Drift = 9 in.

(d) Drift = 10 in.

At the bottom flange level, where a 1-in. hole was drilled, a crack did not initiate from the hole in Specimen K1, even though crack developed in Specimens K2 and K3 at 5 percent drift. Figure 7 shows the fracture propagation in the hole region for Specimen K2. Although the crack propagation along the k-line was relatively fast, the behavior was not brittle and the amount of strength degradation was limited.
