Experimental Evaluation of Kaiser Bolted Bracket Steel Moment-Resisting Connections

SCOTT M. ADAN and WILLIAM GIBB

The Kaiser bolted bracket (KBB) is a new beam-to-column moment connection that consists of proprietary cast high-strength steel brackets that are fastened to the flanges of a beam and then bolted to a column. This fully restrained connection is designed to eliminate field welding in steel moment frame construction.

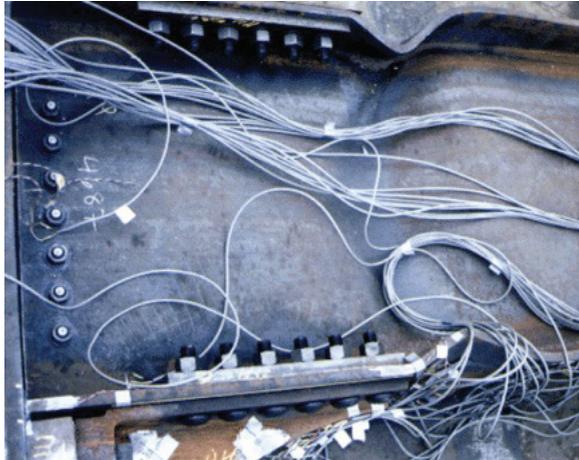
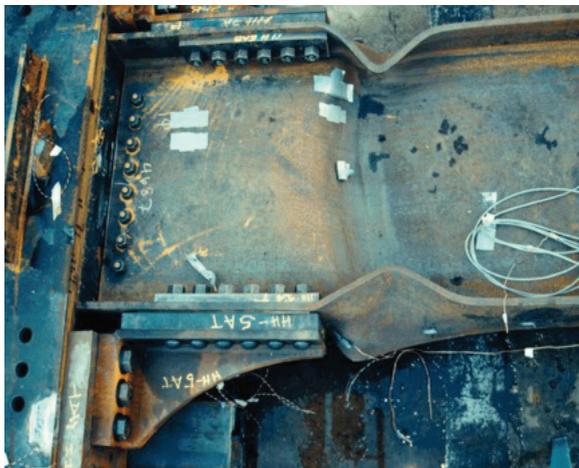
Fig. 7. Photographs of specimens at the end of testing:
 (a) HH-5 east beam hinge formation; (b) HH-5A hinge formation;
 (c) HH-5 east beam flange local buckling.

The tests were halted at 6.1% and 6.8% drift for specimen HH-5 and HH-5A, respectively, after the maximum actuator stroke was reached. At this level of rotation, a distinct plastic hinge had formed near the far end of the brackets as shown in Figures 7(a) and (b) (p. 192) for specimen HH-5 and HH-5A, respectively. Figure 7(c) shows a close-up of the beam flange near the end of the bracket in specimen HH-5 east, highlighting the ability of the thin brass washer and clamp plates to mitigate net area fracture. This detailing prevents flange buckling and abrading from distorting the first row of bolts as exhibited in earlier bolted bracket testing (Kasai et al., 1998).

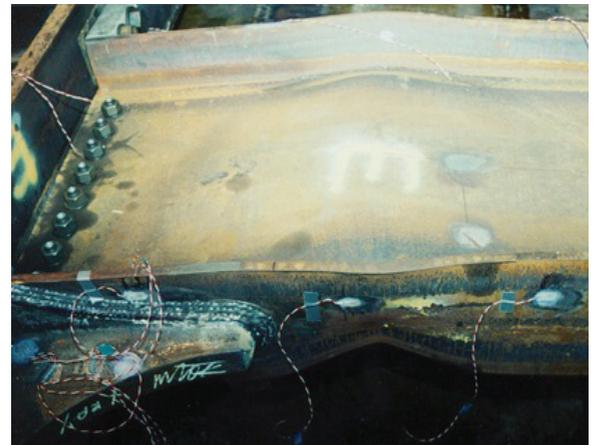
Fig. 8. Photographs of specimens at the end of testing:
 (a) HH-8 fillet weld crack close up; (b) HH-8 hinge formation;
 (c) HH-7 flange gross area fracture.

As shown in Figure 8(a) (p. 192), a 2-in. (50-mm) crack in the bracket-to beam fillet weld of specimen HH-8 was observed near the nose of the bracket at approximately 3.3% drift. Following a short pause, the test was continued with no observance of further crack growth. At approximately 5.6% drift, the test was halted to prevent damage to the apparatus due to excessive beam buckling. In both specimens HH-6 and HH-8, a plastic hinge was formed in the beam near the far end of the brackets. Figure 8(b) shows the hinge in specimen HH-8 at the end of the test.

Following a significant amount of inelastic strain, specimen HH-7 failed by gross area ductile fracture of the beam flange near the end of the bracket. While the cyclic loading of the remaining specimens at Wyle Labs was halted prior to fracture, given the observed cyclic inelastic strains, had the testing continued, flange gross area fracture would have been expected in these specimens as well.

As described previously, and as shown in Figure 8(a), the bracket fillet weld in specimen HH-8 developed a 2-in. (50-mm) crack at the nose of the bracket. Despite the incident, the test was continued with no further observed crack growth. It is believed that the high toughness weld metal was a key factor that prevented the growth of the crack. Following the test, the procedure used to fillet weld the bracket to the beam was modified to avoid terminating weld passes near the bracket nose. Apparently, the specimen HH-8 weld passes had been terminated in this region. During the subsequent tests for specimens HH-7 and HH-9, no cracks were observed in the fillet welds made with the revised procedure.

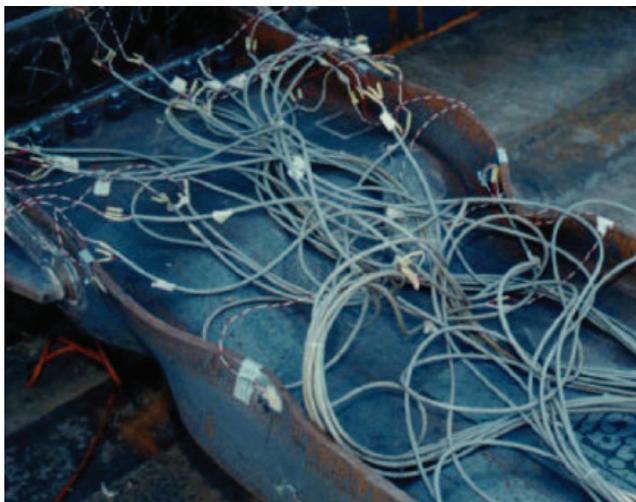
Fig. 9. Photograph of hinge formation at the end of testing specimen HH-9.
