Fatigue Testing and Retrofit Details of High-Mast Lighting Towers

RYAN J. SHERMAN, MATTHEW H. HEBDON and ROBERT J. CONNOR

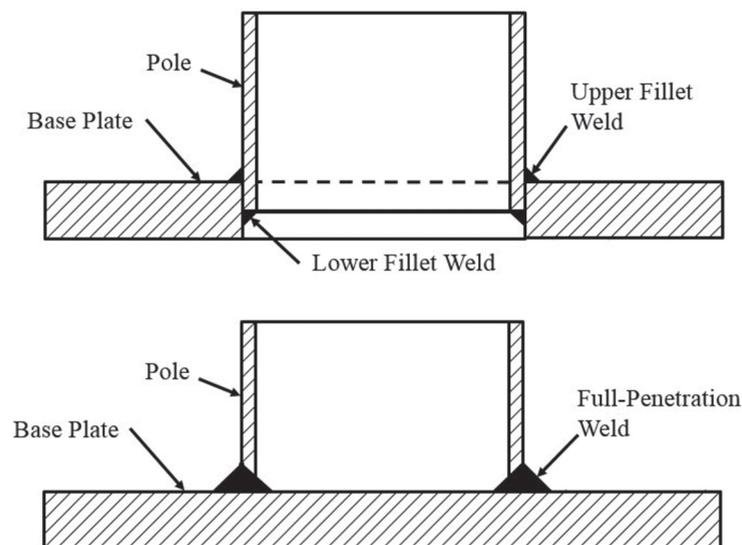
being removed from service. Sketches of these connection details can be found in Figure 1.

Fig. 1. Typical HMLT base connection details: welded-through socket (top) and full-penetration weld (bottom).

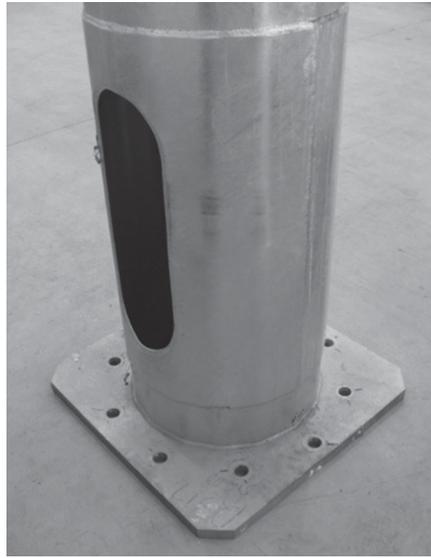
Fig. 3. Base section of as-built test specimen (note doubler plate around hand-hole detail).

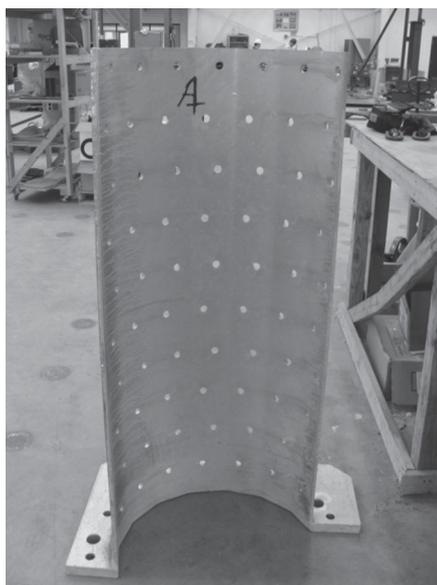
Fig. 5. Typical tall-jacket retrofit.

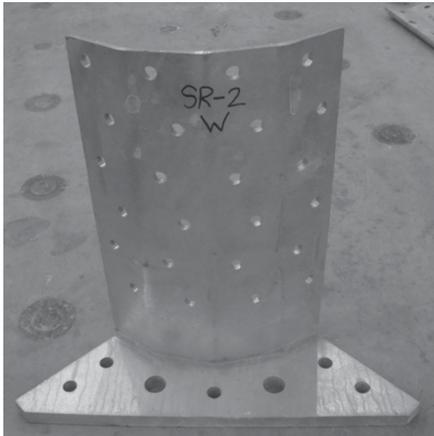
Fig. 7. Typical short-jacket retrofit.

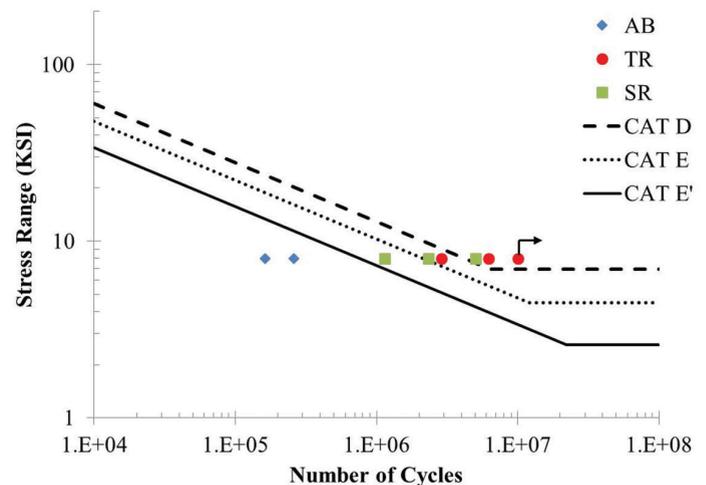
the tube wall, 8 ksi, versus the number of cycles to failure for each specimen was plotted on an *S-N* curve (see Figure 14), showing the increase in life for the jacket retrofits compared to the as-built pole specimens. This fatigue curve was indicative of the performance for in-service conditions because, for an in-service HMLT, the nominal stress-range due to loading does not change (i.e., wind or loading did not increase because a retrofit was installed). By comparing the *best* performing as-built pole specimen to the *worst* retrofit specimen (AB_2 to SR_1), an increase in life of greater than 440% was achieved.

Fig. 14. Fatigue test data (nominal stress-range) plotted with AASHTO fatigue curves.

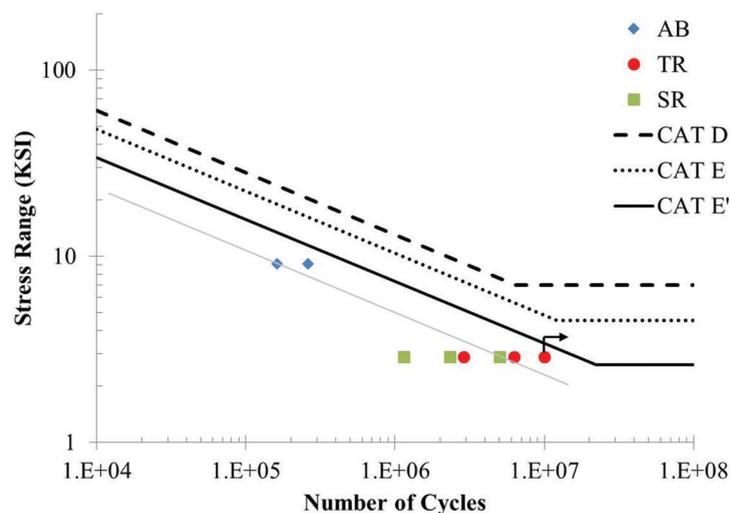
bottom of the retrofit jacket, adjacent to the weld, only the retrofit jacket was available to carry the moment due to the severed as-built pole to base connection. As a result, only cross-section of the retrofit jacket was used to calculate the stress range at this location. Using these revised stresses and the projected stresses from the as-built pole, the data were plotted again as shown in Figure 15.

Plotting the adjusted data indicated that the increase in fatigue life was primarily due to the decrease in stress range at the controlling fatigue detail and not due to a significant improvement in detail category. The sloped line through the fatigue data points in the *S-N* curve of Figure 15 suggested the behavior of the tall-jacket retrofit was approximately the same as the as-built pole. In fact, the fatigue behavior of the short-jacket retrofit appeared to be slightly worse than that of the as-built structure. The lower fatigue life was not surprising because the short jacket was observed to be more flexible. This added flexibility produced out-of-plane bending stresses near the base plate weld, which are not accounted for by the basic nominal stress range calculations. Thus, a lower fatigue life is observed. Figure 15 shows that the fatigue life of the short jackets was lower than both the as-built specimens and the tall jackets. Thus, the increase in life realized by adding the retrofit jacket was due to the drop in the effective stress range and not an improvement in fatigue category associated with the CJP weld.

Fig. 15. Fatigue test data (nominal stress-range projected to base) plotted with AASHTO fatigue curves.
