Old Bridges Give Clues to Steel Deck Performance

ROMAN WOLCHUK

Two notable examples are the Harlem River Bridge and the Bronx-Kill Bridge in New York City built in 1936 and recently resurfaced. The writer had an opportunity, on behalf of American Iron and Steel Institute, to investigate the conditions of these steel decks after 27 years of service.

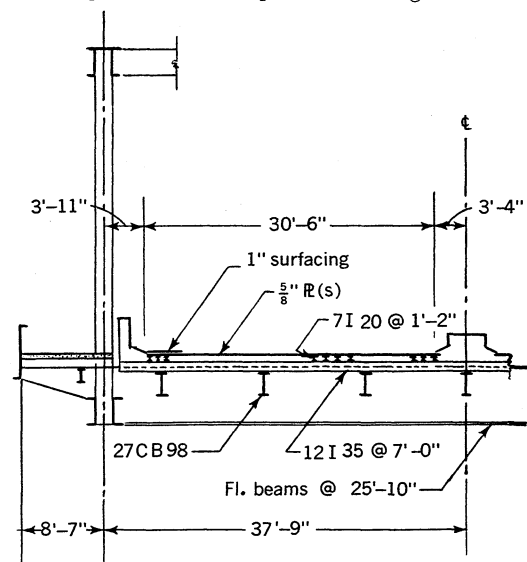
Fig. 1. Cross section of Harlem River Bridge

Figure 1 shows the cross section of the 6-lane Harlem River Bridge, a 310-ft lift span.
