Experience with Use of Heavy W Shapes in Tension

JOHN W. FISHER and ALAN W. PENSE

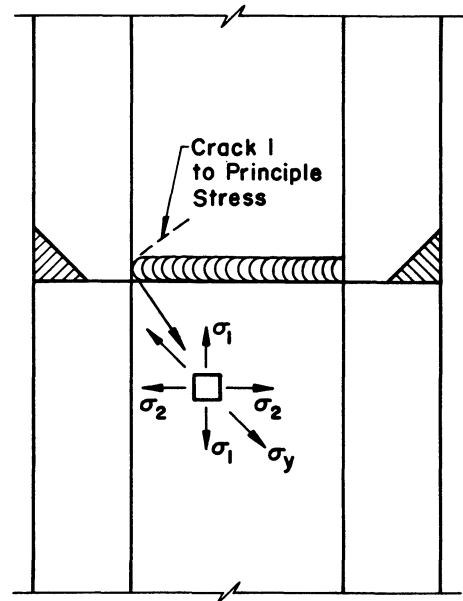
The cracks that originated from the web groove weld termination shown in Fig. 3 occurred in W14 x 730 A572 Gr.50 steel sections. However, this material was supplied as killed, fine-grain practice steel. Figure 13 shows a schematic of the column splice at the cracked section. Partial penetration welds were placed in the flange and a double bevel groove weld in the web. At the weld ends, the bevel was radiused to the surface. Production of the web groove welds creates high tensile residual stresses in the longitudinal and transverse directions of the weld as it shrinks and cools. As a result, the weld termination resides in a region of yield point residual tensile stress in the web of the rolled section.

Fig. 13. Schematic showing joint geometry, residual stress orientation and crack

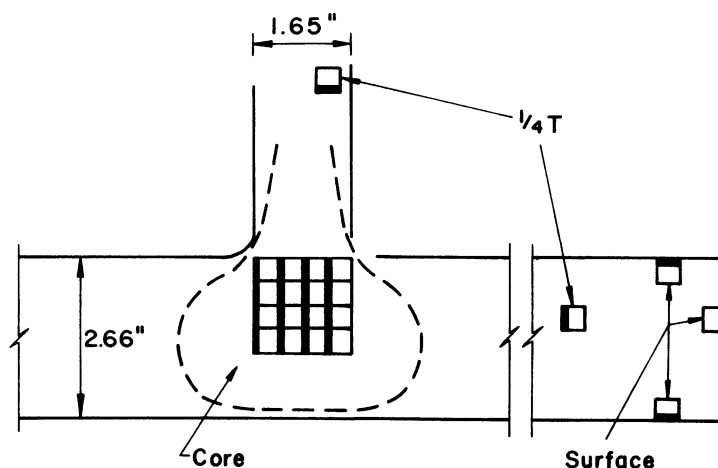
Fig. 14. Schematic showing CVN test locations for W14 \times 370 section—Supplier A

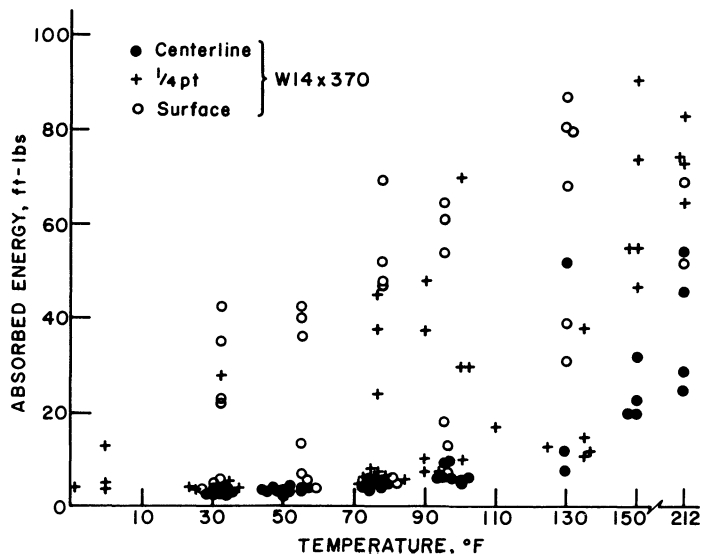
The test results are summarized in Fig. 15. The quarter thickness results are shown as plus (+), the web-flange core region and centerline as solid dots (•) and the surface layers as open dots (○). It can be seen the web-flange core and the flange quarter-point specimens provided comparable levels of absorbed energy up to 130° F. The quarter thickness web specimens were similar to the flange-web core below 100° F. However, at and above 100° F, web specimens tended to exhibit higher levels of energy and scatter.

The surface specimens with notches within 0.2 in. of the surface all provided significantly higher levels of absorbed

Fig. 15. Charpy V-Notch test results for $W14 \times 370$ section—Supplier A

energy. Few of these specimens were less than 20 ft-lbs. down to 32° F. Hence, the outer skin of the section had adequate levels of absorbed energy for welded surface attachments and shallow discontinuities.

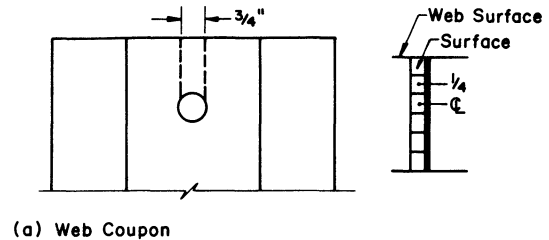
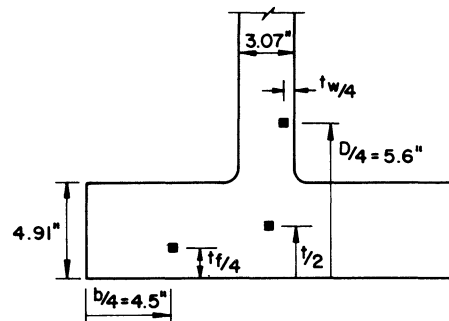
Test results for web specimens fabricated from the small segment shown in Fig. 16 are plotted in Fig. 17. The specimens were tested at 40° F, 70° F and 100° F. These test results are shown as solid and open dots and a cross. The tests by the manufacturer were only carried out at 100° F. The test results can be seen to be similar to the absorbed energy provided by the $W14 \times 370$ section plotted in Fig. 15. One side of the web surface provided higher levels of energy than its companion on the other side.

Fig. 16. Schematic showing CVN test specimen locations for $W14 \times 730$ sections—Supplier B

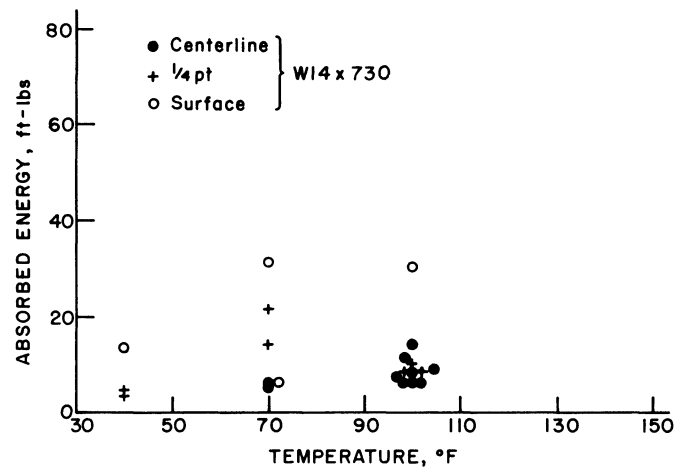
The test results indicate that providing steel to killed fine-grain practice has not resulted in a significantly higher level of absorbed energy for this $W14 \times 730$ section. Its level of absorbed energy is nearly identical to the $W14 \times 370$ section that was not furnished as killed steel. Additional tests carried out on $W14 \times 550$, $W14 \times 605$ and $W14 \times 730$ A572 steel sections were limited to segments cut from the web, shown schematically in Fig. 18. The surface layer specimens were notched so that the notch tip was within 0.25 in. of the web surface. The other speci-

Fig. 17. Charpy V-notch test results for $W14 \times 730$ section—Supplier B

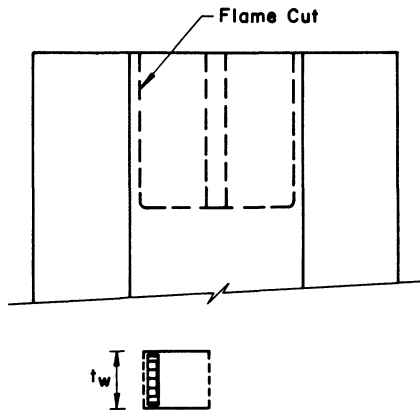
Compact tension specimens were fabricated from the flanges of the $W14 \times 370$ section in Fig. 1 and the web segments sketched in Fig. 18 for the $W14 \times 550$, $W14 \times 605$ and $W14 \times 730$ sections. Each flange specimen was cen-

Fig. 18. Schematic showing location of web samples removed from sections—Supplier C

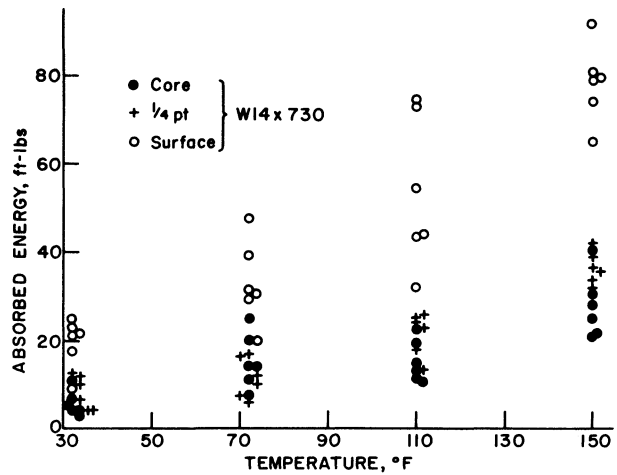
mens were near the 1/4 point and the centerline. The test results are plotted in Figs. 19, 20 and 21 for the three section sizes. It can be seen that the centerline of each of the web sections examined were not much different than the $W14 \times 370$ and $W14 \times 730$ sections shown in Figs. 15 and 17. The results from the $W14 \times 605$ section were lower at one end than at the other. However, both ends fell within the scatterband provided by the $W14 \times 370$ section.

Fig. 21. Charpy V-notch test results from web of W14 x 730 section—Supplier C

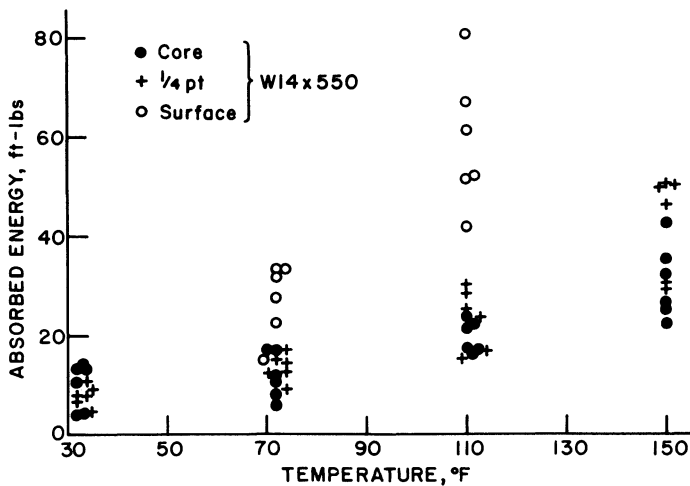
Fig. 19. Charpy V-notch test results from web of W14 x 550 section—Supplier C

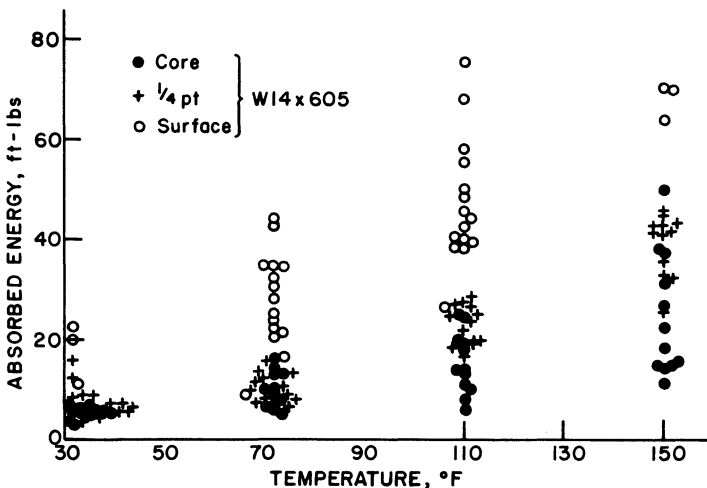
Fig. 20. Charpy V-notch test results from web of W14 x 605 section—Supplier C

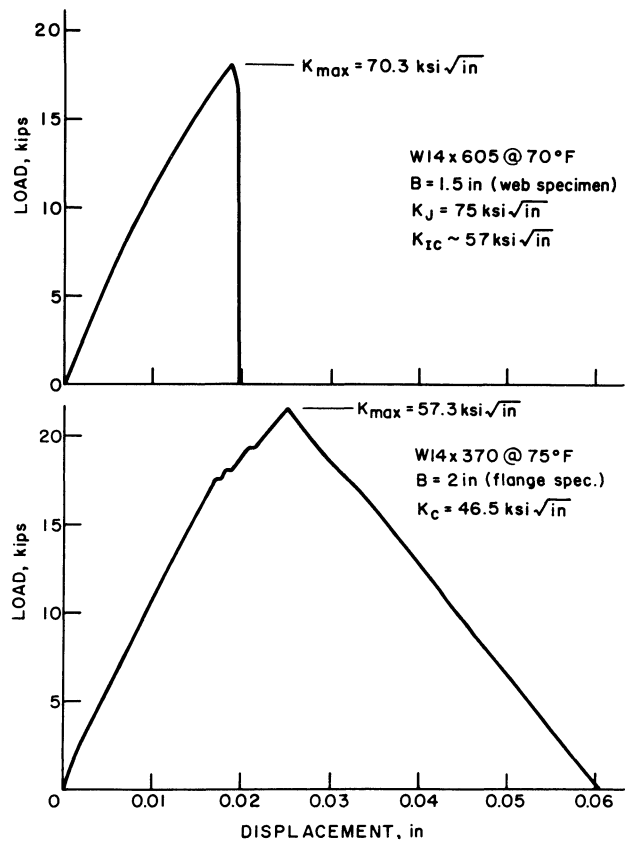
Fig. 22. Load-deflection curves for compact tension specimens from W14 x 370 section (Supplier A) and W14 x 730 section (Supplier C)

Figure 22 shows the load-deflection curve obtained for

tests carried out at 75° F on the W14 × 370 flange and the W14 × 605 web. The load-deflection plot for the flange was typical for all tests carried out on the west beam section in Fig. 2. Linear behavior was experienced throughout the tests of the W14 × 370 section specimen. An initial pop-in crack was heard at a stress intensity level of 34.2 ksi √in. As is apparent, several other crack advances were observed before final failure. The 5% secant offset suggests a fracture toughness K_{Ic} (static) of 46.5 ksi √in. It is apparent the fracture toughness for the service temperature corresponding to failure is about 45 ksi √in. for the W14 × 370 section in Fig. 23.

The W14 × 605 section results plotted in Fig. 23 exhibited minor inelastic behavior before fracture. K_{max} (based on P_{max}) provides a fracture toughness estimate of 70 ksi √in. The K_J estimate considering the nonlinear load-deflection response increased the estimated resistance to 75 ksi √in. The 1-½ in. thick specimen did not satisfy the requirements of E399 for plane strain, i.e.

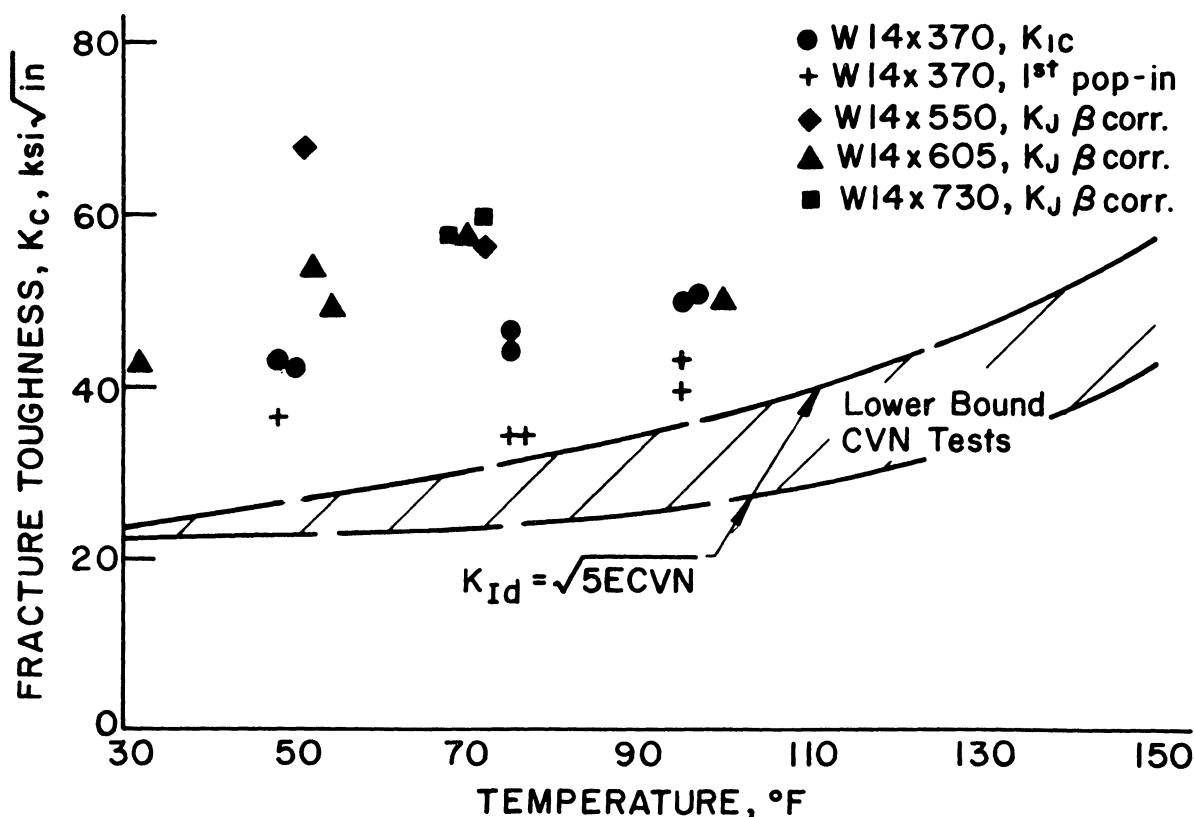
Fig. 23. Comparison of static K_c test results with lower bound Charpy V-notch estimate (dynamic)

Figure 23 summarizes the test results and also shows the estimated dynamic fracture toughness K_{Id} , based on the relationship:

where K_{Id} is psi $\sqrt{\text{in.}}$, E is the elastic modulus in psi and CVN is ft-lbs of absorbed energy. This relationship is frequently referred to as the Barsom correlation equation.³ It can be seen from Fig. 23 the fracture toughness between 50° and 100° F varies between 40 ksi $\sqrt{\text{in.}}$ and 60 ksi $\sqrt{\text{in.}}$ for all five sections examined.

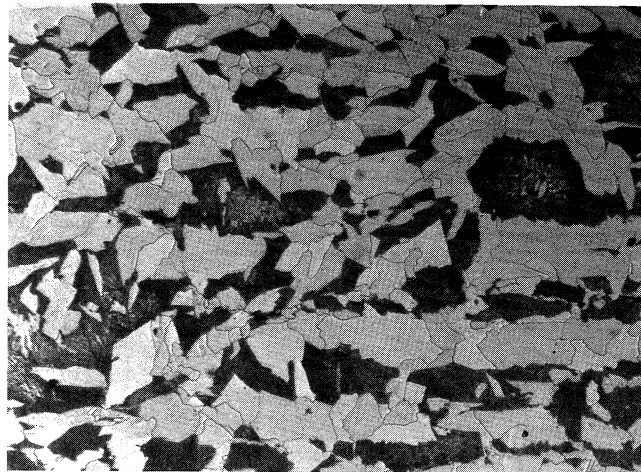
region was between ASTM 0 and 1. Hence, the two W14 × 370 sections connected by the groove-welded splices had comparable metallographic characteristics. The section removed from the web of the W14 × 730 section, shown schematically in Fig. 16, exhibited similar characteristics. Figure 27 is a photomicrograph of the web centerline @ 100x. The prior austenite grain size is between ASTM 1 and 2. A cylindrical core removed from the web-flange core area provided an ASTM grain size of 0. Hence, the killed-steel W14 × 730 sections provided essentially the same prior austenite grain size characteristics as the W14 × 370 sections in Figs. 25 and 26.

Fig. 27. Microstructure of web centerline (see Fig. 16.) @ 100x (W14 × 730)—Supplier B

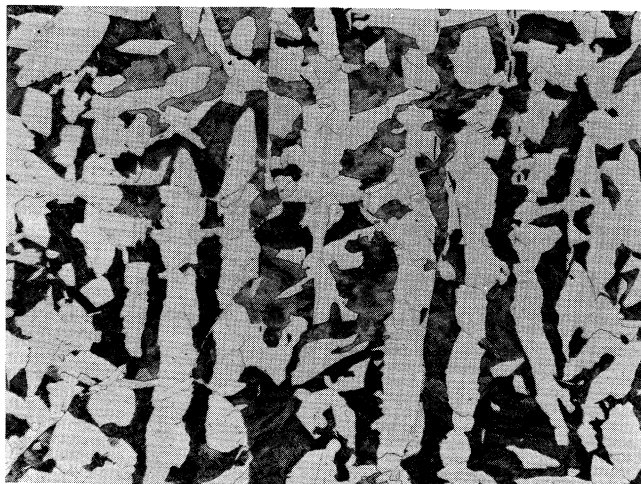
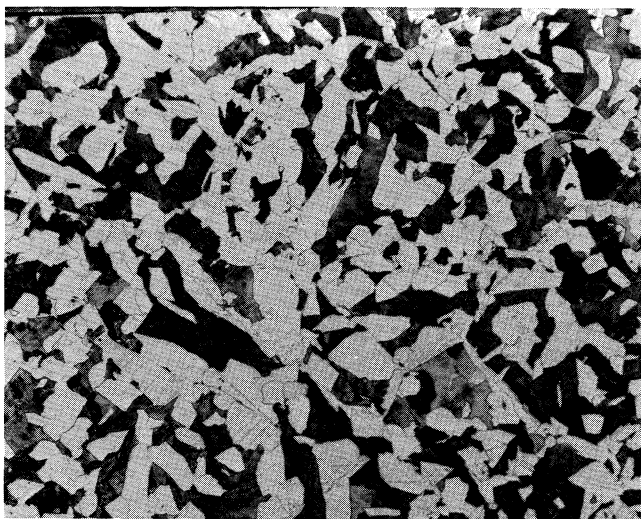
The microstructure of the three sections examined from Supplier C are shown in Figs. 28, 29 and 30. The photomicrographs show the grain structure at the web centerline near the quarter depth of the section. The evaluation of grain size in these steels is more complex than might appear. The microstructure of these steels contains two constituents. Light etching nearly pure iron (ferrite) and dark etching iron-iron carbide mixtures (pearlite). These two regions are seen in Fig. 28, where the ferrite grain size is most readily seen. It is the size of the white-appearing grains that surround the darker pearlite regions. This is *not* the grain size referred to in “fine-grain practice.” Rather, it is the austenite grain size existing at high temperatures prior to transformation to ferrite and pearlite. Prior austenite grain size is difficult to evaluate in low-carbon steels because the low temperature products, ferrite and pearlite obscure it. It is evaluated using ASTM specifications which involve heating the steel to a temperature below that at which the steel is usually finished (1,750 °F) followed by slow cooling. This is called the McQuaid-EHN Test. When a steel is finished in normal rolling practice, it may not actually have a fine prior austenite grain size that it has in the McQuaid-EHN Test, especially in the heavy sections.

Fig. 28. Microstructure of web—W14 × 550—Supplier C

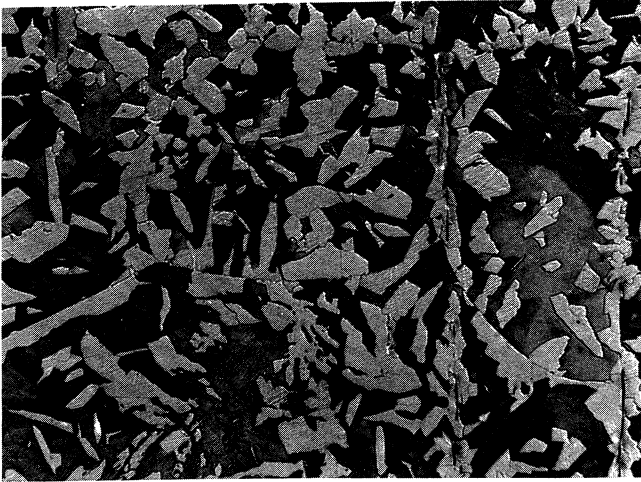
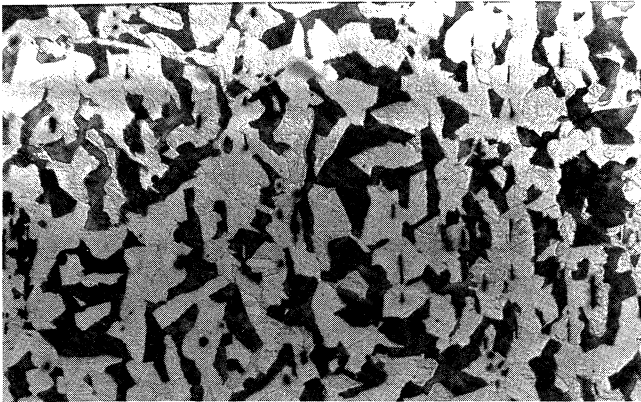
Fig. 29. Microstructure of web—W14 × 605—Supplier C

tice steel (Fig. 29a), is large. Thus, fine-grain practice had little effect here.

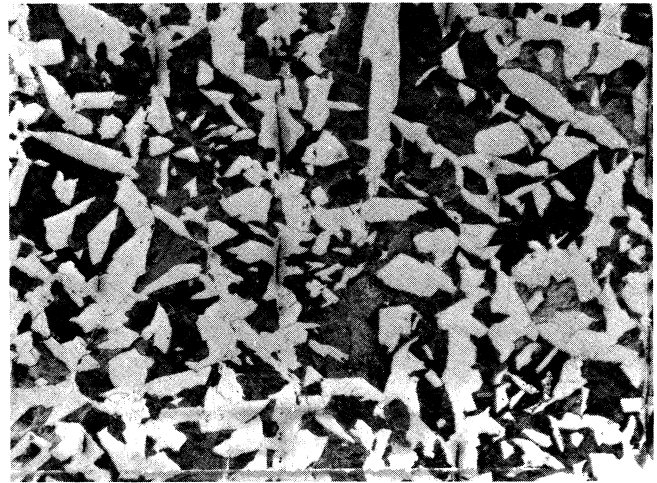
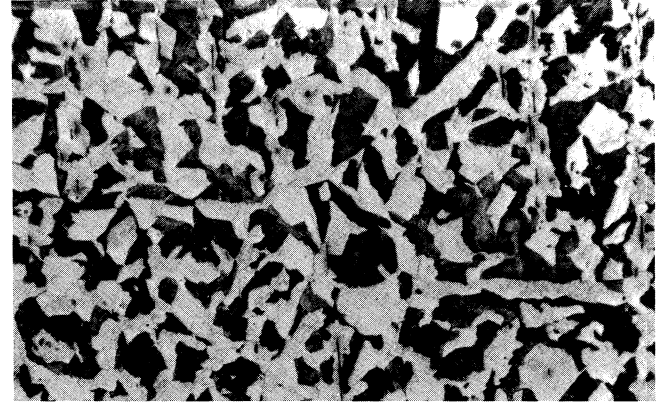
If the pearlite content is unusually high, the prior austenite grain size can be seen. This is the case in Figs. 25 and 26, and to a lesser extent in Fig. 30. The prior austenite grain sizes in both these cases, one of which is a fine-grain prac-

Fig. 30. Microstructure of web W14 × 730—Supplier C

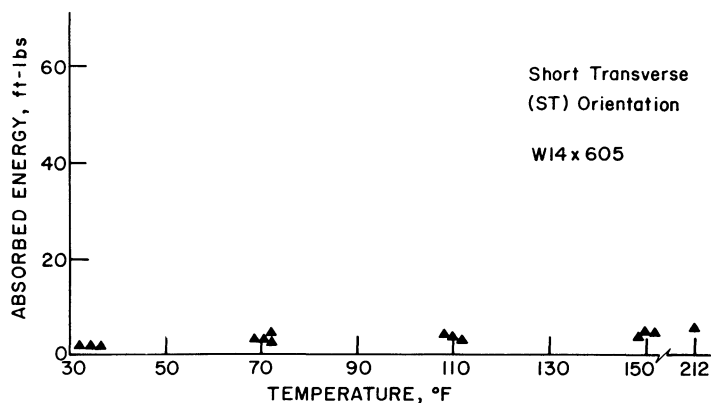
Fig. 34. Charpy V-notch tests in the short transverse direction (notch parallel to axis of shape) W14 x 605 section

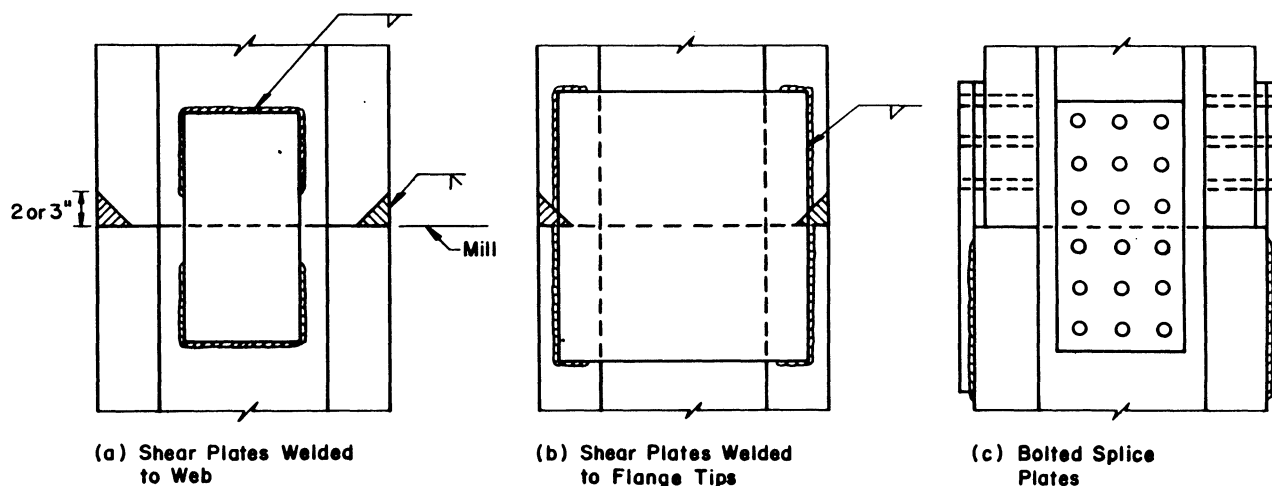
Fig. 35. Alternative column splices that minimize weld restraint tensile stresses

Care should be exercised in the use of groove welded web splices in column sections. It would be preferable to use fillet-welded shear plates attached to the section surface or a bolted shear splice, as in Fig. 35.
