Distortion-Induced Cracking During Transit

W. M. KIM RODDIS

3. CASE STUDY: DISTORTION-INDUCED CRACKING IN BUILDING TRUSSES DURING TRANSIT

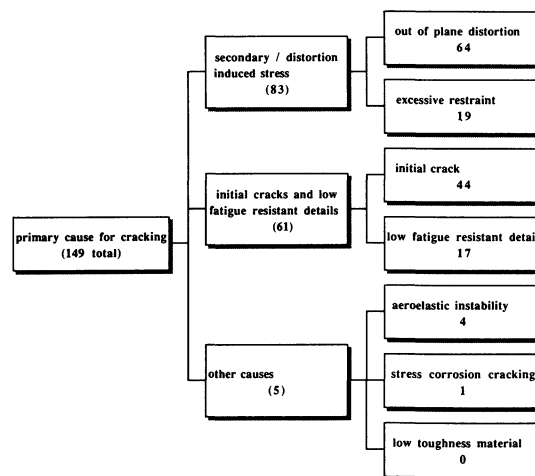
To understand distortion-induced cracking, it is useful to determine what conditions commonly lead to this type of cracking and then look at some specific examples. A survey^{6,7} of 142 bridges that had developed cracking gathered information on 149 instances of primary cracking causes (several sites developed more than one type of cracking in different structural details). These 149 cases can be grouped into 28 categories of cracking.¹ These categories can be organized into a hierarchical classification of the most prevalent causes of cracking in steel bridges.⁸ Figure 1 shows such a classification of the primary causes for cracking in steel bridges, with the most commonly occurring items listed first. It is interesting to note that low toughness material was not observed to be a primary cause of cracking in this survey, showing that specifying higher toughness will not avoid cracking problems in many cases. The most frequent type of cracking is that caused by secondary and/or distortion-induced stress. Figure 2 shows

Fig. 1. Classification of primary causes for cracking in steel bridges.

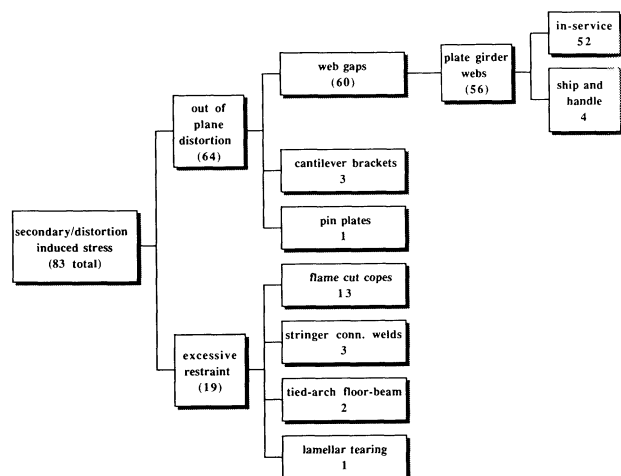
a more detailed breakdown of this major category of cracking, listing subcategories based on the kind of detail in which cracking occurs. The subclass of out-of-plane distortion in a small gap, usually a segment of a girder web, is the largest group. The local gap geometry creates an abrupt stiffness change. The effects of cyclic distortions are concentrated in this gap, leading to distortion-induced cracking. These web-gap cracks are most frequently due to distortions experienced in-service but may also be caused by handling and shipping.

Fig. 2. Classification of secondary/distortion-induced stress cracking in steel bridges.
