The Effects of a Severe Fire on the Steel Frame of an Office Building

ROBERT J. DEXTER and LE-WU LU

ABSTRACT

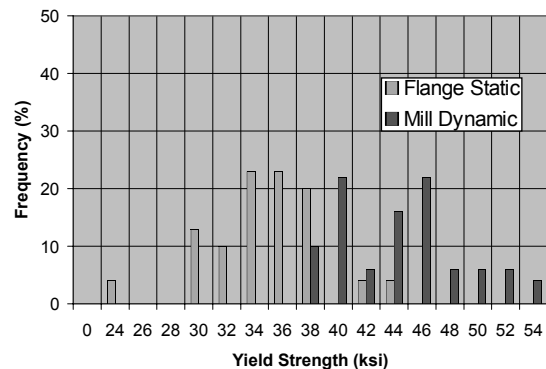
For example, Figure 5 compares the static test data from the flanges of many A36 column sections tested at Lehigh University (the same data shown in Figures 3 and 4) to the corresponding mill test data for these same shapes. It can be seen that the mean of the static test data is about 36 ksi whereas there are no mill test values less than 36 ksi, and the mean from the mill test data is about 43 ksi.

Fig. 5. Comparison of distribution of quasi-static yield strength values from flanges of a large number of A36 structural steel sections unaffected by fire (bars on the left) to the corresponding mill test data (bars on the right).

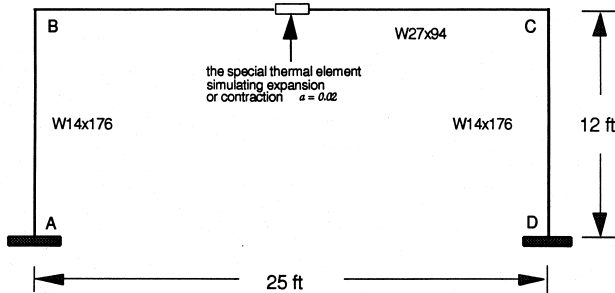
This principle can be demonstrated by a simple example. Consider the fixed-base portal frame shown in Figure 10, which has a span length of 25 ft and a height of 12 ft. The girder is W27×94, and the columns are W14×176, all made of A36 steel. The effect of expansion or contraction of the girder due to fire is simulated by inserting, at its mid-span, a special thermal element. The amount of thermal expansion (or contraction) can be adjusted to produce a desired “locked-in” bending moment distribution in the members as well as some rotation at a plastic hinge. In this example, the plastic hinges develop at the base of the columns.

Fig. 10. Model for analyzing a steel portal frame with local expansion or contraction at center of girder.

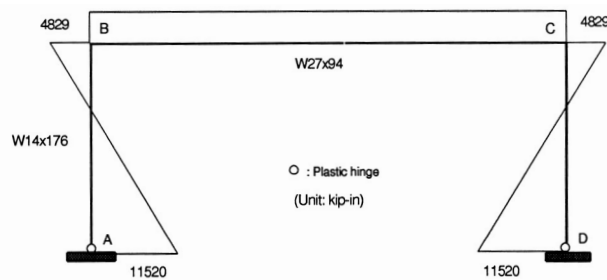
Figure 11 shows the bending moment distribution in the frame (plotted on the tension side of the members) when the amount of expansion introduced in the element is just sufficient to cause plastic hinges to form at these locations

Fig. 11. Bending moment diagram when plastic hinges form at column bases due to expansion of girder.

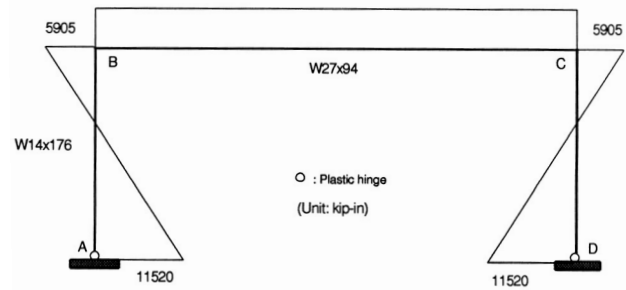
(bending moment equal to 11,520 kip-in). For any additional expansion, the columns behave as if they are hinged at their bases, as the resisting moment is unchanged. The bending moment diagram in the structure when the rotations of the lower ends of the columns reach 0.0029 radians is shown in Figure 12.

Fig. 12. Bending moment diagram when rotation at plastic hinges is 0.0029 radians.

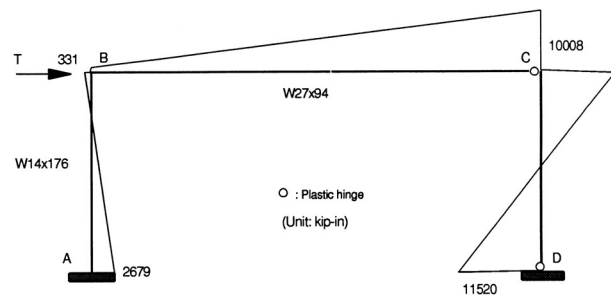
At this stage, a lateral load T is applied to the frame at the girder level. During the application of T , the bending moment at D remains at the plastic moment value. Figure 13 shows the bending moment diagram in the frame when a plastic hinge forms at C , the leeward end of the girder, at $T = 128$ kips. The bending moment at that location is 10,008 kip-in.

Fig. 13. Bending moment diagram when lateral load $T = 128$ kips.

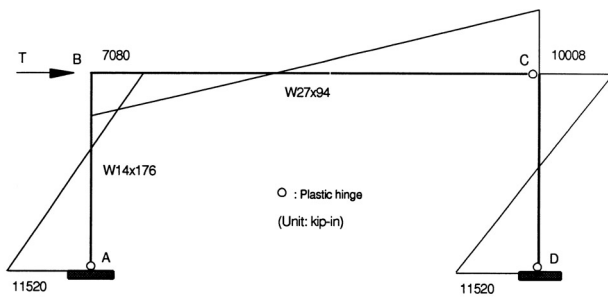
When T reaches 278 kips, a third plastic hinge re-forms at the base of the left column (point A). Figure 14 shows the bending moment distribution at this load. The structure attains its plastic limit load at $T = 299$ kips when a fourth plastic hinge forms at the windward end of the girder (point B). The limit-load moment diagram is given in Figure 15. The relationship between the lateral load T and the horizontal displacement at the column top is shown in Figure 16 [marked as Case (a)].

Fig. 14. Bending moment diagram when lateral load $T = 278$ kips.

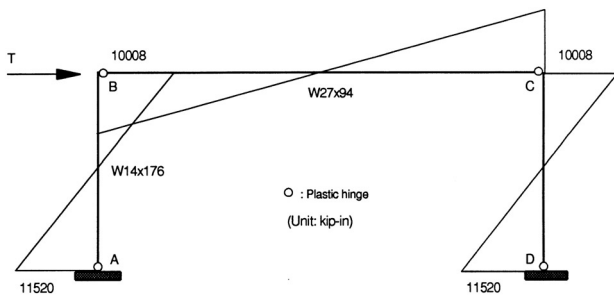
Fig. 15. Bending moment diagram when ultimate load $T = 299$ kips is reached.

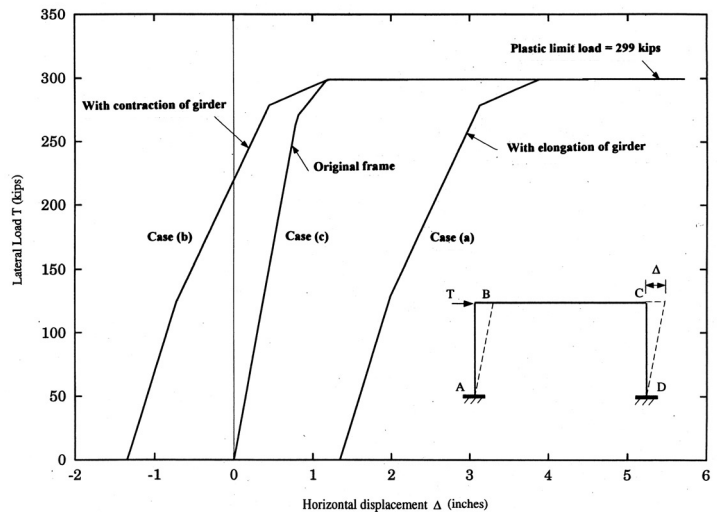
also plotted in Figure 16, shows that the same plastic limit load is achieved. Case (c) assumes that there are no "locked-in" stresses anywhere in the structure, and the analysis again gives the same plastic limit load. All the calculations are based on the original geometry and dimensions of the frame.

Fig. 16. Lateral load vs. displacement relationships of portal frame.

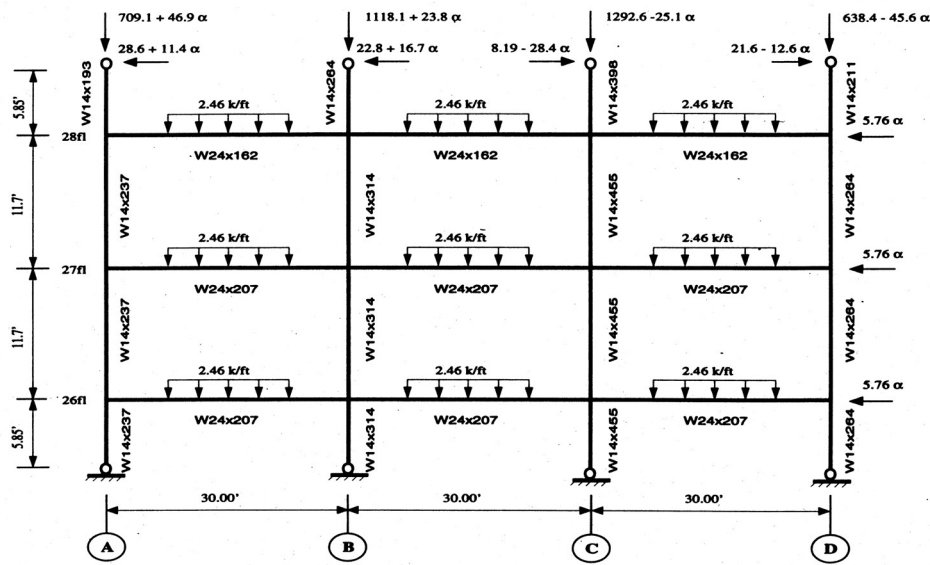
To study the influence of locked-in forces on lateral load-carrying capacity, the structure is analyzed once without locked-in forces and again with locked-in forces. An inelastic finite element program was used to perform the analysis. The locked-in forces (bending moment, axial and shear forces) are again introduced by using a thermal element placed at the mid-span of each girder. The introduction of the locked-in forces occurs when the structure is loaded only by gravity load. The amount of thermal contractions in the girders is adjusted so that the initial distortions of the columns are in approximate agreement with those found in the post-fire inspection (see Figure 2). The initial distortions and the locked-in bending moment distribution assumed in the analysis are shown, respectively, in Figures 18 and 19.

Fig. 17. Load arrangement for analysis without locked-in forces.
