Cyclic Behavior of Large Beam-column Assemblies

EGOR P. POPOV, NAVIN R. AMIN, JASON J. C. LOUIE and ROY M. STEPHEN

This paper, with minor modifications, is reprinted from *Earthquake Spectra*, the professional journal of the Earthquake Engineering Research Institute, Vol. 1:2, 1985.

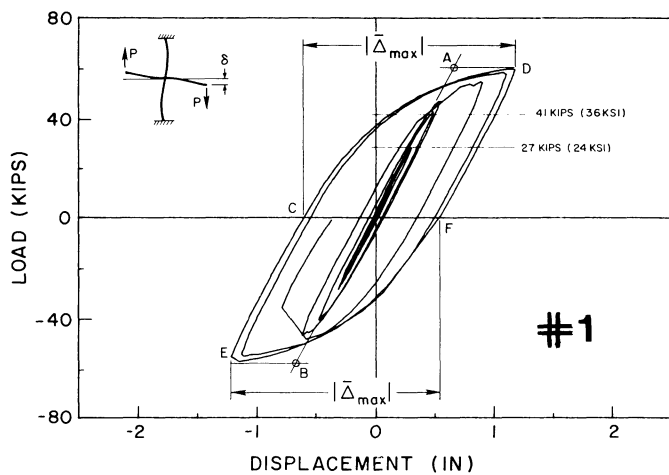
Fig. 8. Average cantilever end load vs. average beam-end deflection—Specimen 1

end deflection for Specimen 1 is shown in Fig. 8. The specimen responded elastically up to and slightly beyond the load equivalent to the nominal maximum beam stress of 36 ksi. The total applied moment vs. panel shear strain is shown in Fig. 9. All of the hysteretic loops exhibited stable characteristics. The maximum average load reached by the actuators was about 60 kips at an average tip displacement of 1.2 in.

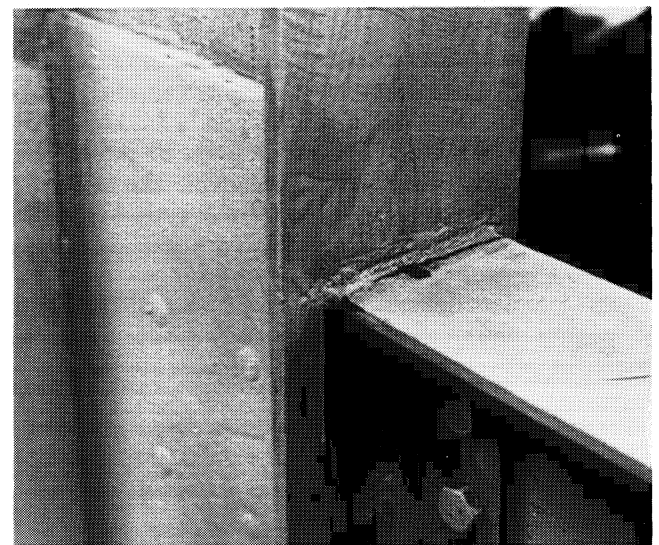
Fig. 10. Specimen 1a instrumentation arrangement and 1b failure location

In Fig. 10a, the linear potentiometers for measuring horizontal displacements between flanges, as well as a pair of similar instruments placed diagonally for determining the panel zone distortion, are shown. The photograph in Fig. 10a was taken at the nominal beam yield load, and one can note the cracking of the whitewash in the panel zone indicating yielding of the column web. The specimen failed abruptly with noise; complete flange failure occurred in the heat-affected zone of the beam-to-column weld. The frac-

tured specimen is shown in Fig. 10b. Note, no cracking of whitewash can be observed on the doubler plate, showing little participation of this relatively thin plate in resisting panel shear. During the test, the panel zone buckled at center $\frac{1}{8}$ in. to $\frac{3}{16}$ in. out of plane.

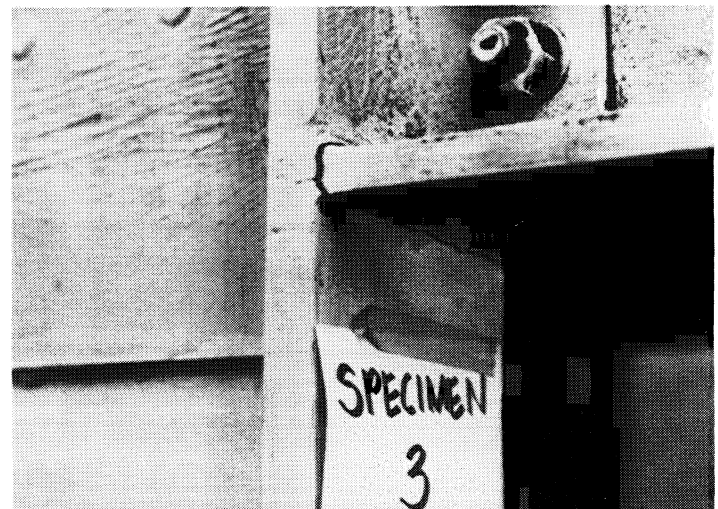
Fig. 16. Specimen 3a during testing and 3b after failure

Specimen 3—The average cantilever load vs. average beam deflection for Specimen 3 is given in Fig. 14, and the total applied moment vs. panel shear strain is shown in Fig. 15. The average maximum beam tip load was about 125 kips at an average tip displacement of 1.4 in. Figure 16a shows the doubler plate at the end of the test indicating strong participation of the $\frac{3}{8}$ -in. thick doubler plate in resisting the panel shear. The fracture of the flange weld is shown in Fig. 16b. The failure was very abrupt.

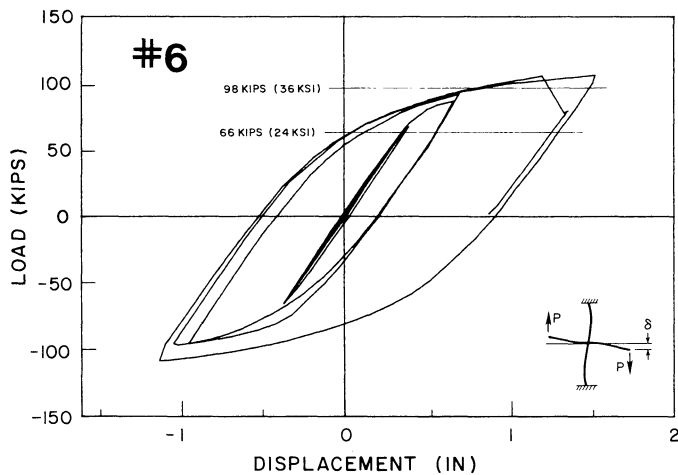
Fig. 24. Average cantilever end load vs. average beam-end deflection—Specimen 6

Specimen 6—This specimen was similar to Specimen 4, except no doubler plate was applied, making the panel zone weaker in shear. To prevent the panel zone from buckling, a vertical stiffener was attached approximately at mid-width of the panel zone. Such plates occur in most framing. The average cantilever beam load vs. average beam deflection is shown in Fig. 24, and the total applied moment vs. panel shear strain is given in Fig. 25. The average maximum load applied was 106 kips at an average beam tip displacement

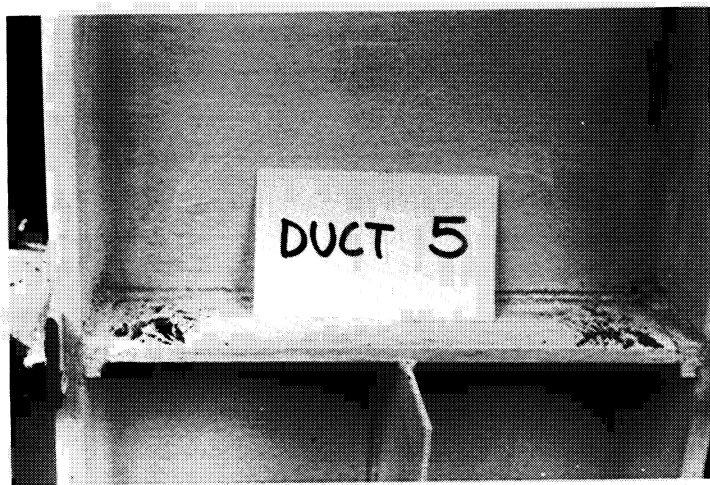
Fig. 33. Evidence of stiffener yielding next to column flanges shown by cracked whitewash—Specimen 8

Very little inelastic behavior was observed in the beams in the first six experiments. Yielding was largely confined to the panel zones. Some beam as well as panel zone yielding occurred in the last two specimens. Generally, stiffeners showed yielding near the column flanges (an example in Fig. 33). Moreover, during some tests it could be observed the stiffeners buckled in the regions adjoining column flanges. Measurements of the longitudinal stiffener elongations essentially confirm this observation (see Fig. 19 and another example in Fig. 34). From these two illustrations it is evident stiffeners yield when beam moments are in the strain-hardening range.
