## ERRATA

# The Behavior of Steel Perimeter Columns in a High-Rise Building under Fire

Paper by MARIA M. GARLOCK and SPENCER E. QUIEL

(4th Quarter, 2007)

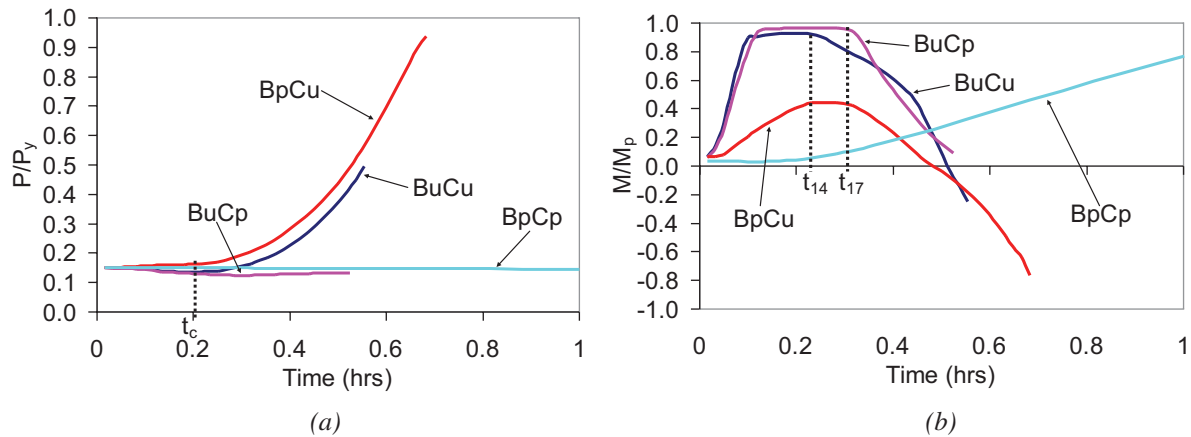
Fig. 11. Computational (SAFIR) results for (a) axial load ratio and (b) plastic moment ratio for the column just below Floor 23.

Figure 11 should be replaced with the following figure.
