# Post-Fire Axial Load Resistance of Concrete-Filled, Double-Skin Tube (CFDST) Stub Columns

REZA IMANI and MICHEL BRUNEAU

## ABSTRACT

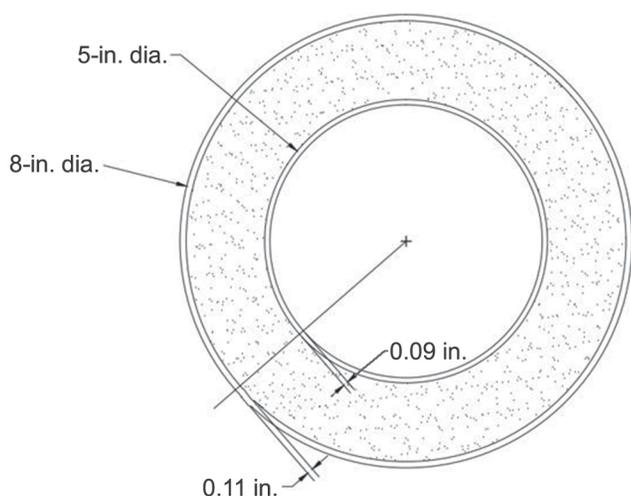
Fig. 1. Cross-section of the stub columns.

Three CFDST stub columns, hereafter referred to as SC1, SC2 and SC3, were built with identical height (i.e., 1 ft) and cross-section, as shown in Figure 1. The outer and inner tubes were 8-in.- and 5-in.-diameter, respectively. Concrete was poured between the two steel tubes and, as recommended in AISC Design Guide 19 *Fire Resistance of Structural Steel Framing* (Ruddy et al., 2003), small ( $\frac{1}{8}$ -in.) vent holes were drilled into the outer tube to allow pressure relief during fire. Stub columns SC1 and SC2 were built with a total of two and three ventilation holes. The first two holes were located on the round surface of the specimens at about 1 in. from the top and bottom plates. The third hole, in the case of SC2, was located at the opposite side of the other vent hole drilled near the top end. The intent of an additional hole was to crudely investigate whether additional ventilation and pressure relief can change the resulting temperature history and possible permanent fire effects on the strength of stub columns. Stub column SC3 was kept without holes and was to be tested without having been previously exposed to fire to serve as a reference specimen.

where  $A$  refers to the cross-sectional area described by the subscripts (i.e., inner/outer steel tubes and concrete between them) and  $f_y$  is the yield strength of steel taken from the coupon tests. Applying Equation 1 to the CFDST section geometry shown in Figure 1 with the room temperature values of  $f'_c$  and  $f_y$  (as previously mentioned) results in a theoretical squash load value of 428 kips. The theoretical calculated value is within 10% of the test result (i.e., 471 kips).

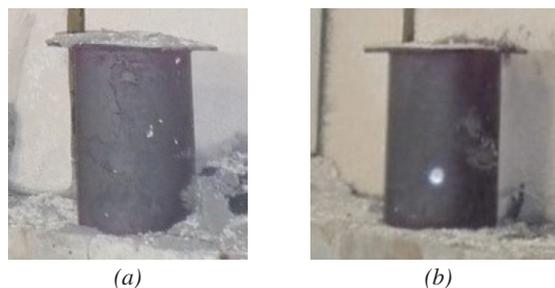
Fig. 2. Stub columns after fire test: (a) SC1; (b) SC2.

compression limit state. No visible damage was detected on the stub columns after the fire test for the intensity and duration described earlier. Both specimens were left to gradually cool down to room temperature.

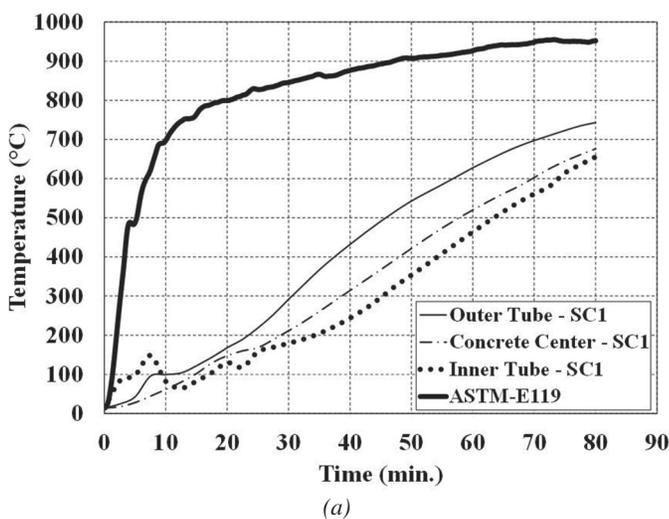
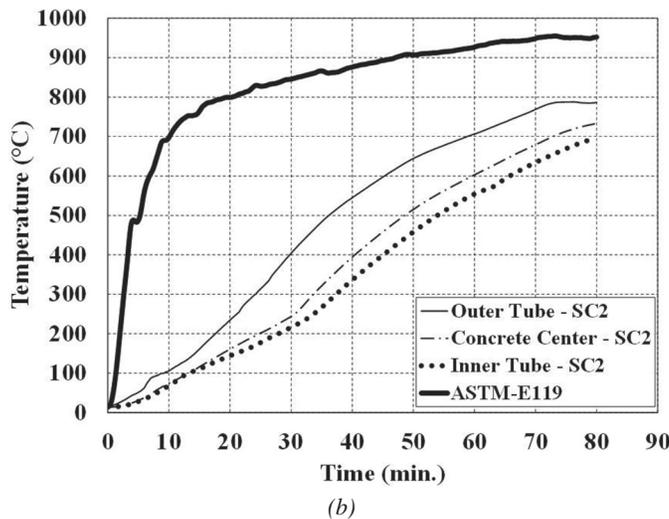
Fig. 3. Temperature data measured from the stub columns: (a) SC1; (b) SC2.

Figure 3 shows the time histories of temperature recorded by the thermocouples installed in the stub columns along with the average furnace air temperature during fire. Note that the actual test stopped at around 70 minutes and the recorders were kept operating for a few additional minutes. The recorded temperature curves generally show a smooth increasing trend, except for the ones recorded by the thermocouples installed on the surface of the inner tube for both SC1 and SC2 that show sudden fluctuations, especially during the first 20 minutes of the test. These fluctuations are speculated to occur due to the random arrangement of aggregates in the concrete of the specimens, causing moisture and pressure relief at certain times and affecting the thermocouple readings.

thermocouples installed in SC2 are about 50°C higher than the values for SC1. Because the difference in temperature is noticeable in values recorded on the outer surfaces of columns and from the beginning stages of the test, it is inferred that the reason for this difference is likely related to the different locations of the stub columns at the bottom of the furnace. Note that nine thermocouples were installed at different heights inside the furnace, and the average of readings from all of those was used to control average temperature to follow the standard fire curve. Beyond this, recommended additional experimental research may be informative to study the possible effect of vent holes on temperature distribution within the specimens.

where  $k_{c,\theta_{max}}$  is a reduction factor that is provided in Eurocode 4 tables for normal- and light-weight concrete and  $f'_c$  refers to the compressive strength of concrete at room temperature. Considering  $\theta_{max} \approx 700^\circ\text{C}$  for the case in hand (see Figure 3) and a  $k_{c,\theta_{max}}$  factor of 0.3 (from Eurocode 4 tabulated values), the residual compressive strength is calculated to be about 27% of the initial (i.e., room temperature)  $f'_c$  value. For steel, although it is considered to almost fully recover after cooling down to room temperatures from maximum temperature levels seen in Figure 3, Eurocode conservatively recommends a 10% reduction factor to be applied to the room temperature yield strength value.

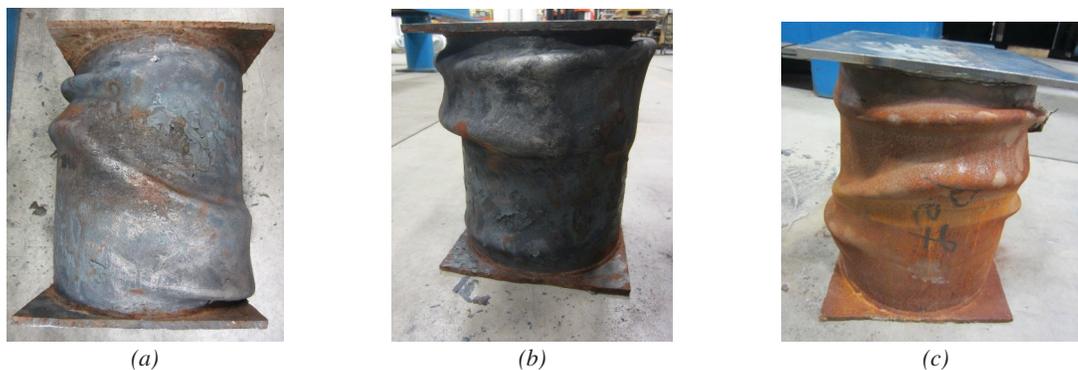
Fig. 4. Failed stub columns: (a) SC1; (b) SC2; (c) SC3.

To investigate the permanent effects of an approximate 1-hour-long fire exposure on the squash load of CFDST columns (ASTM, 2012), an axial loading test was conducted on the SC1, SC2 and SC3 stub columns. The squash tests were conducted using the 2,200,000-lb uniaxial loading testing facility of Taylor Devices Inc. in Buffalo, New York. Axial load was applied to 12×12×¼-in. cap plates welded to both ends of each stub column. All tests were terminated upon observance of significant loss in axial load capacity, which was typically accompanied by severe local buckling of the steel. Figure 4 shows photos of all three failed stub columns.

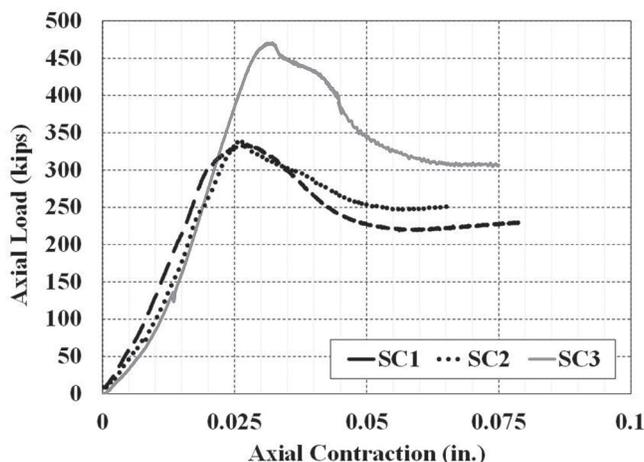
Fig. 5. Axial force vs. axial contraction curves from squash tests.

Figure 5 shows axial load versus axial contraction results for all three stub columns (SC1, SC2 and SC3). The initial phase of all three curves (i.e., axial contraction below 0.025 in.) nearly follows a similar path, suggesting that the fire loading history, in the absence of structural loads, has caused no significant permanent effects on the elastic stiffness of SC1 and SC2.

However, the figure demonstrates differences in maximum strength and post-maximum strength for the three specimens. Stub columns SC1 and SC2, which were both subjected to fire previously, had maximum axial load values of 334 and 339 kips, respectively. These values are about 28% less than the 471-kip squash load obtained for the reference specimen not subjected to fire (SC3).

calculated with the average measured strength values at room temperature and the reduction factors mentioned earlier for the case in hand, a theoretical reduction of 40% is achieved for the squash load of stub columns. As such, test results reveal that the strength reduction factors specified in Eurocode 4 might be slightly conservative (28% reduction in test versus the calculated 40%) but can provide a reasonable estimate of the post-fire conditions. A similar reduction is seen in the post-peak strength plateau reached in both SC1 and SC2 curves, where SC1 and SC2, respectively, show 18 and 24% reductions in axial force from the recorded value of 305 kips for SC3 (i.e., the specimen not subjected to fire).
