# Integrity of Structural Steel After Exposure to Fire

R. H. R. TIDE

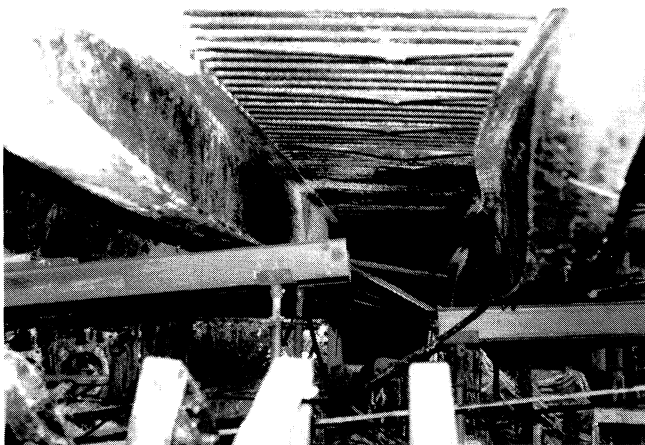
Fig. 7. Considerable thermally induced beam twisting.

Camber and sweep of each fire exposed, structural steel member should be determined using appropriate measurement techniques (plumb bob, stringline, laser). A Category 1, 2 or 3 designation should then be assigned to each member. Most often, the Category 2 or 3 designation can be assigned without measuring because of severe local buckles or excessive deflections. Illustrative examples of member categorization are presented in Figures 7 to 9. In Figure 7, the two

twisted steel beams would be classified as Category 2. Members like this would usually be discarded for economical reasons even though heat straightening is possible. Similarly, the buckled beam shown in Figure 8 would probably be replaced for economical reasons. In comparison, the severe local buckling in the column shown in Figure 9 would normally be repaired under loaded conditions. Because of supported load above and the location, the cost to replace the column justifies in-place repair by either reinforcing plates, heat straightening, or both. However, for this particular case there was unacceptable vertical displacement, and therefore the column was replaced after jacking up the column shaft so that the floor grade could be reestablished.

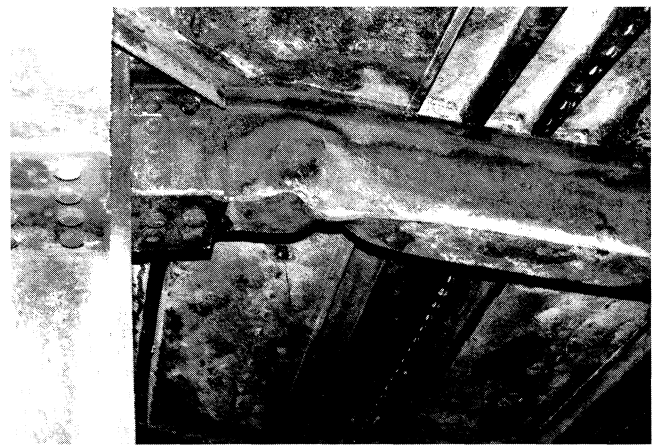
Fig. 8. Severe local buckle in beam.
