CLOSURE

The Effects of Over-Compressing ASTM F959 Direct Tension Indicators on A325 Bolts Used in Shear Connections

Paper by EDWIN R. SCHMECKPEPER, RICHARD J. NIELSEN, and GUY GENTRY
(1st Quarter, 1999)

Closure by Edwin R. Schmeckpeper

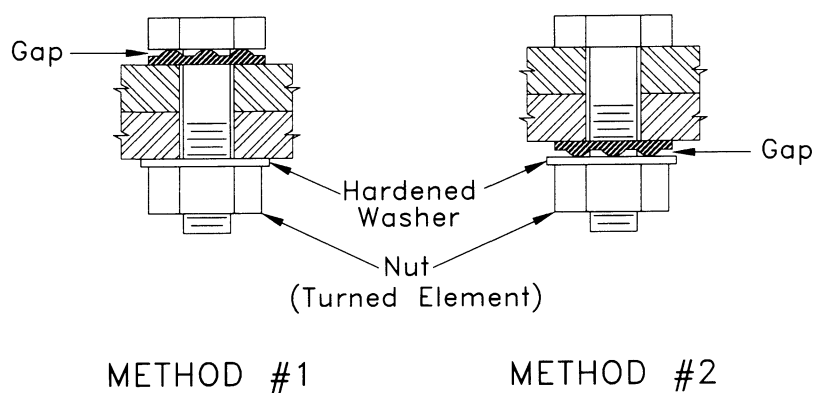
The comments concerning Figure 1 on page 40 of the subject paper are correct. There is a drafting error in Figure 1, for Method #2. The location of the DTI and hardened washer are transposed. The correct figure is given below.

Fig. 1. (Revised) DTI Installation Methods

It should be noted that the text of the paper which refers to Figure 1, on page 40, paragraph 2, places the DTI in the

correct location. The paper states “in Method No. 2, DTIs are placed under the ‘turned’ part”.
