# Experiments on the Effects of Power Actuated Fasteners on the Strength of Open Web Steel Joists

MICHAEL D. ENGELHARDT, ZACHARY KATES, HERMANN BECK and BLAKE STASNEY

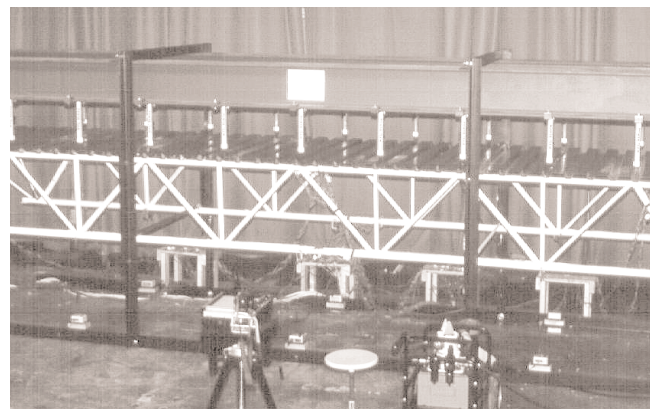
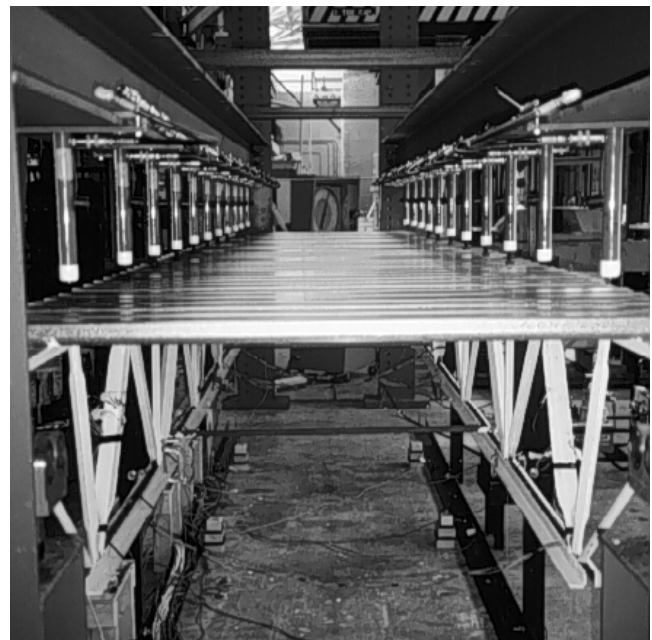
Fig. 3. Photos of test specimen.

(a) Overall view

(b) Section View

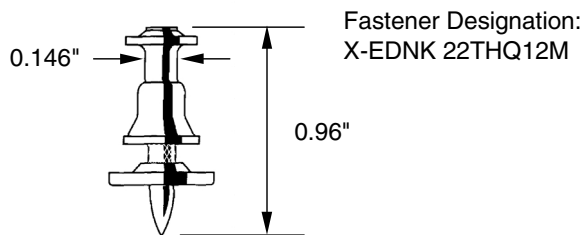
Fig. 4. PAF used in test specimens.

For specimens with PAFs, the fastener chosen for these tests is illustrated in Figure 4. The fastener is manufactured by Hilti Corp. and is designated as "X-EDNK 22THQ12M." The slightly tapered fastener is 0.146 in.

in diameter and approximately 1 in. in length. In addition to the knurled shaft, the fastener has a flat steel washer that assists in aligning the fastener in the installation tool. The washer also provides for a large bearing area on the steel deck, and is intended to prevent the deck from pulling over the top of the fastener. As shown in Figure 4, there is an additional conical washer between the head of the fastener and the flat washer. This conical washer is compressed during fastener installation. This compressed washer is intended to serve as a spring, to assist in keeping the decking in contact with the joist angle and to adjust for variations in energy requirements to properly install the fastener. According to the manufacturer's literature, this fastener is specifically intended for use in fastening steel deck to steel joists, with joist angle thickness in the range of about  $\frac{1}{8}$  in. to  $\frac{1}{4}$  in. As indicated in Table 2, the top chord angles of the 16K2 joists were just under  $\frac{1}{8}$  in. in thickness. The fasteners were installed using a pneumatically driven tool. During the installation process, the joists were supported only at their ends, to simulate the flexibility of the roof system during fastener installation. Figure 5 shows views of installed PAFs. Installation of the PAFs into the thin top chord angles of the 16K2 joists caused slight permanent distortions of the chord angle, as seen in Figure 5(b). As described earlier, the effect of these distortions on the buckling strength of the top chord members was of particular concern.

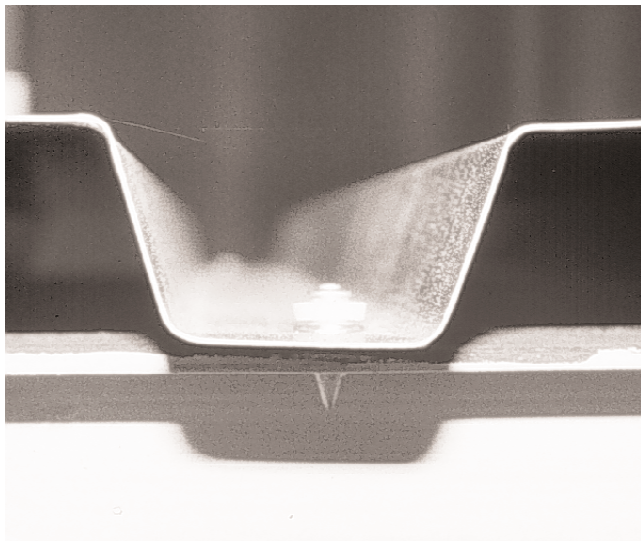
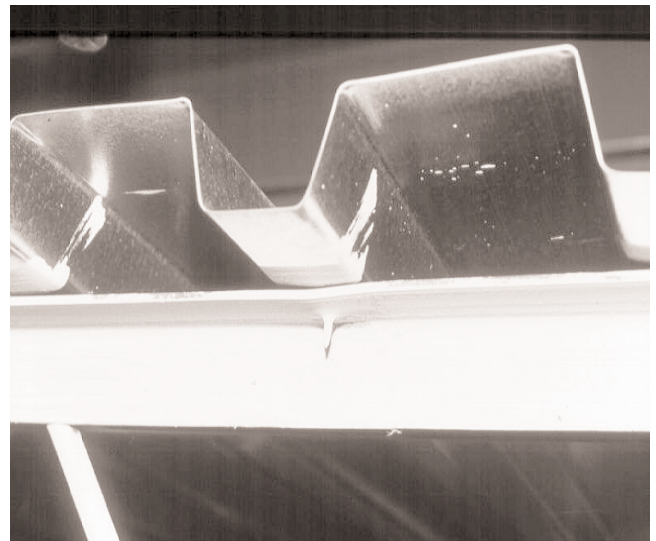
Fig. 5. PAF installed in joist.

(a) PAF in 26K5 joist

(b) PAF in 16K2 joist

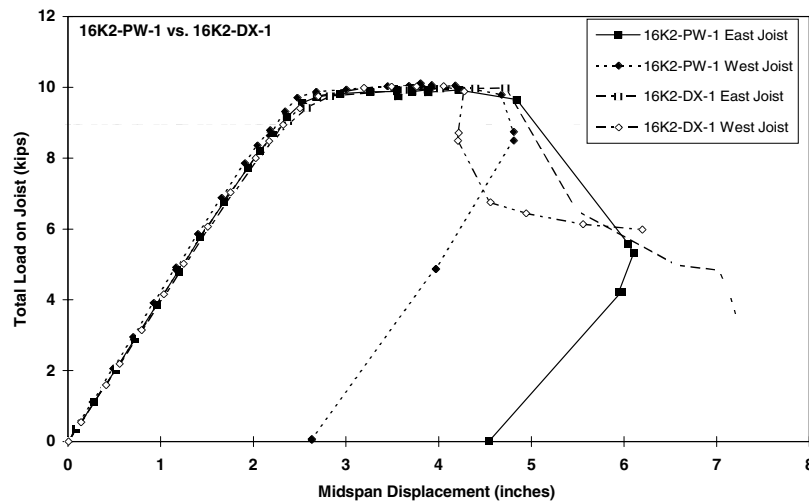
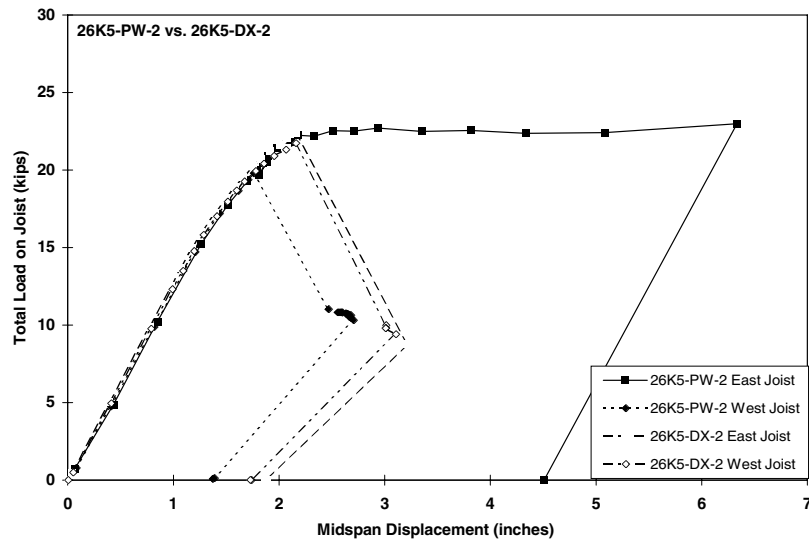
Fig. 6. Typical load-deflection response for joists.

Typical load-deflection plots for several joists are shown in Figure 6. The total load on the joist versus the measured midspan deflection is shown for several 16K2 joists in Figure 6(a) and for several 26K5 joists in Figure 6(b). Based on these load-deflection plots, a ductility ratio was computed for each joist and is listed in Table 4. The ductility ratio was computed as the deflection at joist failure (when unloading occurred) divided by the deflection at yield. Yield was defined at the knee of the load-deflection curve for joists that exhibited a plateau in the load deflection curve, such as the 16K2 joists plotted in Figure 6(a). Several joists exhibited no significant yielding prior to fail-

(a) 16K2-PW-1 and 16K2-DX-1 specimens

(b) 26K5-PW-2 and 26K5-DX-2 specimens

ure, such as three of the 26K5 joists plotted in Figure 6(b). For these cases, the deflection at failure was taken equal to the deflection at yield, resulting in a ductility ratio of 1.0. Thus, joists with a ductility ratio of 1.0 in Table 4 exhibited essentially no ductility prior to failure.

with PAFs. In addition, the 16K2 joists with either puddle welds or PAFs showed essentially the same failure modes. In each case, yielding of the bottom chord occurred first, resulting in a plateau in the load-deflection response of the joist as illustrated by the plots in Figure 6(a). This bottom chord yielding was the source of overall ductility observed in these joists. Yielding of the bottom chord was then ultimately followed by buckling of the central top chord member, which then caused unloading of the joist.

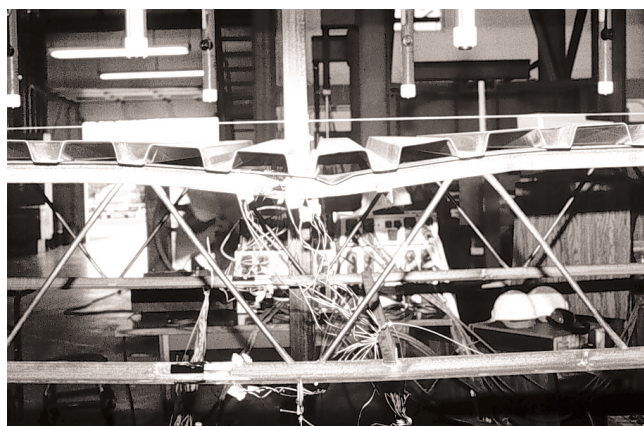
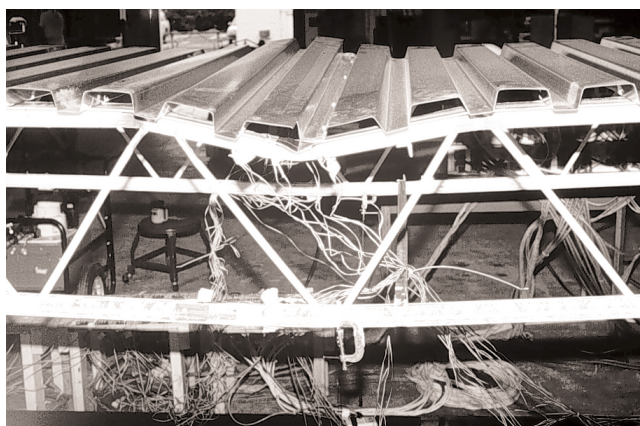
Fig. 7. Buckling of top chord members in 16K2 Joists.

As indicated in Table 4, the top chords for most of the 16K2 joists failed by flexural buckling in the plane of the joist. Figure 7 shows buckled top chords in Specimens 16K2-PW-1 (puddle welds at 36/7 pattern) and Specimen 16K2-DX-1 (PAFs at 36/7 pattern). These photos illustrate the similarity in the joist failure modes. Observe also that for both specimens, the deck remained fastened to the top chord despite the large deformations and distortions of the top chord after buckling. This was observed for specimens both with puddle welds and with PAFs. For two of the joists with puddle welds and for one joist with PAFs, the top chord angles experienced a localized buckling mode of the angle legs as opposed to a flexural type buckling. The failure loads for these joists, however, were no different from the others.

(a) Specimen 16K2-PW-1 (east joist)

(b) Specimen 16K2-DX-1 (east joist)
